City of Corvallis
Corvallis School District

Osborn Aquatic Center Facilities Assessment

Scott
Edwards
Architecture

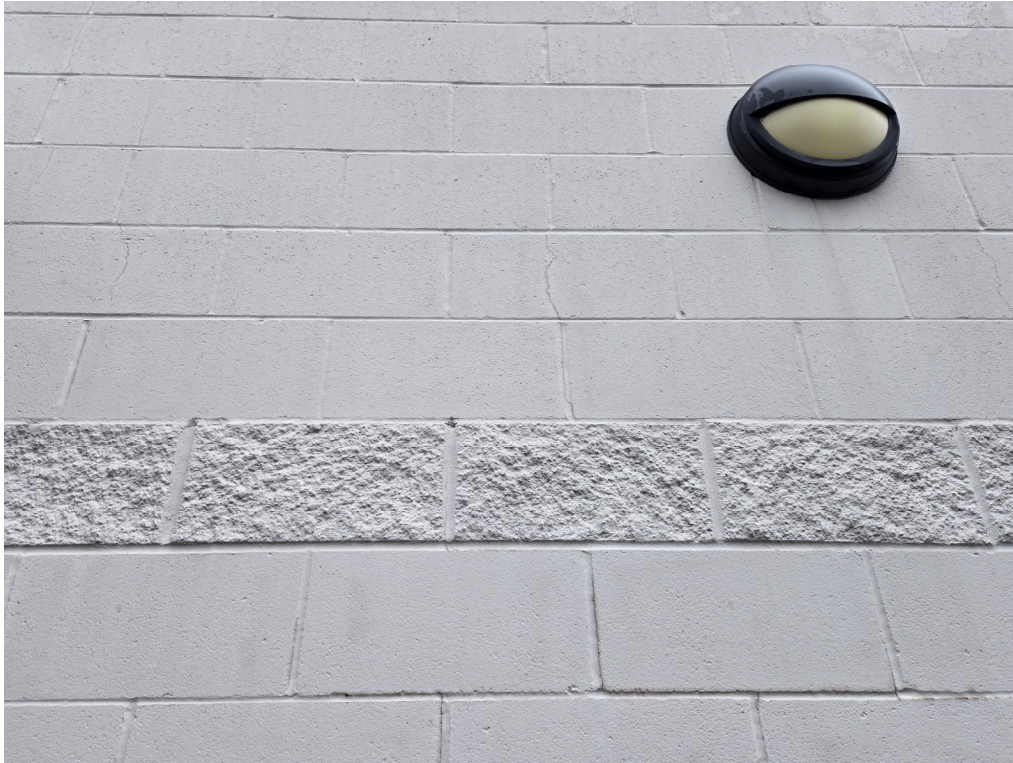
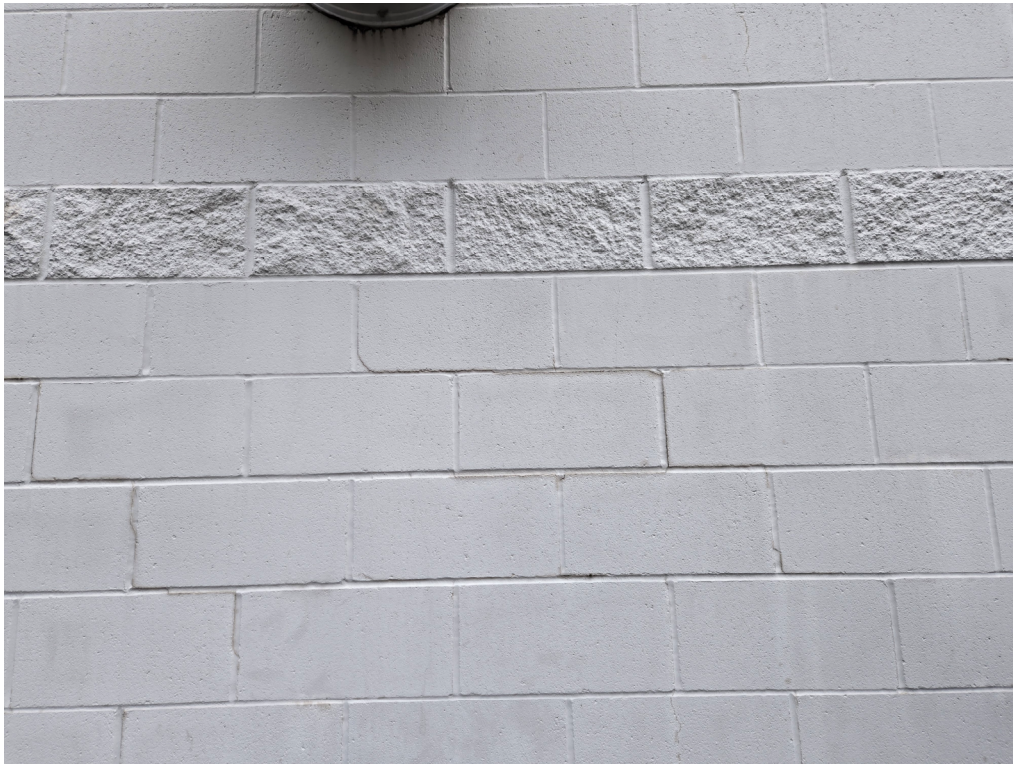
Examples of CMU cracking at detached pool building.

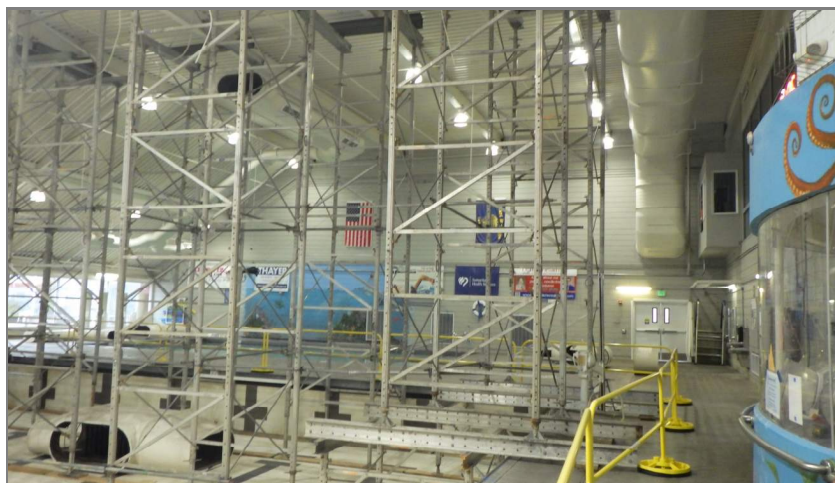
Figure 4.1
Main pool area.

- Interior scaffolding has been erected within the main interior pool area as a temporary measure to support the primary roof structure as the noted deficiencies in previous roof investigations warranted this until repairs could be made.
- The main pool had been drained, and the regular building heating had been turned off as the building was vacated at the time of the site walk.
- Minor cracking below storefront windows along east corridor.
- Minor staining and leaks reported at front office units around windows located on the south elevation.
- Leaks and rust staining around the storefront window finishes along the north elevation of the main pool area.
- Efflorescence and staining below large louvers above the second level seating area.
- Damage to interior window surround trim.

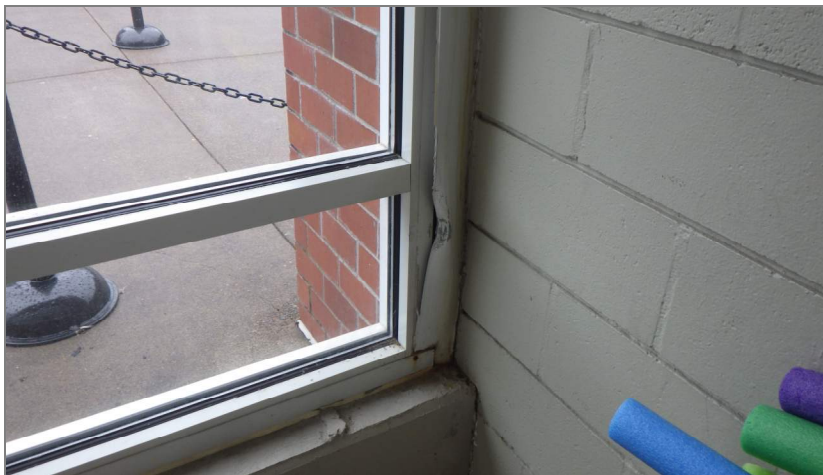
Figure 4.7

Area of window leak at inside corner of office unit.

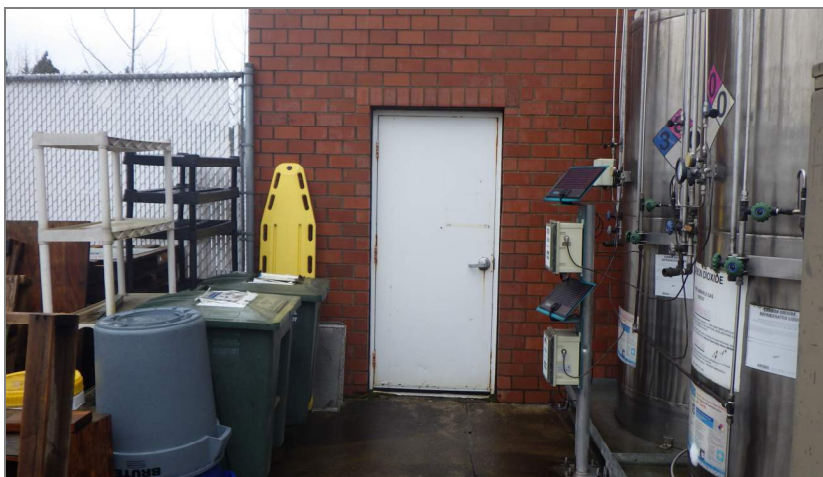
Figure 4.16

There were multiple areas of sealant failure primarily around door and window penetrations, and areas of efflorescence and moss building up on brick surfaces. The efflorescence as observed appeared to be typical for this type of construction. Some penetrations had a sheet metal flashing install at the head, but were bent, backsloped and maybe preventing water from draining out and instead diverting water back into the walls. Additionally, there were select areas showing signs of significant cracking in the mortar and brick at columns along the north elevation which may signify a larger problem requiring repair. At the time of review it is unclear if there is a leak related to the roof which is resulting in the damage to the brick wall area, it is recommended that during the repairs a review occurs to confirm the integration and detailing relating to the roof and coping detailing around this area.

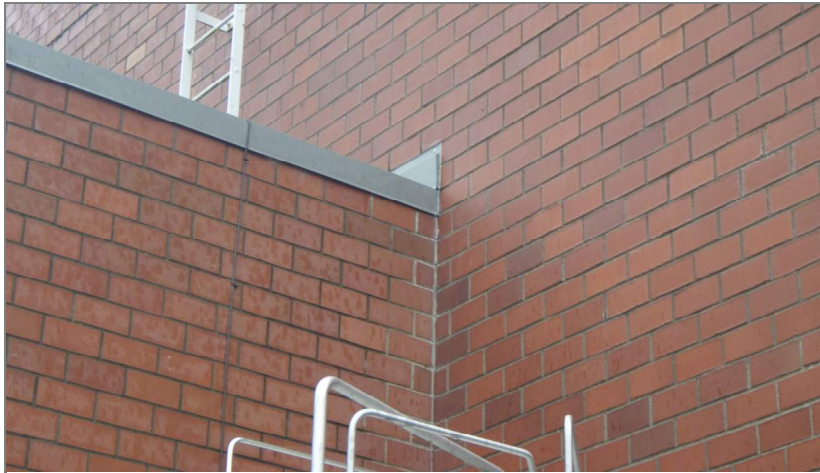
Figure 4.18

Typically, most penetrations had a sheet metal flashing at the head, but the perimeter sealant was noted to be hardened and weathered.

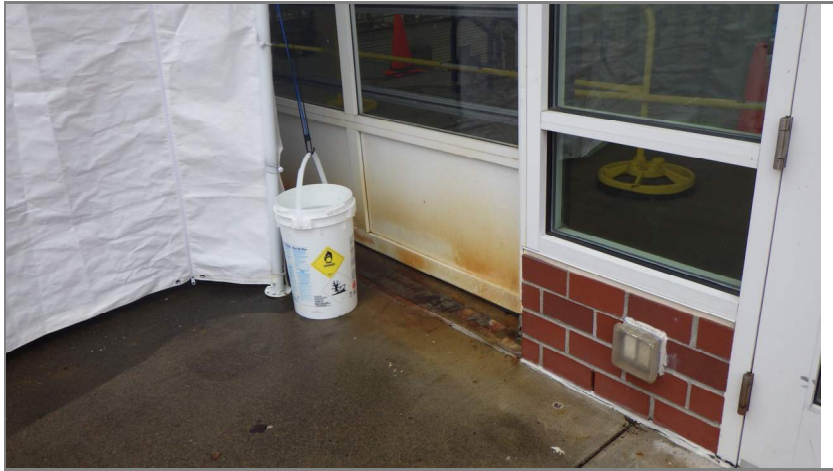
Figure 4.33

Heavy rust stains at steel head above storefront window.

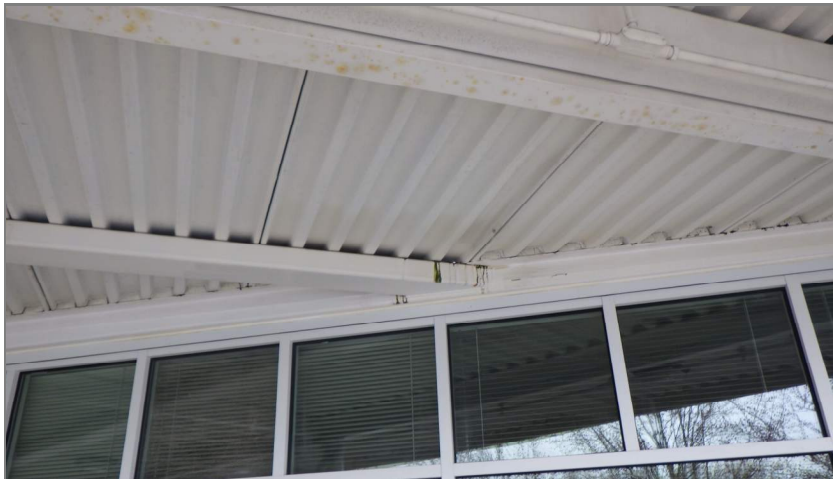
Figure 4.43

Signs of leaks towards the transition back to building.

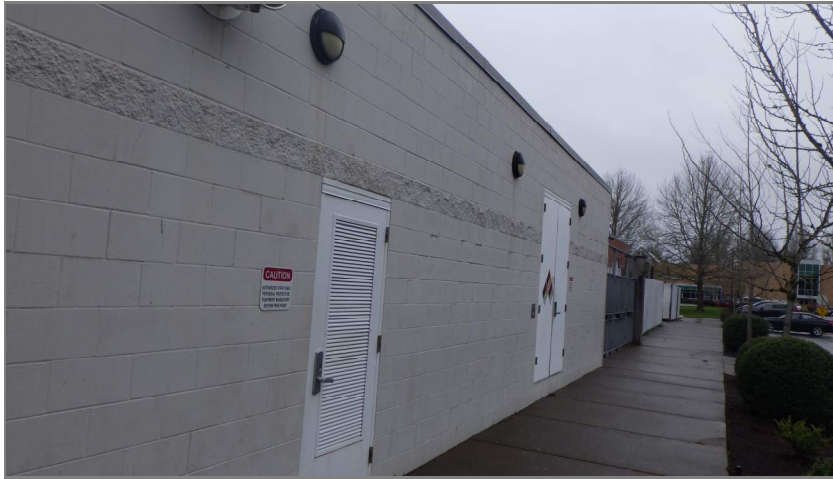
Figure 4.49

Staining above metal head flashing over swing door.
