Facilities Assessment Report Corvallis School District

Submitted to Corvallis School District
by DOWA - IBI Group Architects, Inc.
February 2014

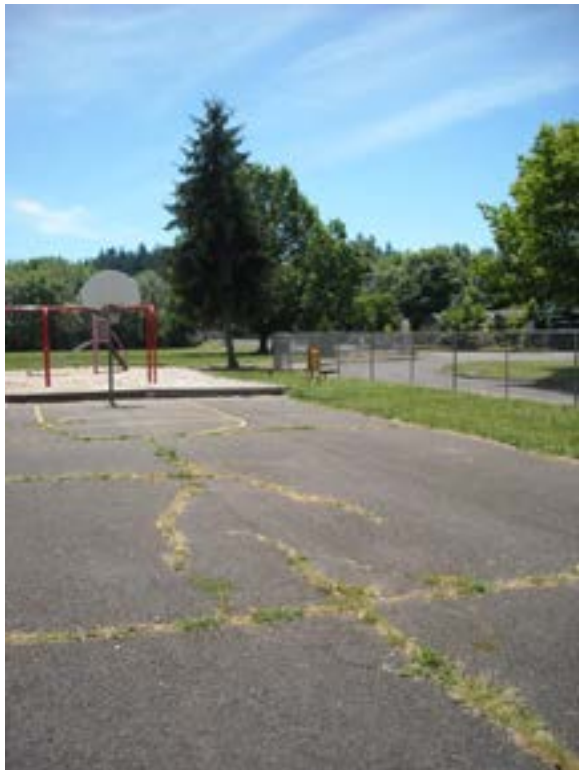
Figure E20.8 – Hard surface conditions

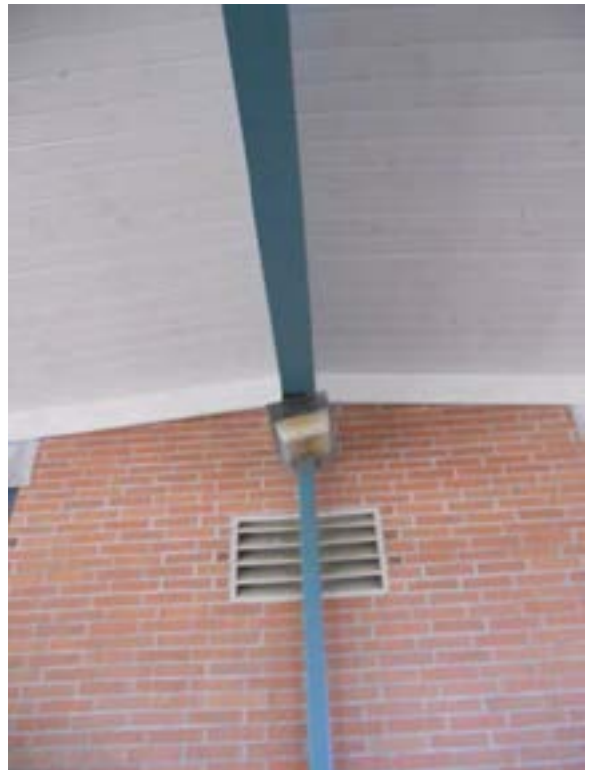
Figure E20.9 – Light is at risk for falling

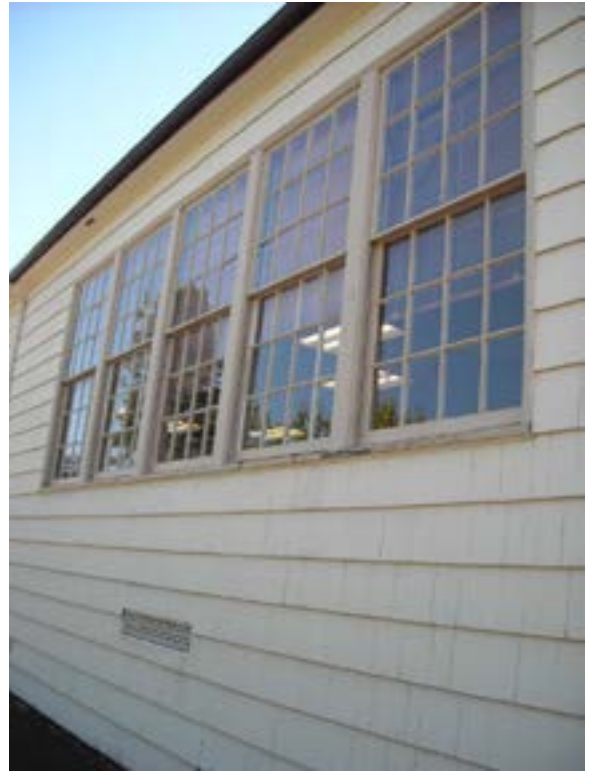
Figure A20.3 – Original window systems

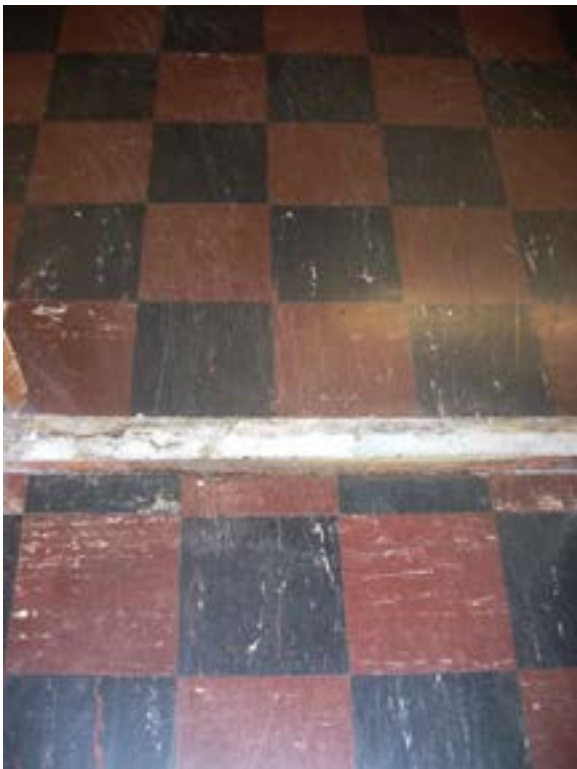
Figure B20.1 – Cracked flooring

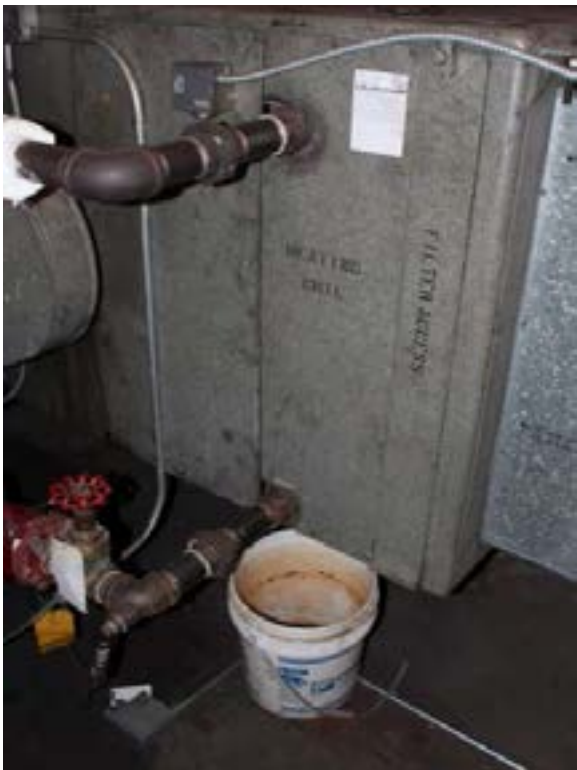
Figure C20.1 – Leaking coils

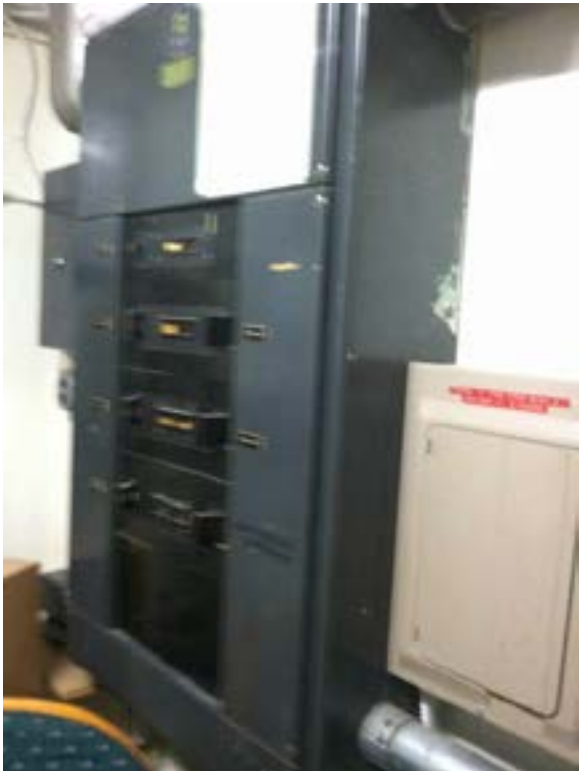
Figure D10.2.a – Main distribution panel

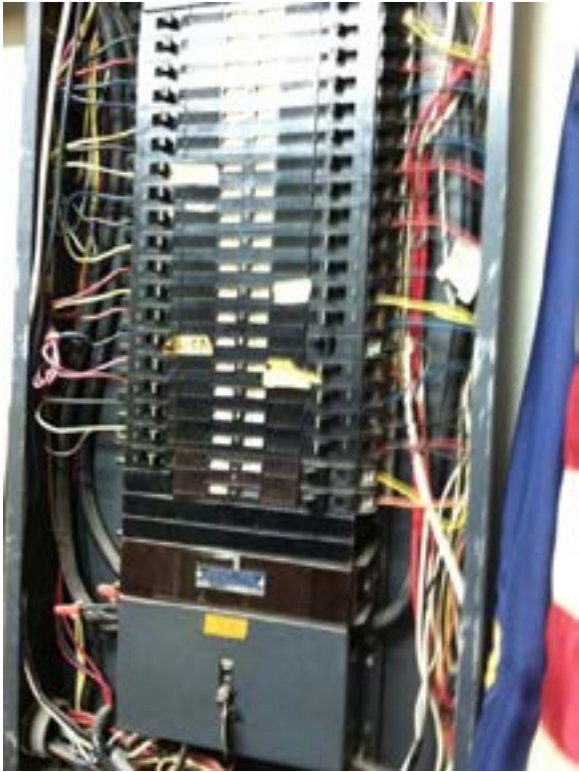
Figure D10.2.b – Panel missing grounding conductors and cover

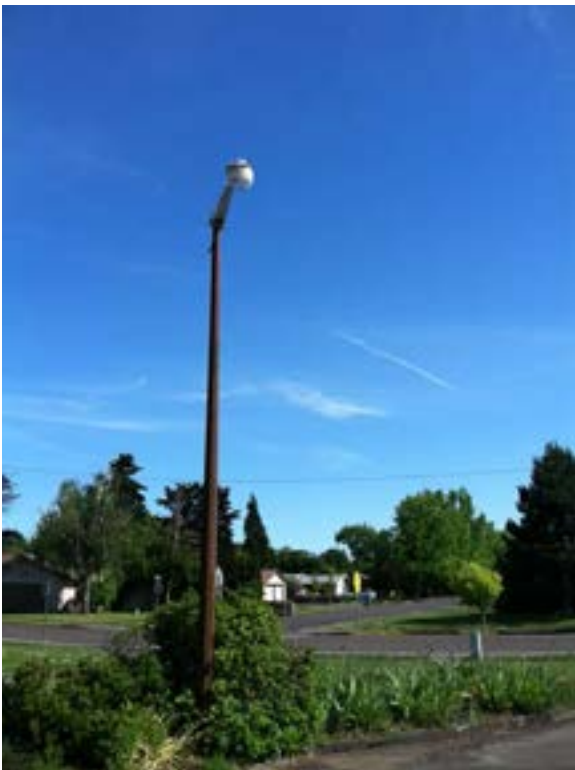
Figure E20.9 – Existing site lighting

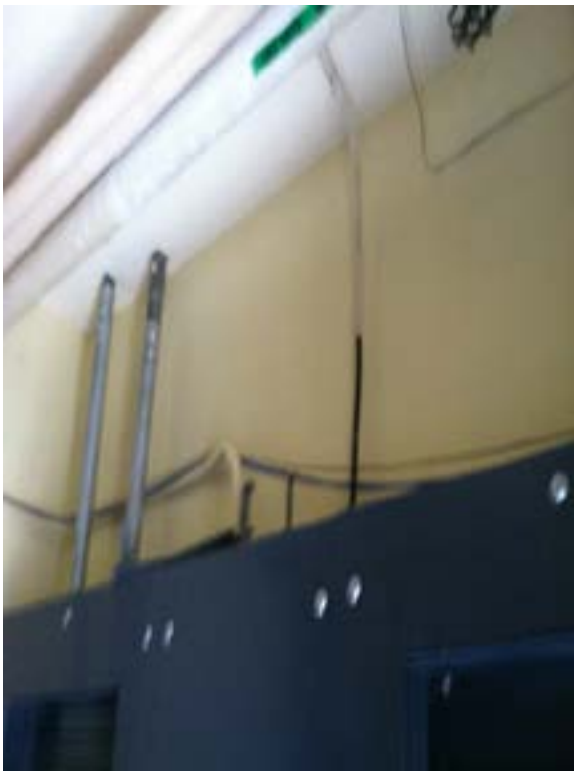
Figure D10.2.a - Pipes installed above panels

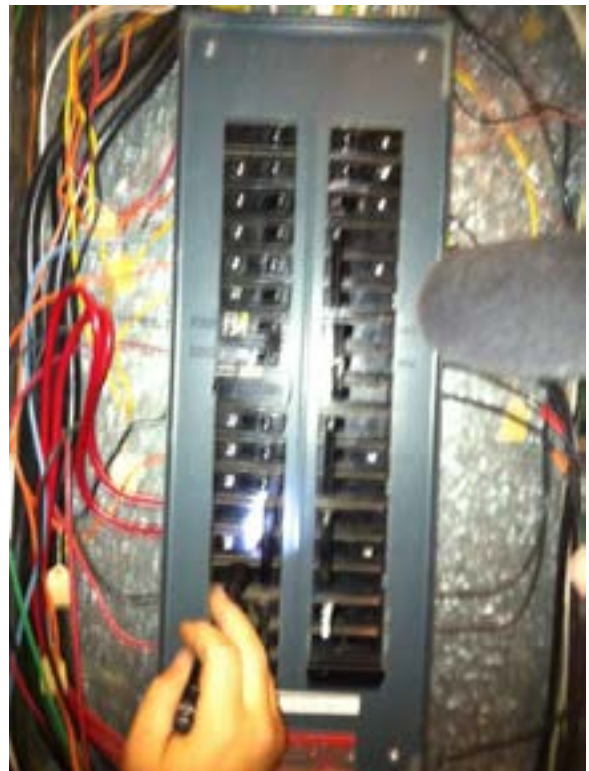
Figure D10.2.b – Grounding bus bar missing

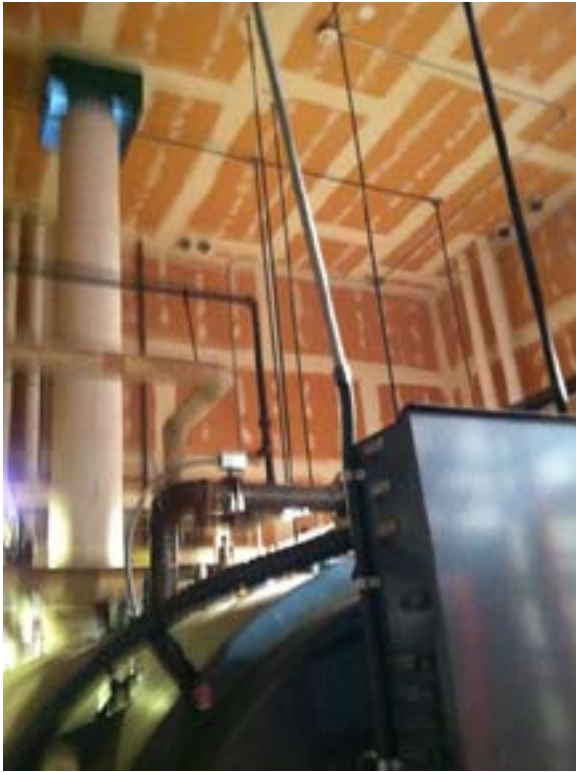
Figure D10.2.c – Incorrect conduit type

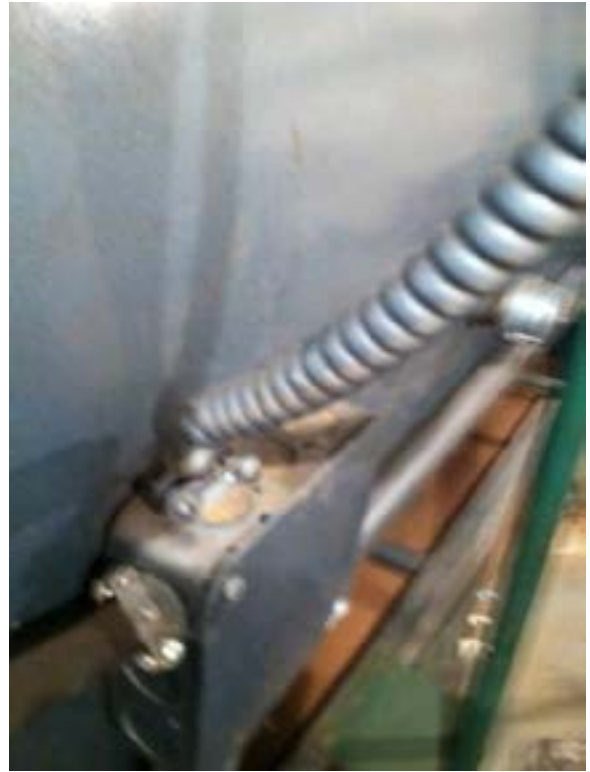
Figure D10.2.d – Damaged armored cable

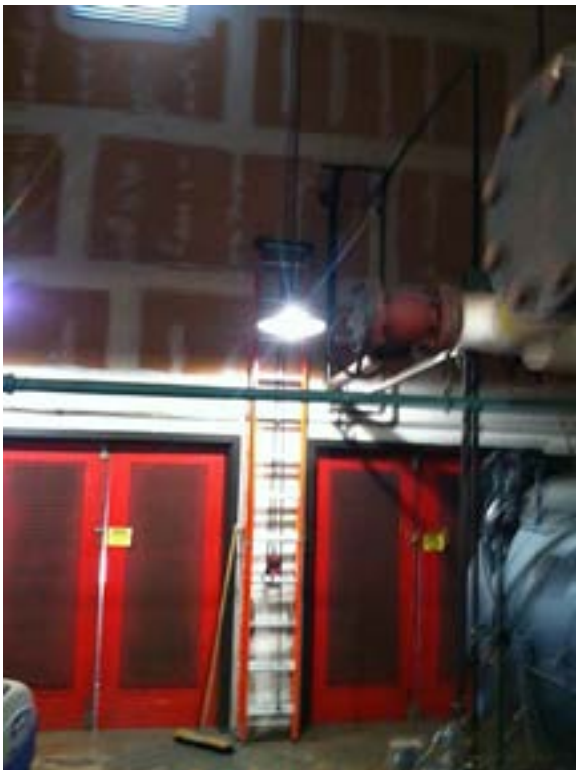
Figure D10.3.a – Mechanical room lighting

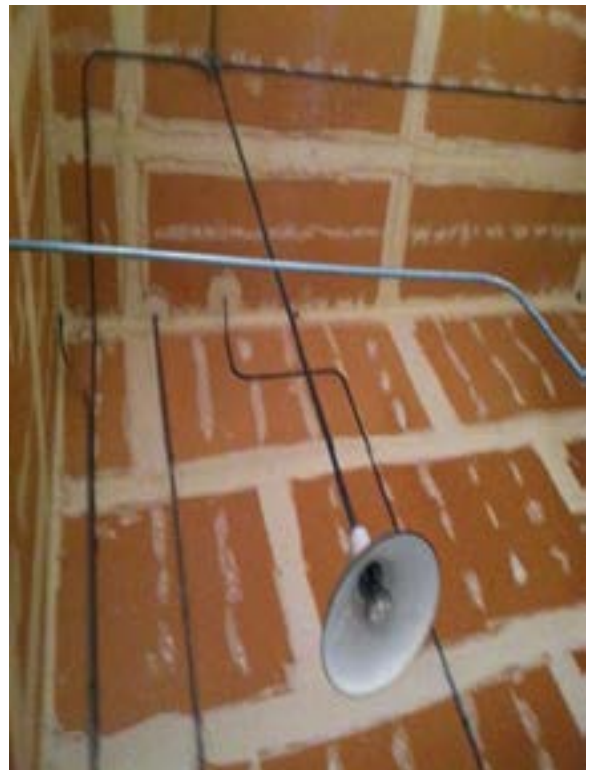
Figure D10.3.b - Failing lighting

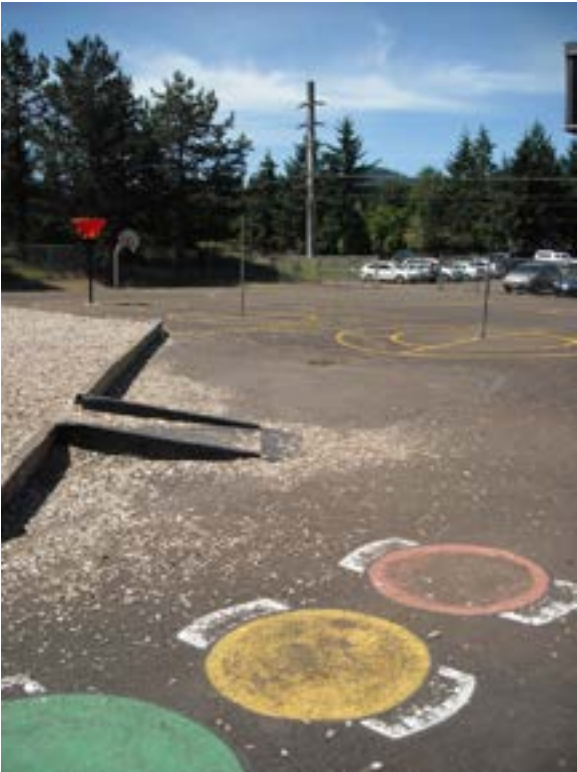
Figure E20.8 – Hard surface play area

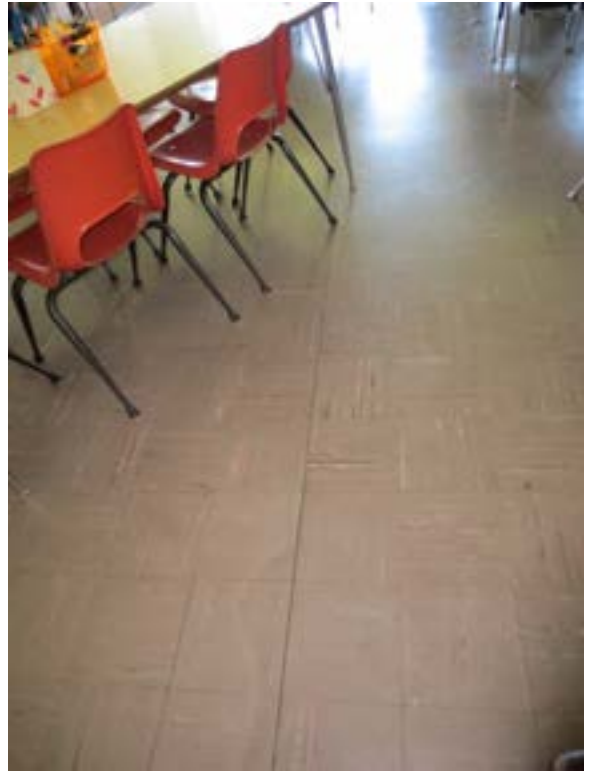
Figure A10.3 – Crack in Room 14 floor finish

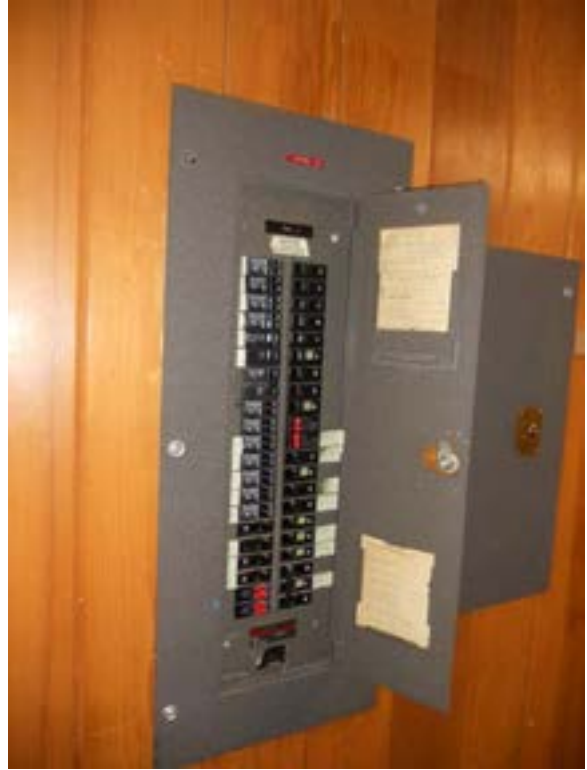
Figure D10.2.a – Lack of spare capacity

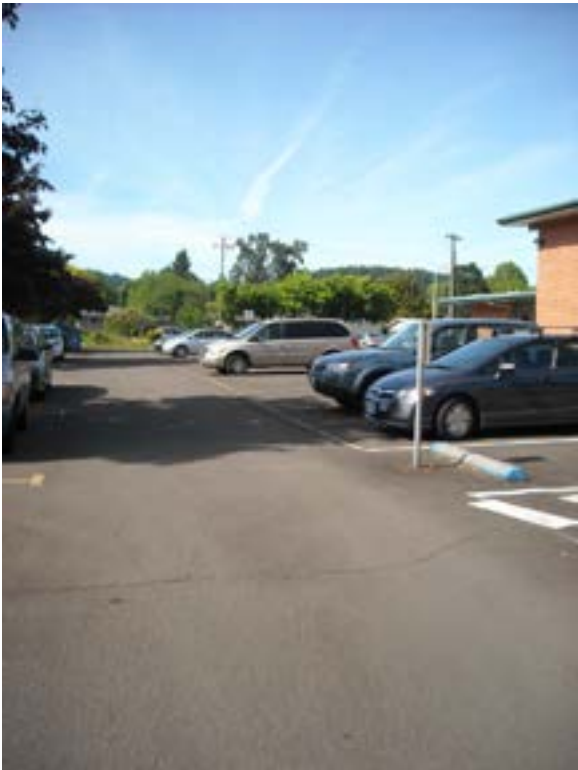
Figure E10.1 – Parking lot

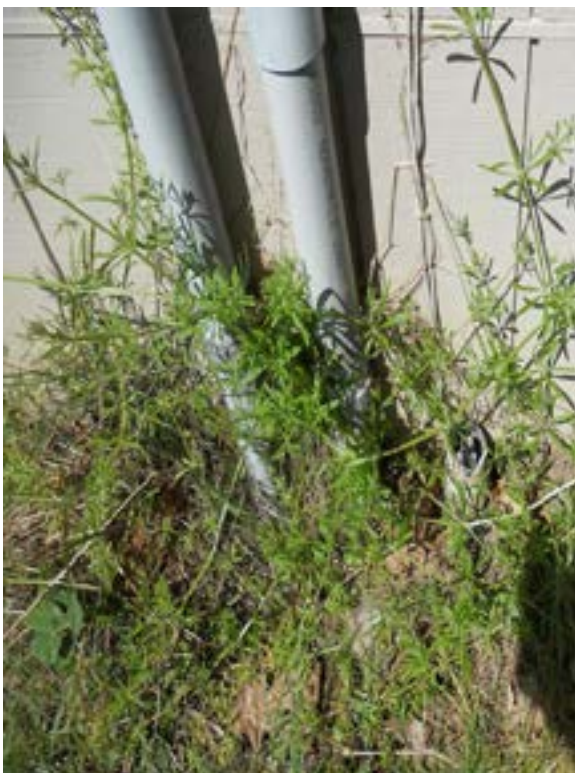
Figure D10.2 – Abandoned electrical feeder

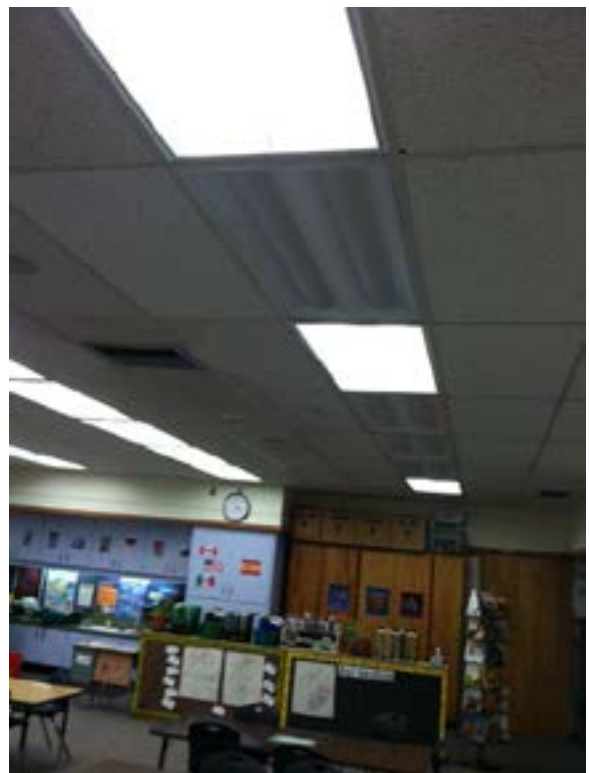
Figure D10.3.a – Typical ballast failure

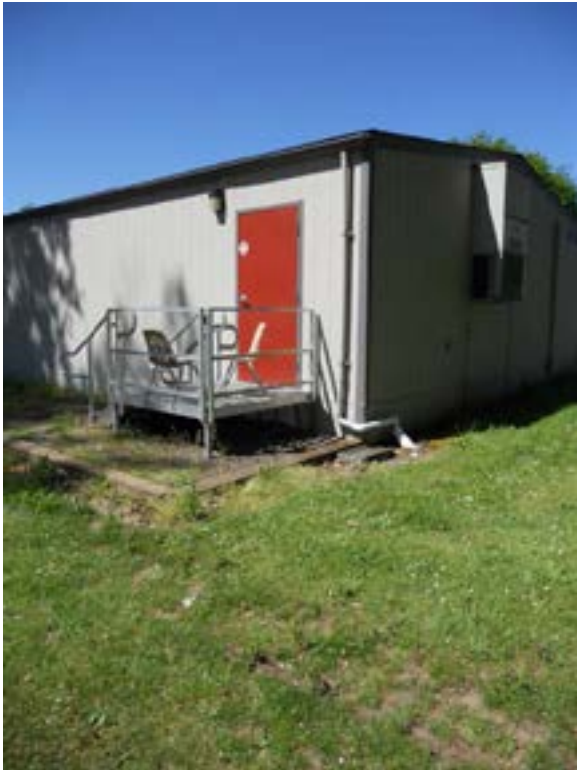
Figure E20.9 – Typical site lighting

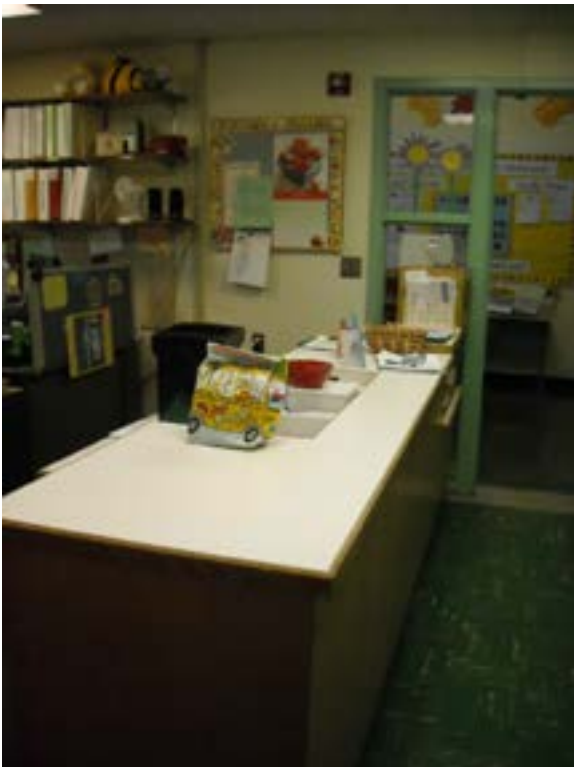
Figure B30.6 – Undersized main office

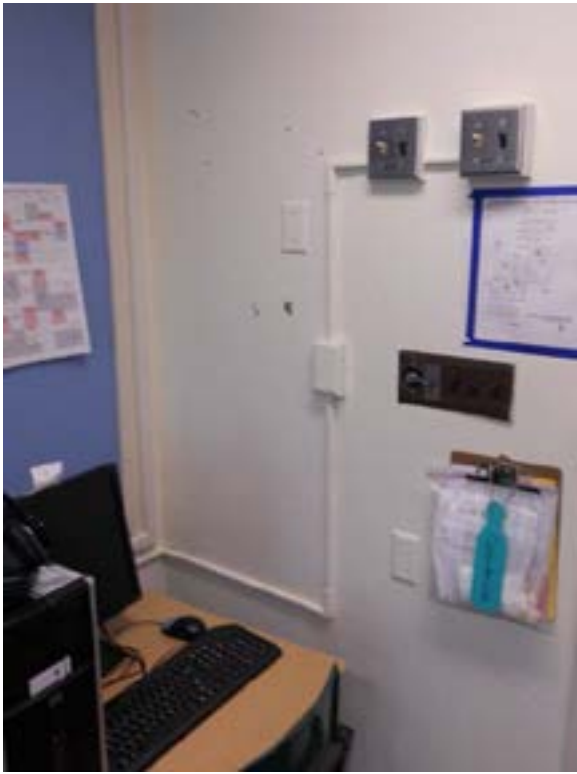
Figure D10.2.d - Computer lab switches

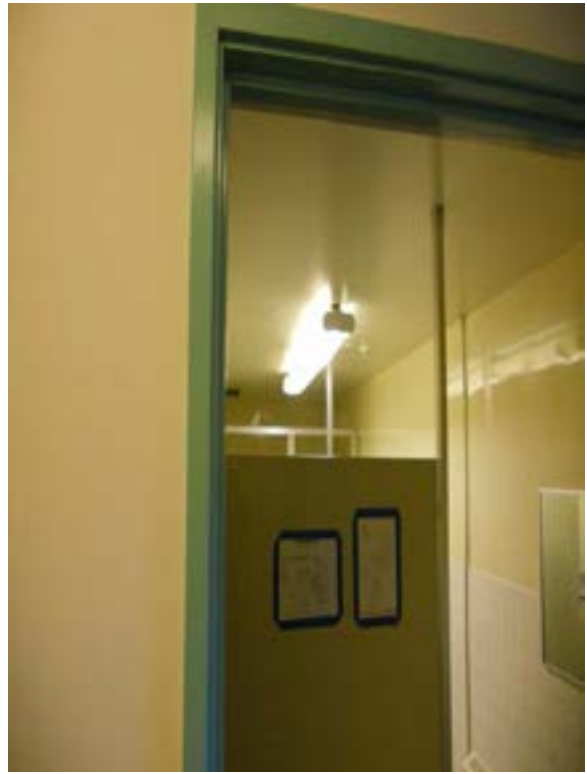
Figure D10.3.a – Light is missing lens

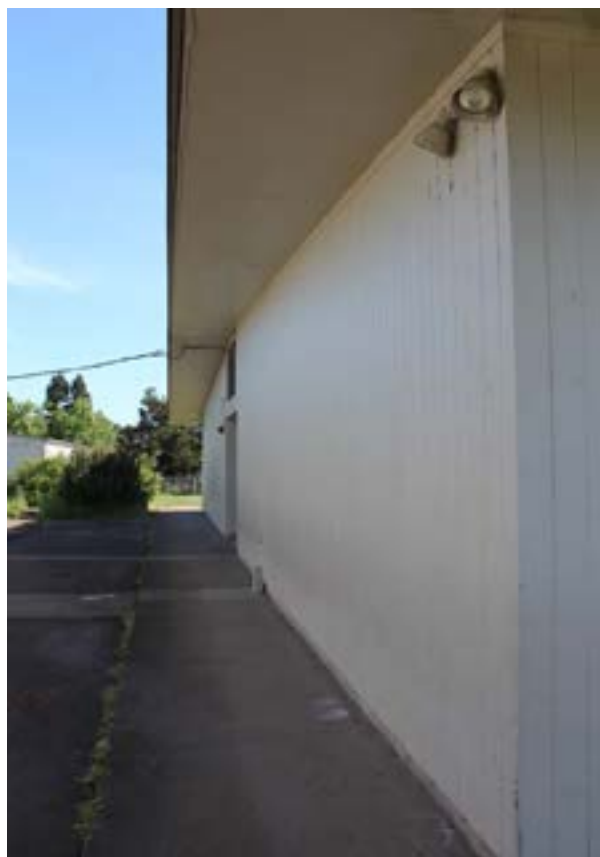
Figure E20.9.b – Incandescent site lighting

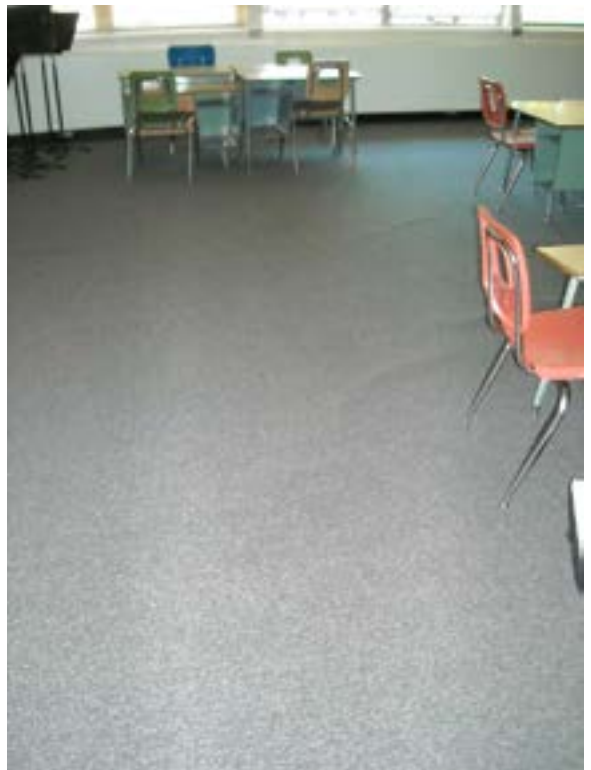
Figure B20.1.a – Classroom carpeting

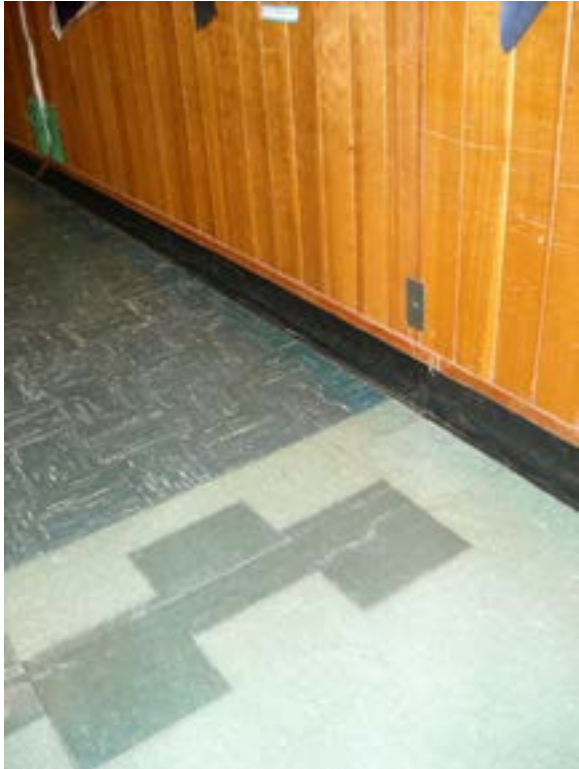
Figure B20.1.b – Cracks in hallway flooring

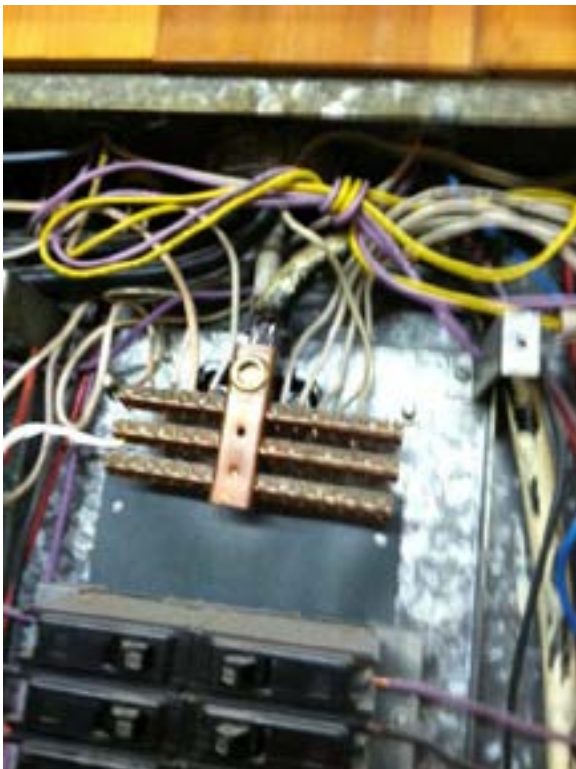
Figure D10.2.b – Neutral conductors share lug

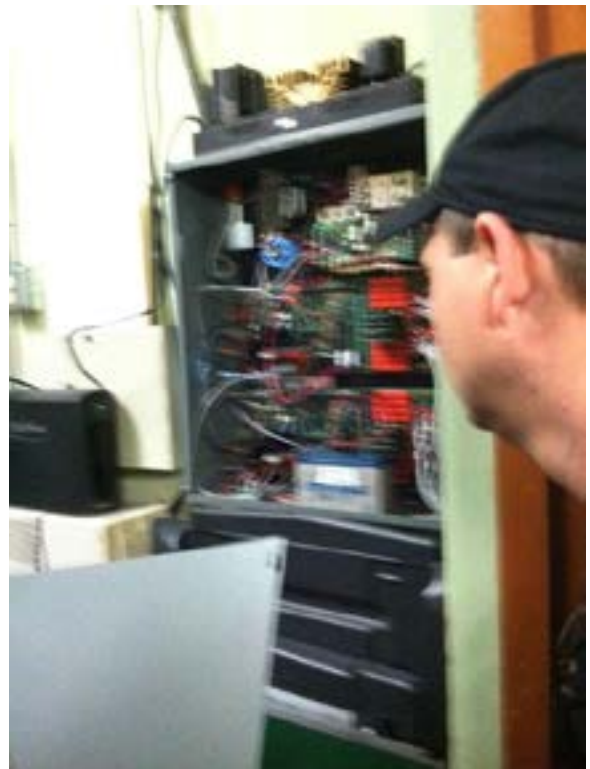
Figure D10.2.c - Cabinet is missing cover

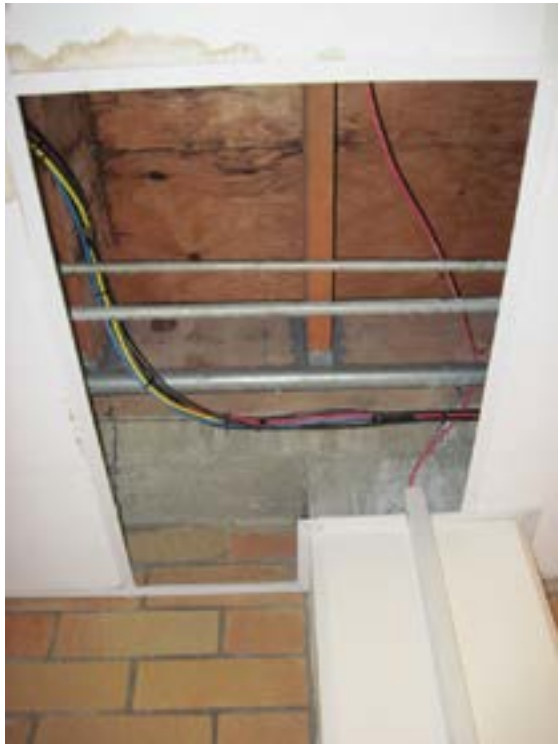
Figure A10.3.a – Roof leak

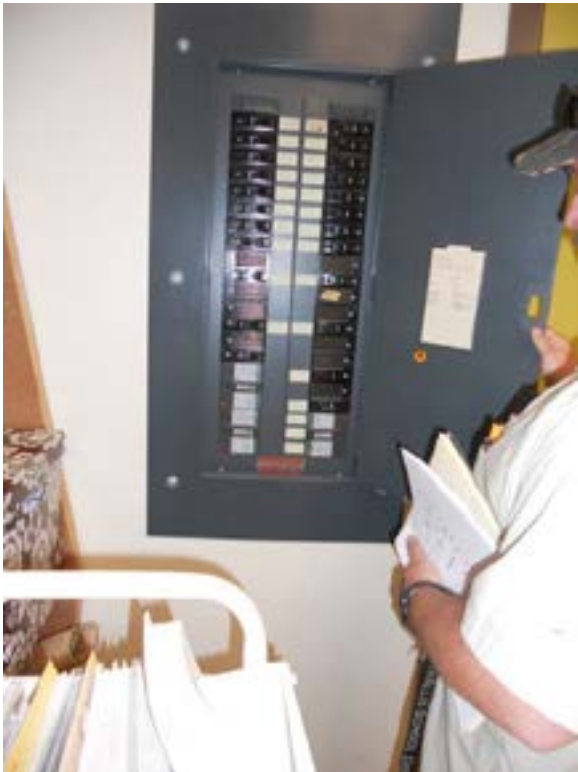
Figure D10.2.b – Lack of panel capacity

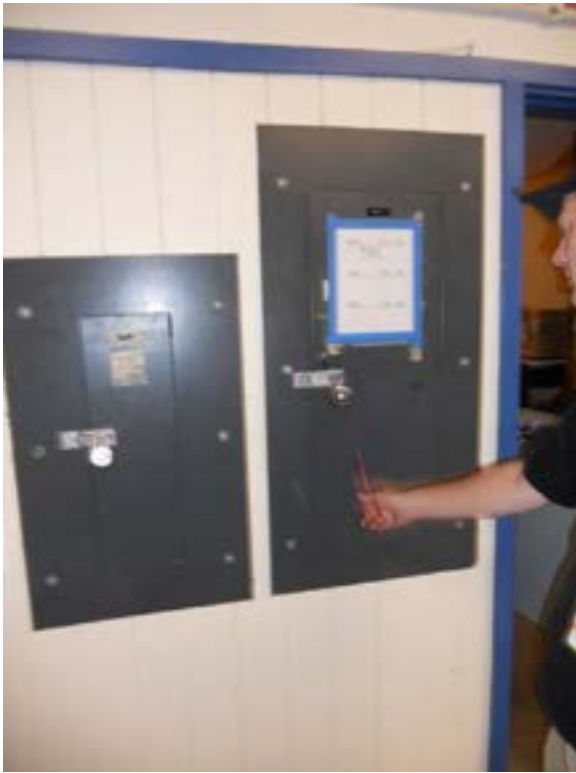
Figure D10.2.d – Inaccessible electrical panels

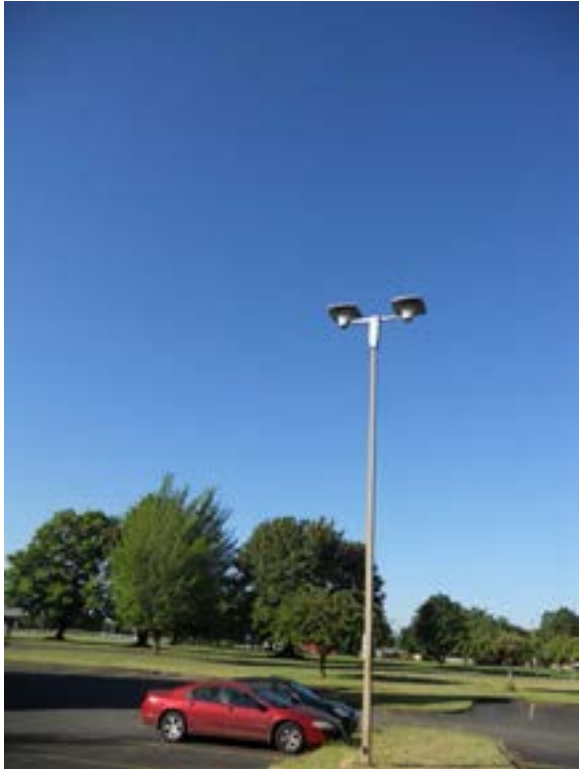
Figure E20.9 – Site lighting missing manhole cover

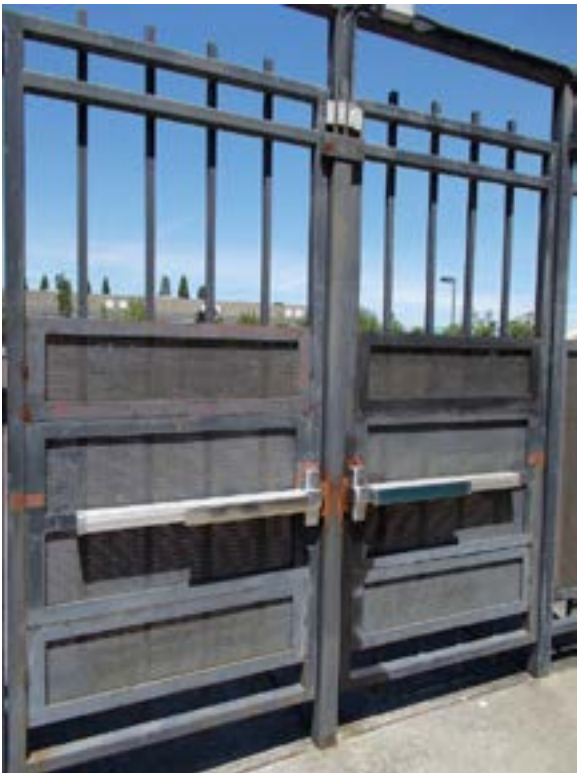
Figure E20.5 – Courtyard gate

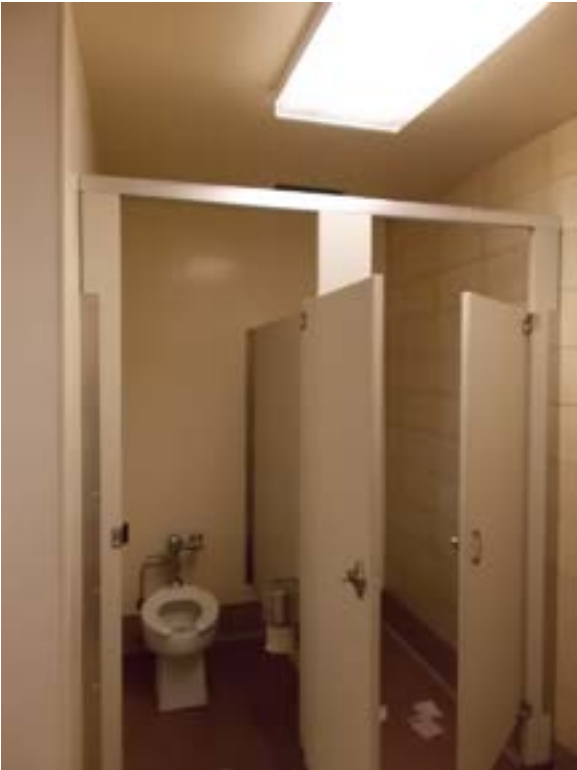
Figure B40.7 – AT North restrooms

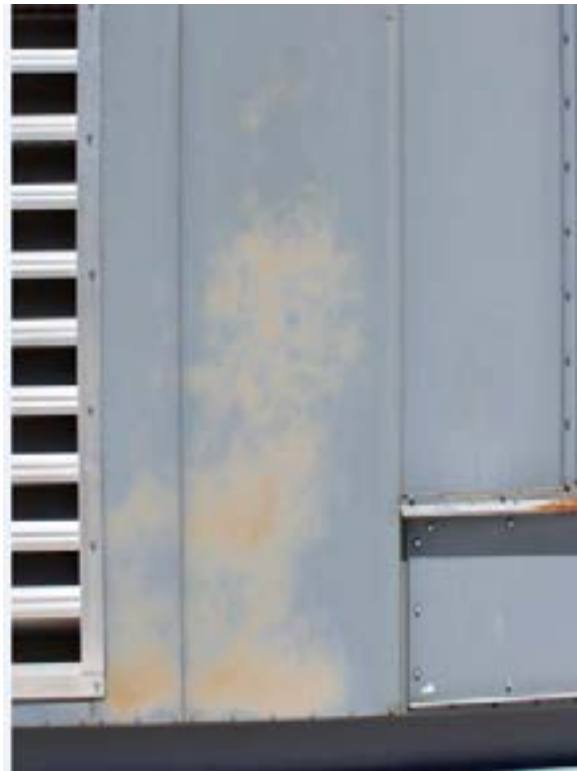
Figure C20.1.a – Paint failing on roof units

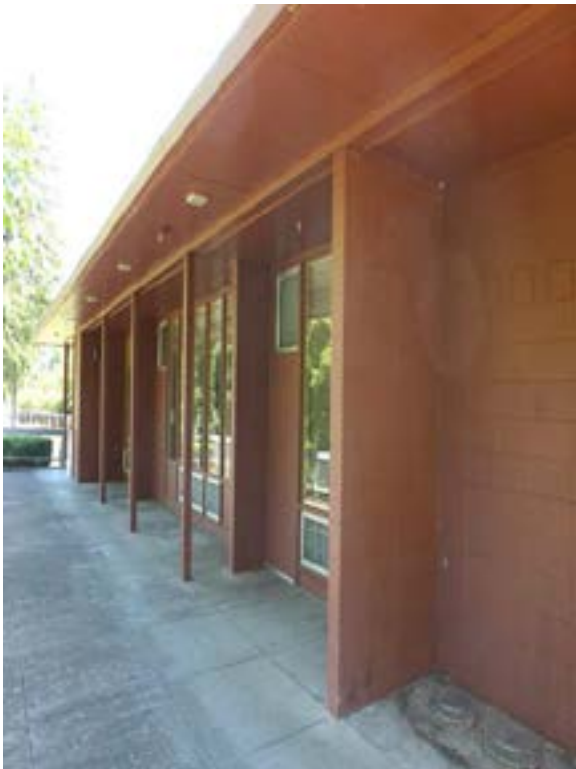
Figure E20.9.a – Incandescent lighting Figure

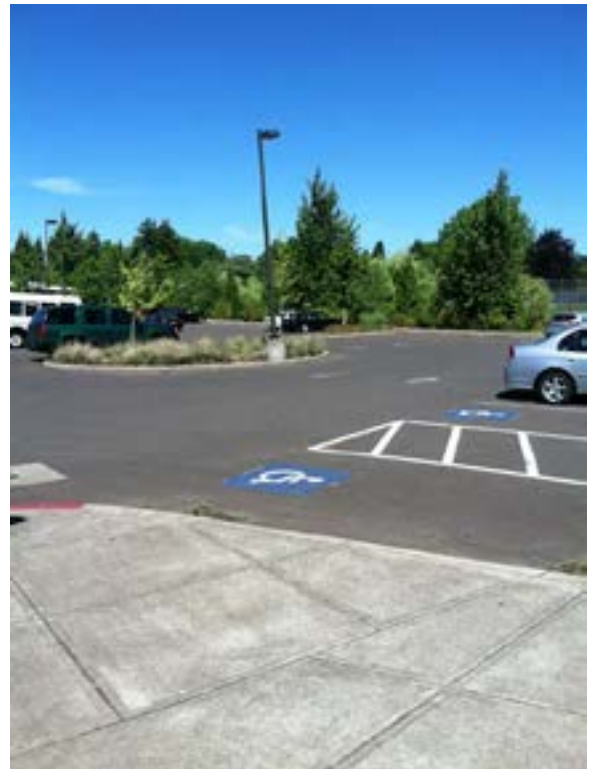
E20.9.b - Light pole foundation

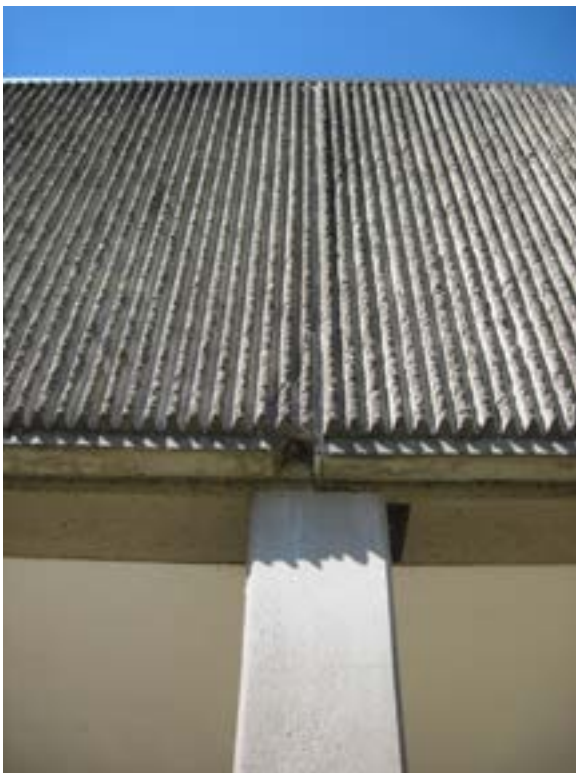
Figure A10.3.f – Fascia panel joint cracks

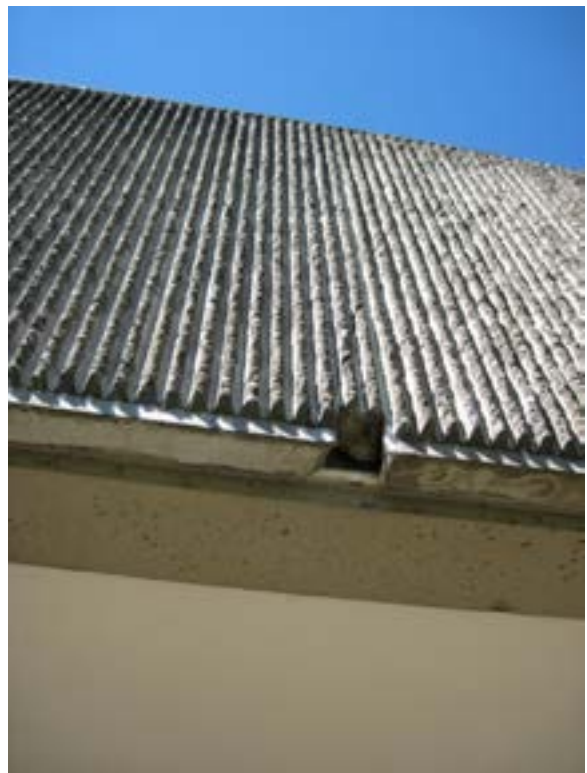
Figure A10.3.g – Fascia panel joint cracks

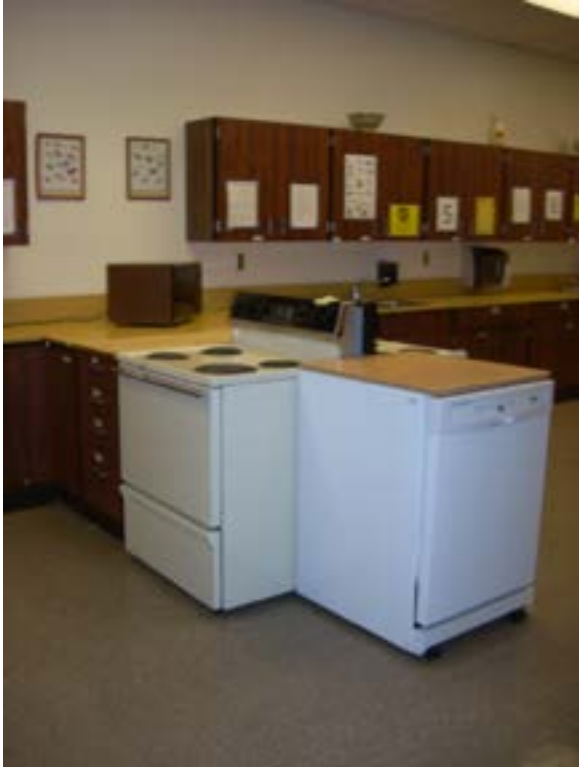
Figure B30.4.b – Foods lab

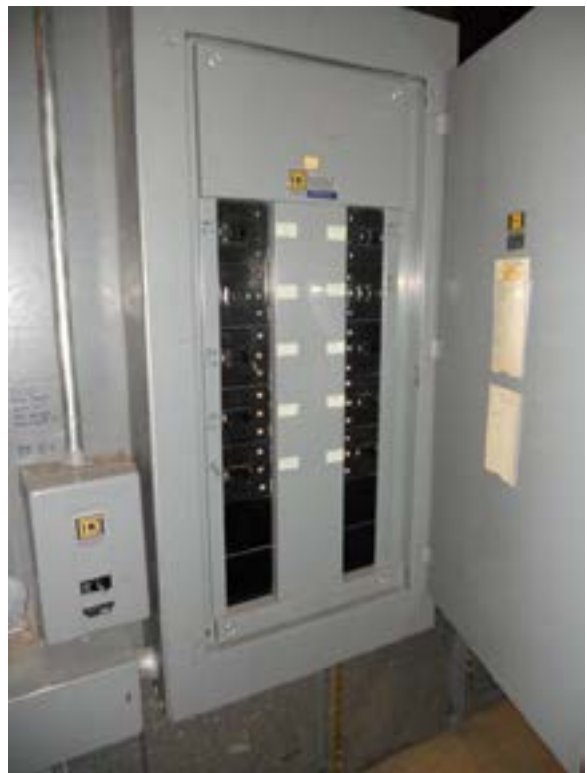
Figure D10.2.b – Typical panelboard

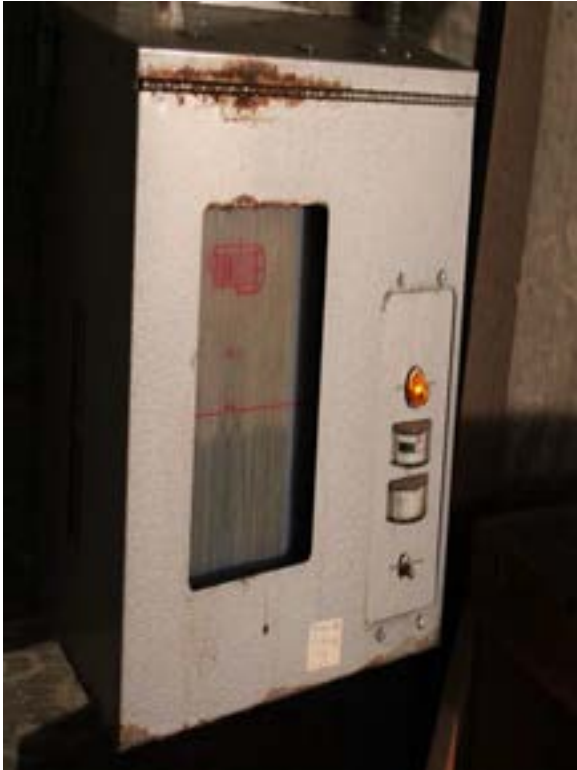
Figure D10.6 – Failed lighting inverter

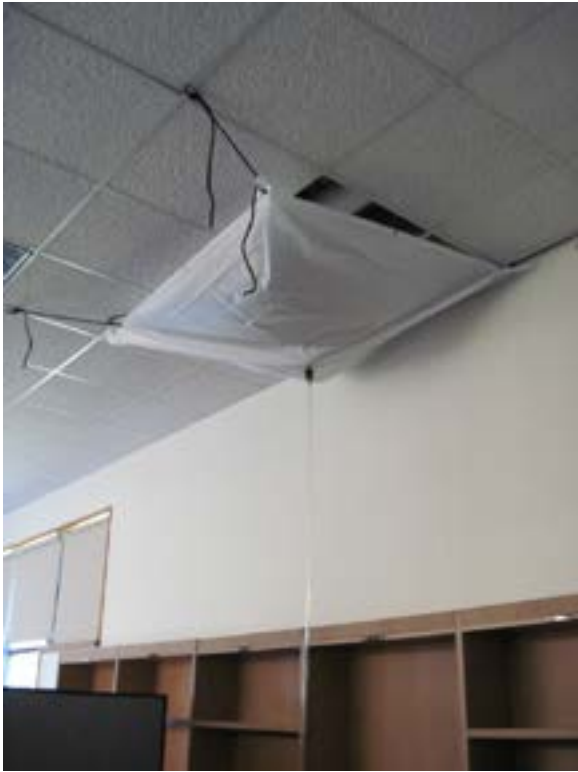
Figure A10.3 – Roof leak

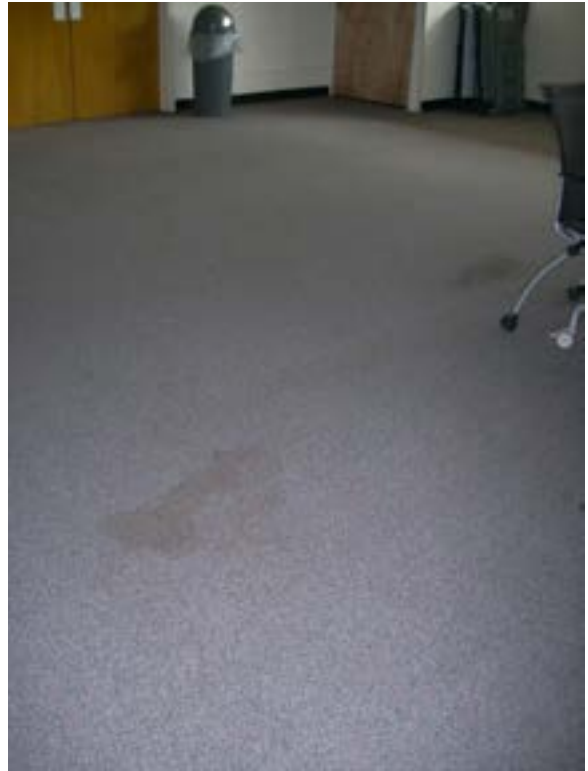
Figure B20.1.b – Board room carpet

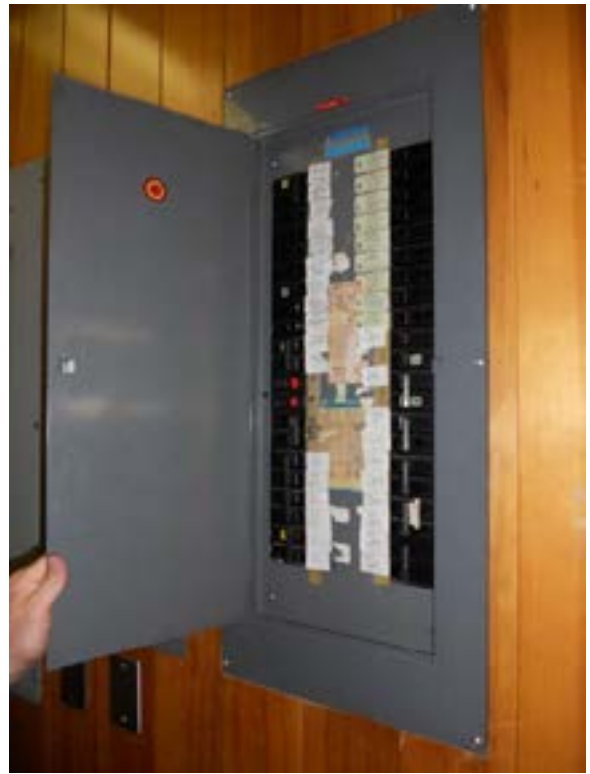
Figure D10.2.b - Multi-section branch panel

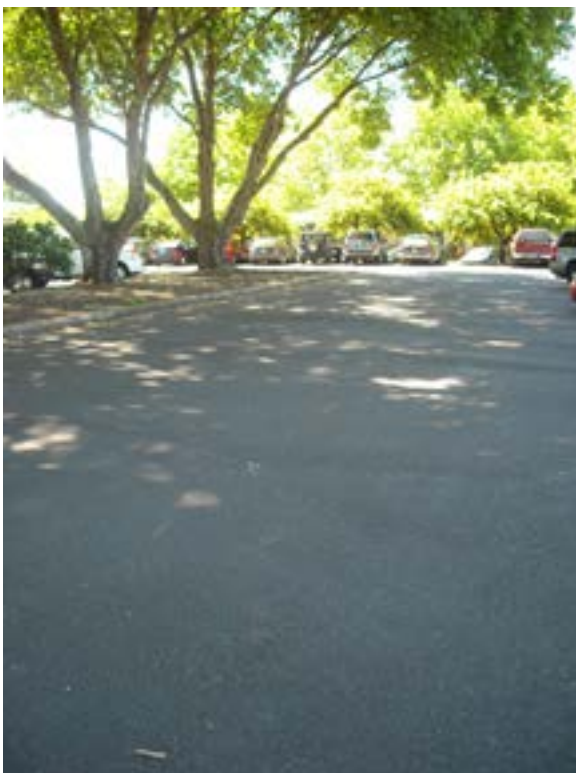
Figure E10.1.c – Tree root damage

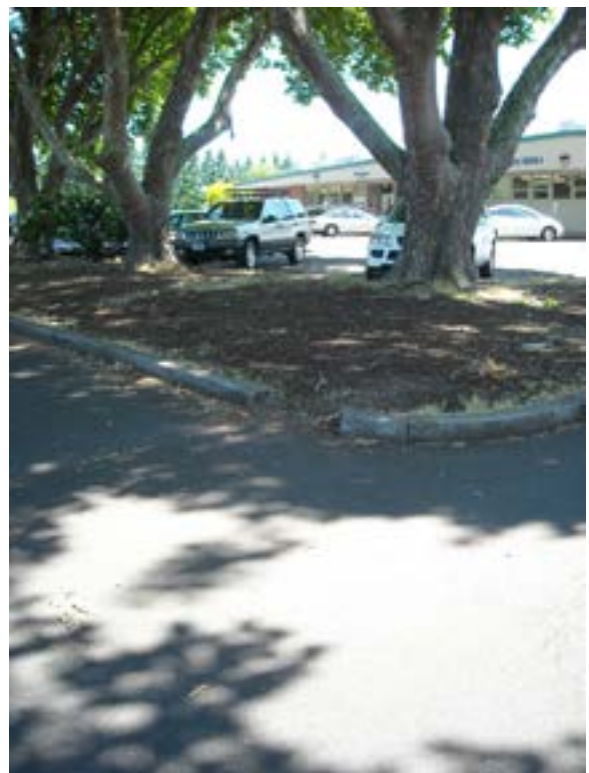
Figure E10.4 – Missing curb
