City of Corvallis
Corvallis School District

Osborn Aquatic Center Facilities Assessment

Scott
Edwards
Architecture

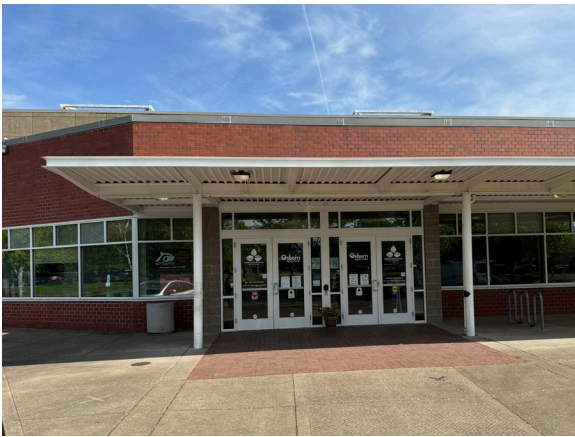
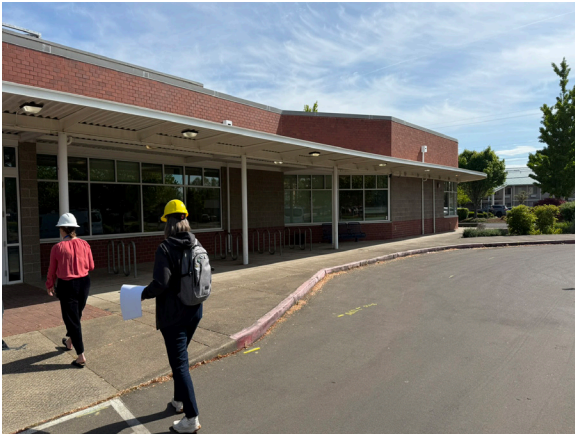
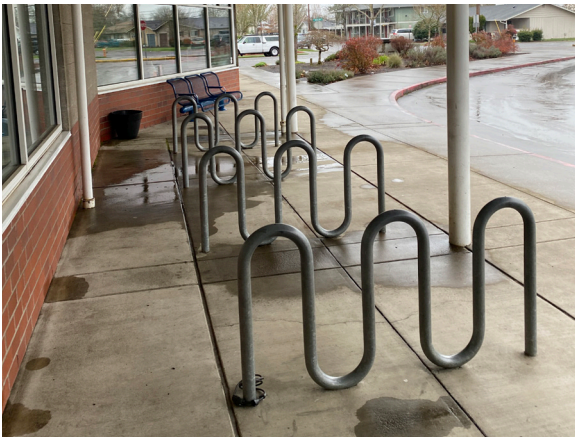
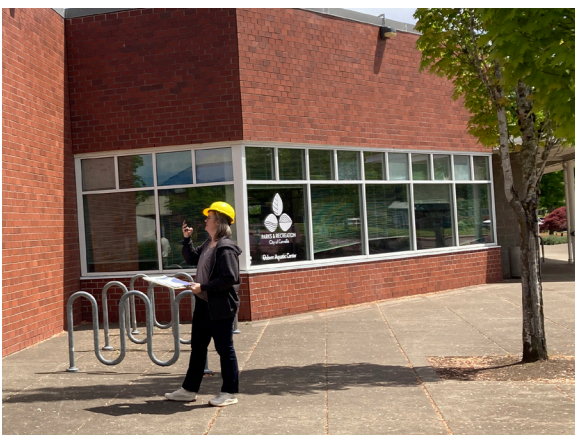
MAIN ENTRY

Exterior main entry with metal canopy.

- Extend covered porch area to the west.
- Repair gutter and drain.
- Add building name signage.
- Provide additional bike parking.

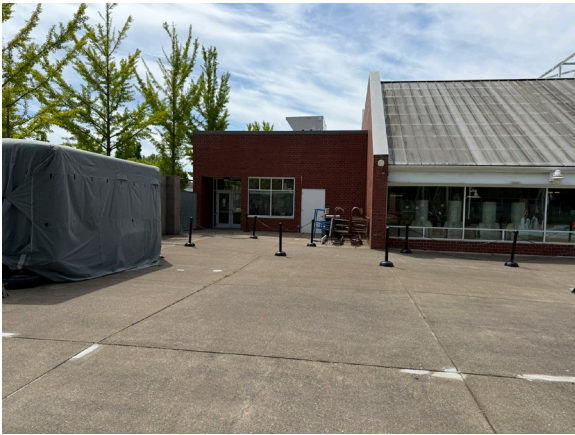
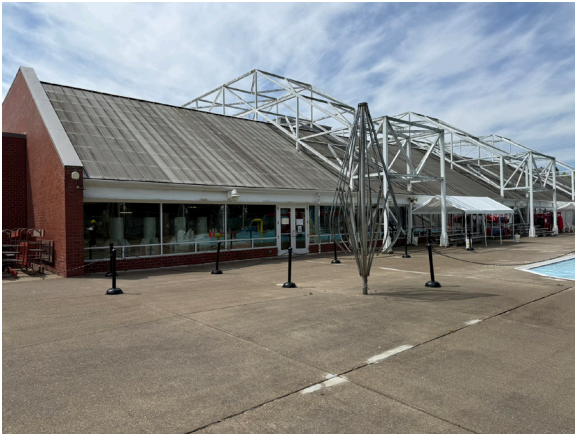
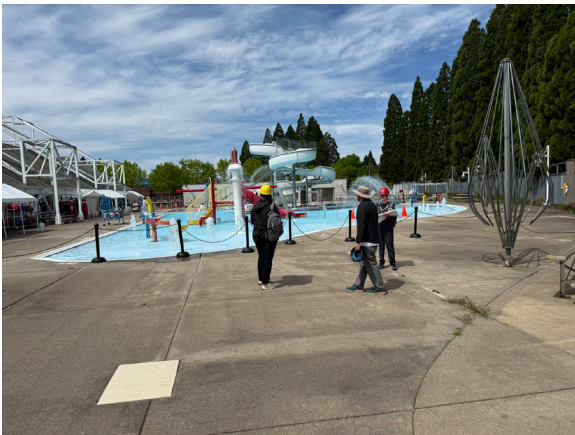
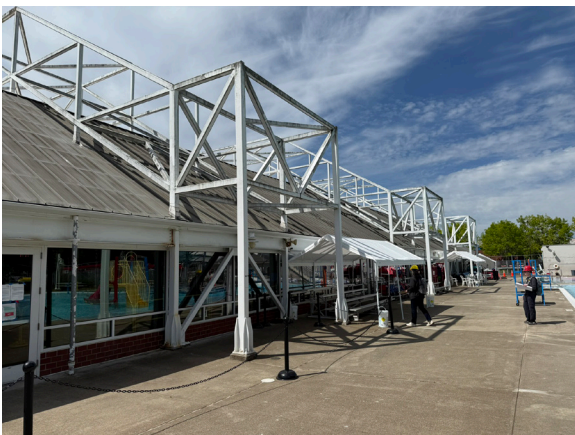
OUTDOOR POOL DECK

Exterior concrete deck used as food court area with food trailer. Includes large umbrellas and some bleacher seating.

- Construct permanent concession building in place of temporary food trailer. Review original plan to expand north end of building.
- Review expansion of seating areas.
- Review original plan to include an outdoor spa in this area.

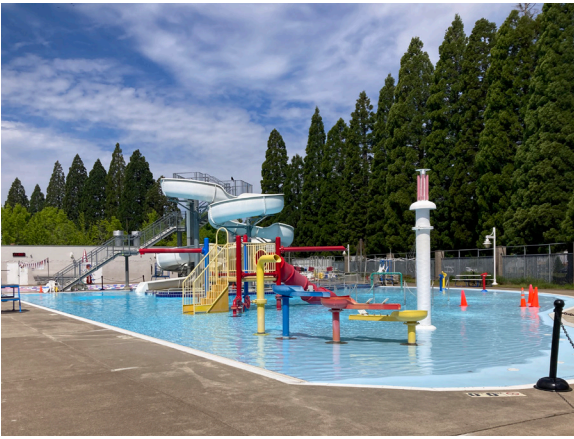
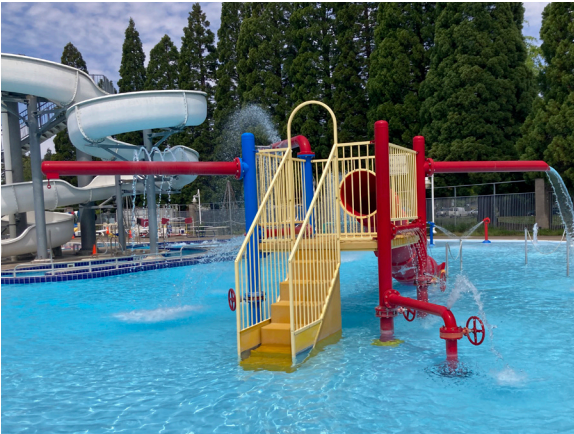
OUTDOOR PLAY POOL

The outdoor recreation pool includes a zero-entry with less than 3' depth wading area with water spray features. Within the same body of water, a 3'-6" depth area is roped off for the water slide splash zone, and a lazy river with moving water currents is included as well.

- One of the wading pool slides is currently out for maintenance.

- Reference Aquatics section for recommendations.
- Service broken pool features.
- Replace missing pool feature components.

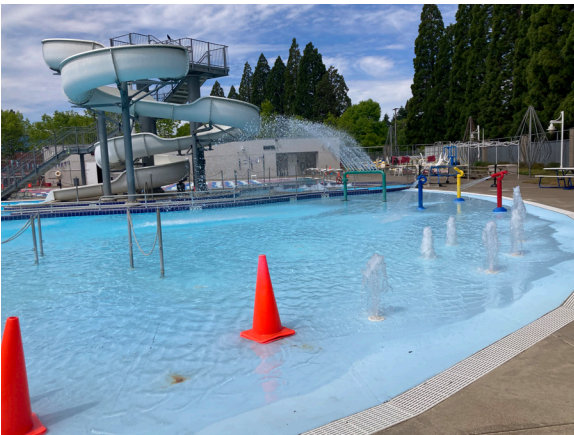
Beach entry walk in to wading area.

- Pool liner was replaced recently.

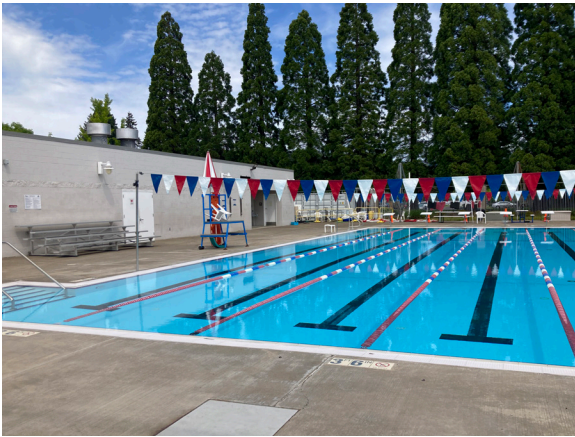
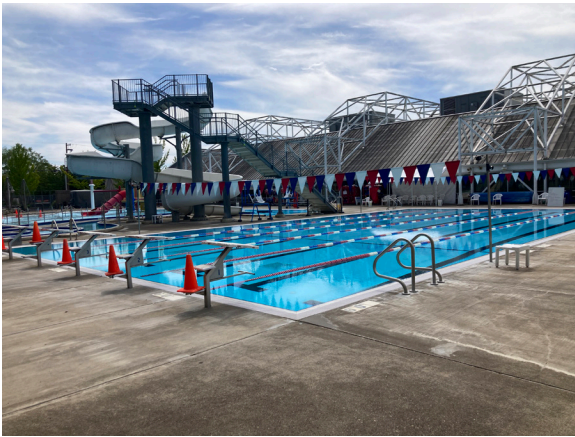
OUTDOOR LAP POOL

The 25-meter outdoor lap pool has 6 swim lanes and a stair entry.

- Reference Aquatics section for recommendations.

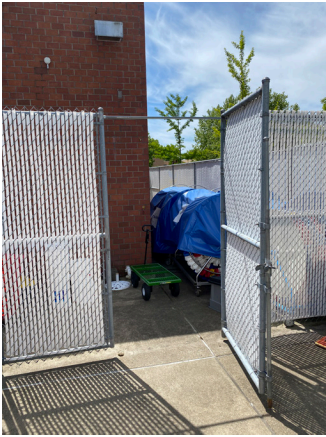
OUTDOOR FENCED STORAGE

Outdoor Storage for climbing walls and meet lane lines.

- Adding a permanent roof over space would better protect items in storage.

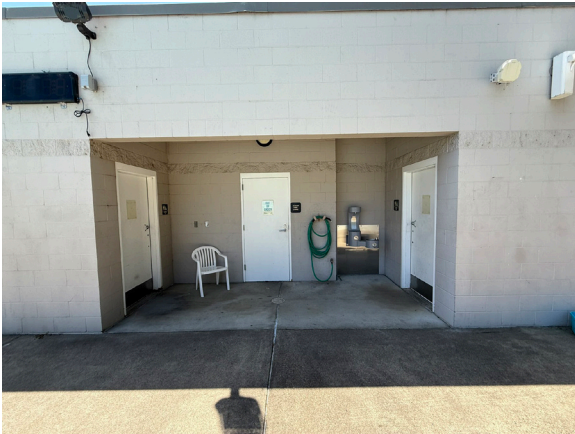
Entry to the Pool Building Men's and Women's Restrooms

- Additional plumbing fixtures may be needed to meet number of outdoor occupants.

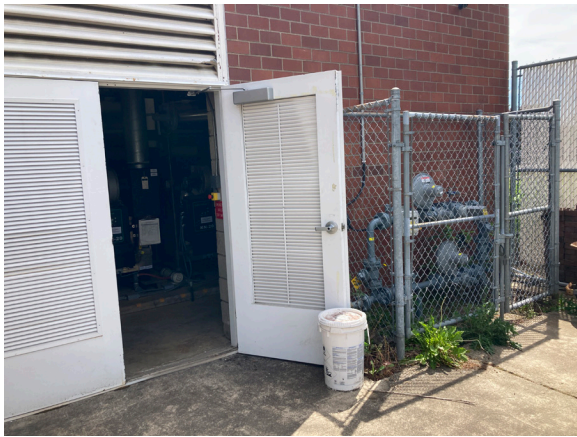
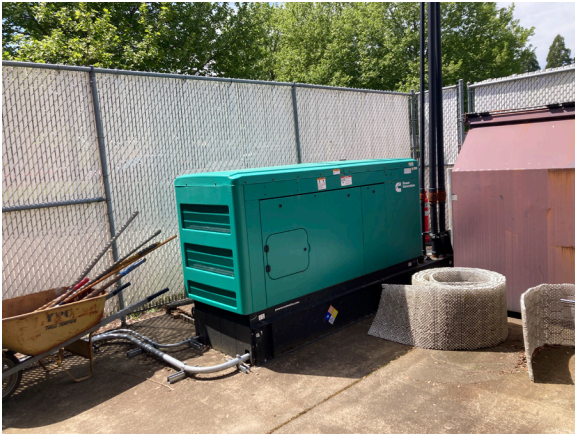
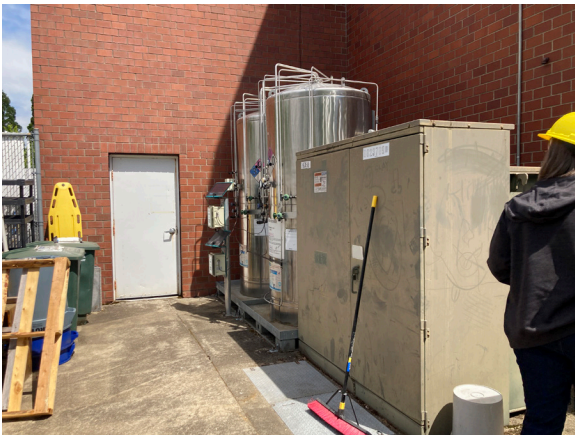
OUTDOOR STORAGE AND TRASH ENCLOSURE

Outdoor Storage and Trash Enclosure

- Repair or replace door and frame from natatorium boiler room. Install emergency exit hardware.

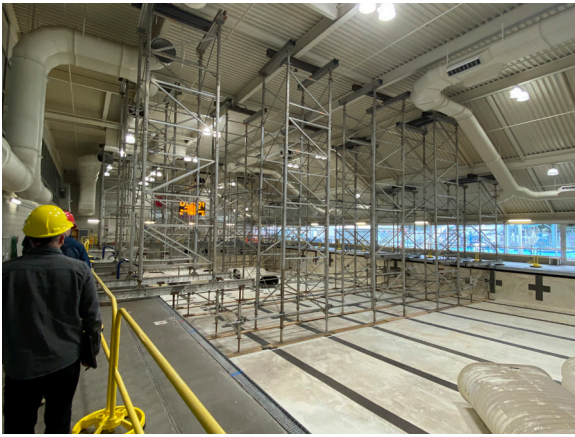
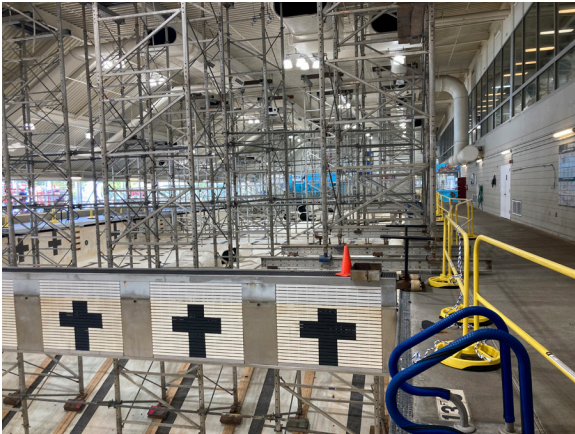
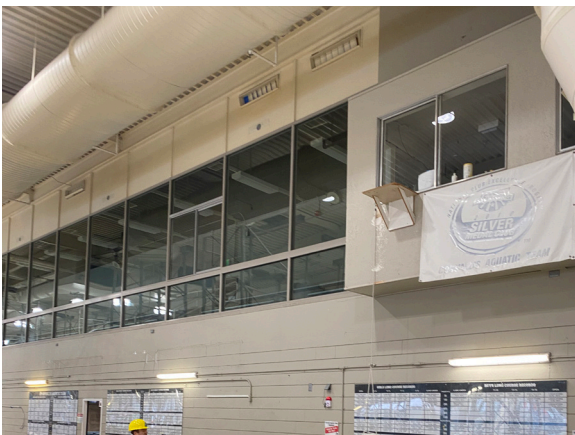
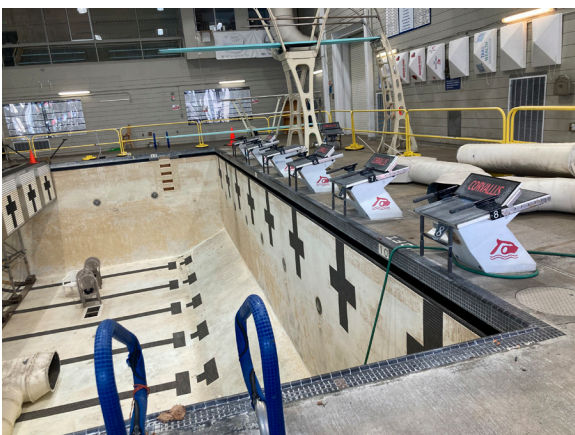
1. NATATORIUM

The Osborn Aquatic Center natatorium (7,930 sf) houses a 50 meter pool and heated therapy pool.

- Complete needed structural renovations.
- Complete needed mechanical renovations.
- Replace broken scoreboard.
- Replace corroded windows and doors.

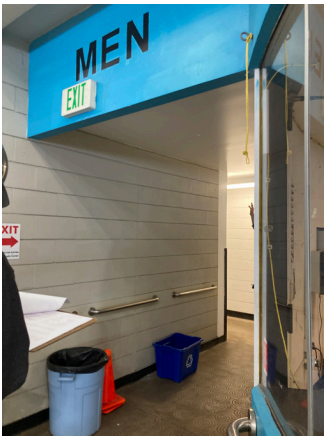
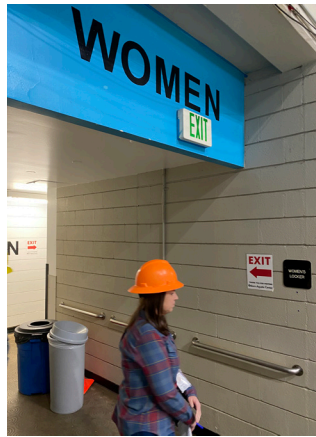
SPACE DESCRIPTION AND ASSESSMENT:
Locker room entries onto deck.

- Install storefront glass and door to separate spaces for HVAC air quality.

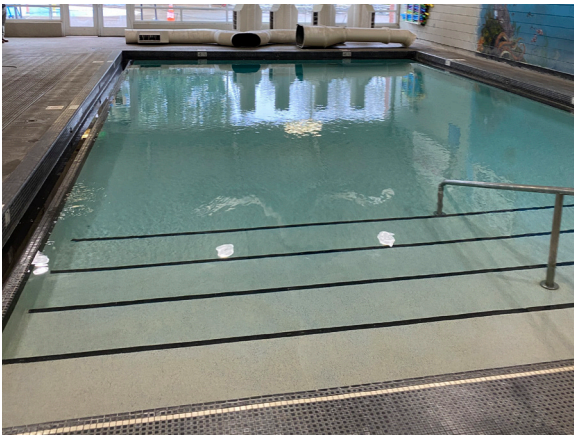
SPACE DESCRIPTION AND ASSESSMENT:
This area of the Natatorium includes the 91 degree therapy pool.

- Therapy Pool tile edge with quartz plaster liner.
- Very robust programming in pool.
- Everything from small children and babies to adult therapy.
- Programming is at capacity due to limited space.

- Long term goal to extend pool area south to align with the main pool edge
- Adding a ramp for increased accessibility and capacity.

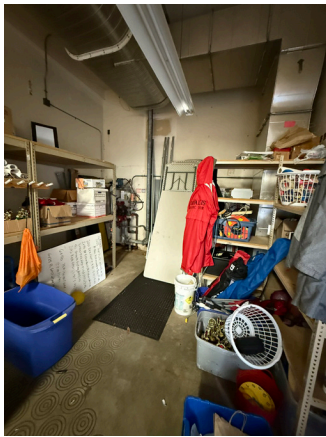
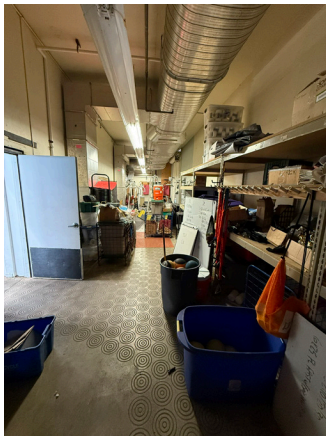
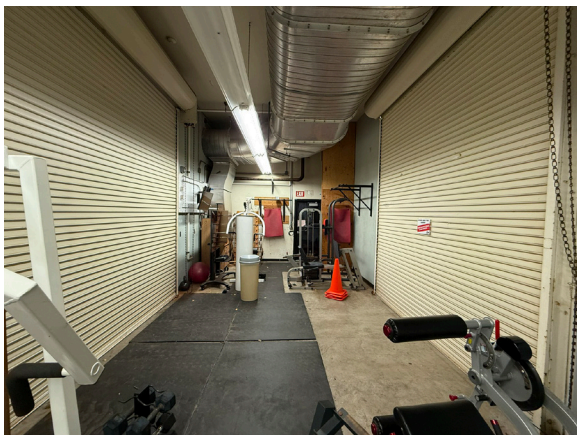
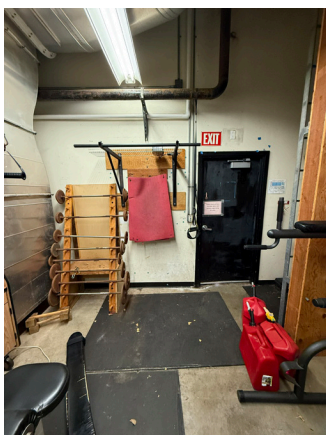
2. NATATORIUM STORAGE ROOM

- The space can be accessed from the desk via a flush pair of doors or an overhead coiling door.
- Access from the room to the exterior of the building is through an overhead coiling door or a single man door.
- This space is currently used as a workout space for cardio and strength conditioning equipment, as well as general storage.

- The space was not designed for fitness equipment and usage.
- Relocate function to a different location within the building.
- Upgrade the overhead lighting within the room.

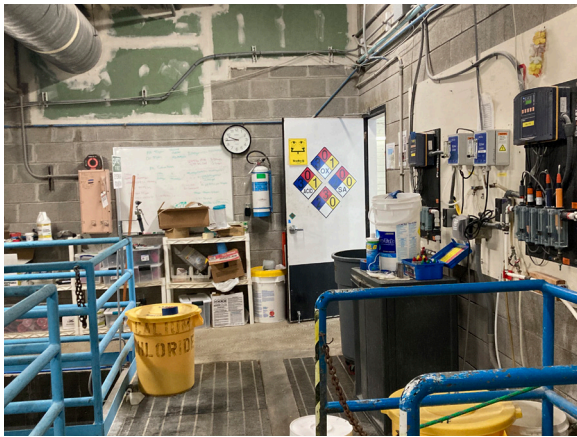
8. POOL FILTER ROOM

This space holds the filter equipment for the Natatorium

- Upgrade overhead and task lighting in the space.
- Provide grate coverage over remaining mechanical spaces to expand usable space.

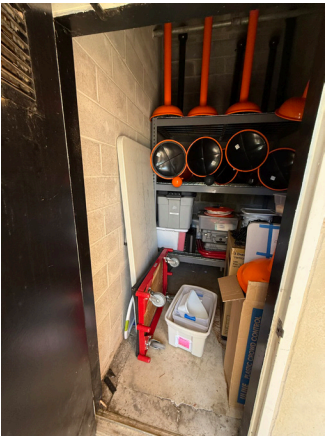
9. POOL EQUIPMENT ROOM (FORMER CO2 ROOM)

Though labeled on building plans as "CO2 Room" it is now used as additional pool equipment storage space.

- Physically combine with rooms 10 and 11.

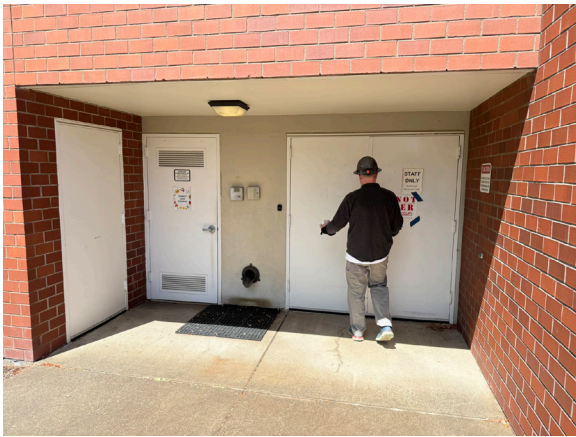
10. POOL EQUIPMENT ROOM

This room functions as the main equipment room for water programming.

- Install storage system to better organize equipment
- Upgrade lighting.
- Combine with rooms 9 and 11.

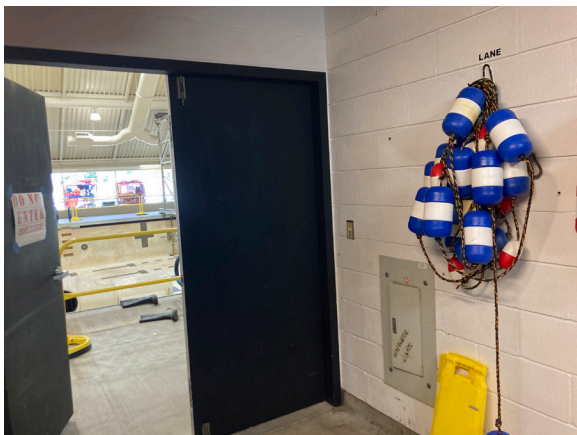
11. POOL EQUIPMENT ROOM

This space is an extension of the previous Pool Equipment Room.

- Install storage system to better organize equipment
- Upgrade lighting.
- Combine with rooms 9 and 10.

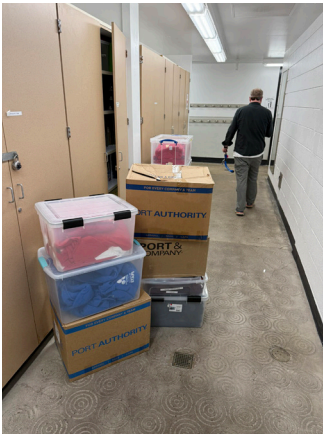
12. WOMENS LOCKER ROOM HALLWAY

Lobby to hallway connection within Womens Locker Room.

- The storage is needed but problematic for access.
- Cabinetry needs to move somewhere else.
- At the time of SEA's in-person assessment it was indicated that the hairdryers at each mirrored counter tend to overheat and brake frequently.
- Wall mounted dryers would be preferred.

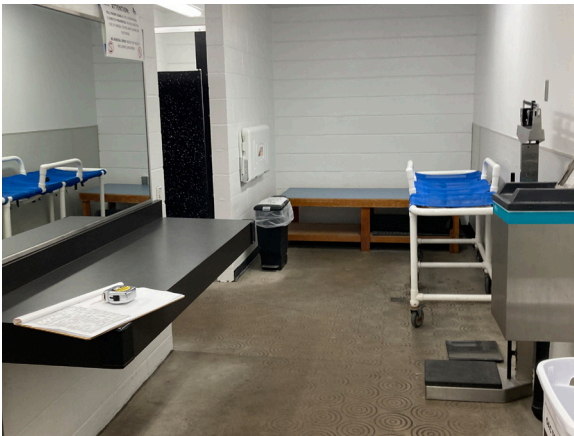
Locker hall includes access to toilets, showers, lockers, and pool entry.

- At the time of SEA's in-person assessment it was indicated that the hairdryers at each mirrored counter tend to overheat and brake frequently, and wall mounted dryers would be preferred.
- FRP, wall base, and door backers need to be replaced. Lighting needs to be upgraded.
- Replace existing hair dryers with wall mounted dryers.

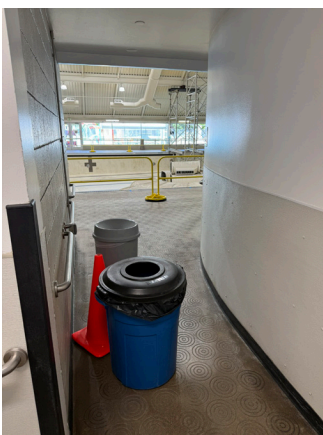
Entry to natatorium within Womens Locker Room.

- Add a door for separation of conditioned areas.

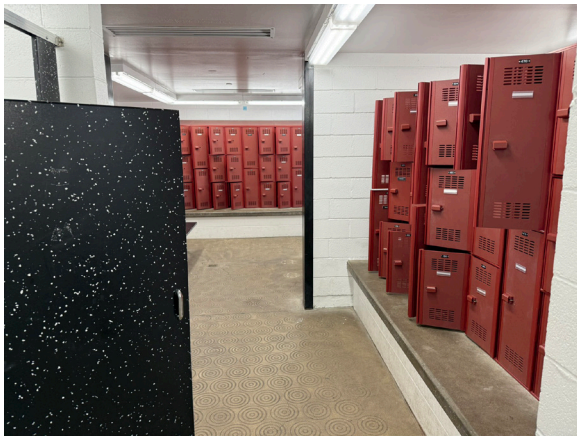
13. WOMENS LOCKER ROOM LOCKERS

The Womens Locker Room locker area contains multiple benches, towel and clothes hooks, and two private changing rooms.

- The private changing rooms are often utilized.
- Facility staff indicated that they are interested in a locking solution for lockers that does not require a padlock or keys.
- Plastic lockers should be replaced.
- Provide locking system that is digital or numeric code based.

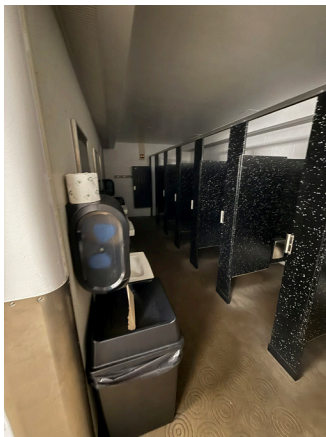
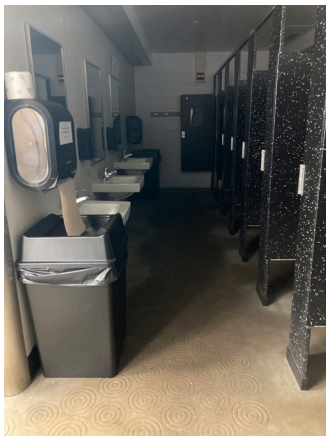
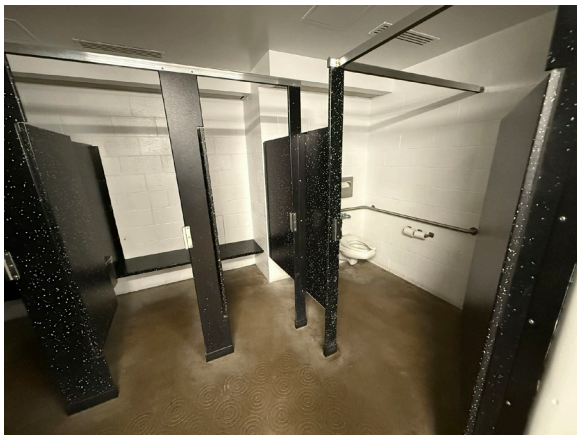
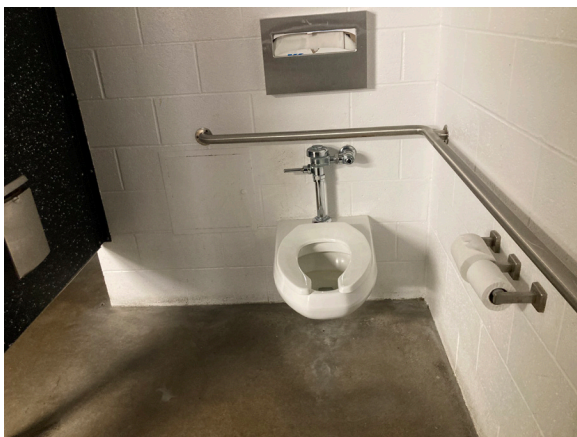
14. WOMENS LOCKER ROOM TOILETS

There are six toilet stalls and three sinks within the Womens Locker Room.

- All under-sink piping must be covered with a temperature controlled slip-covers.
- Replace existing grab bar in accessible stall with updated set of grab bars, including 18" vertical grab bar. Confirm that clear floor area from masonry wall to inside of stall partition is indeed 60" clear.
- Toilet accessories, including toilet paper dispenser, toilet seat cover dispenser, and sanitary napkin disposal container must be within accessible reach range - meeting ANSI Sec 604.7 Dispenser Outlet Location.

- Additional womens water closets need to be added to the Aquatic Center to meet expected occupancy. (3) regular size stalls can fit in the Women's Toilets along the same plumbing wall without infringing on turning radius and circulation.

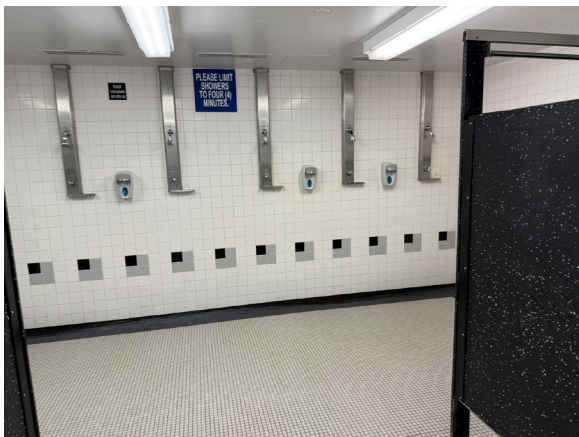
15. WOMENS LOCKER ROOM SHOWERS

The Womens Locker Room showers contain seven open shower heads with a trench drain, and five shower heads with shower curtain and separation panels.

- At the time of SEA's in-person assessment it was indicated that the shower controls are Italian and are hard to fix or replace.
- Soap frequently runs out.
- Replace shower controls.
- Replace rusty bases.

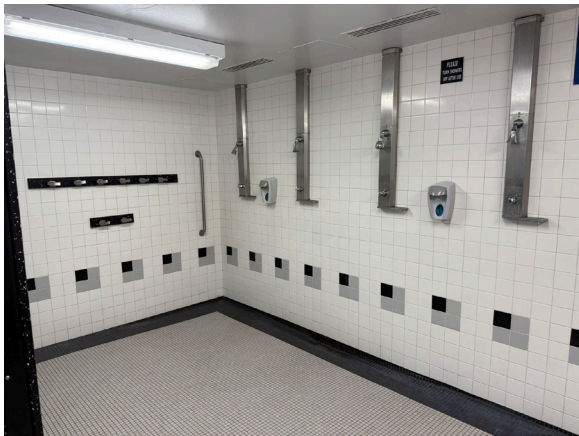
- The transfer-style shower does not provide a full, clear 36" opening for a transfer from a chair. 48" of clear space is needed from the control wall for a transfer.
- Controls needs to be on opposite wall of seat.
- Confirm operable parts of soap dispensers are no higher than 48" from the floor.
- Operable parts of shower controls should be between 36"-48" from the floor.

Seat transfer style shower

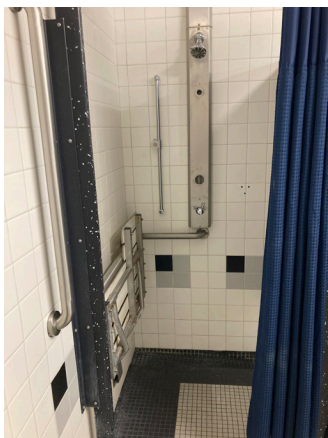
Roll-in style shower

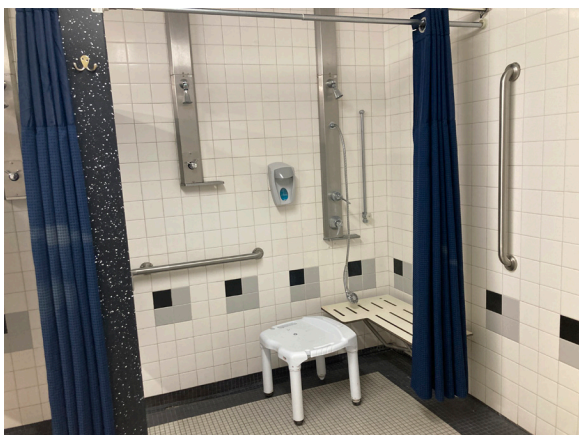
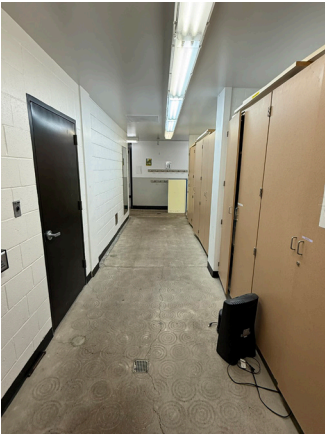
16. MENS LOCKER ROOM HALLWAY

Lobby to hallway connection within Mens Locker Room.

- The storage is needed but problematic for access
- Cabinetry needs to move somewhere else.
- There is rust on cabinetry hinges.

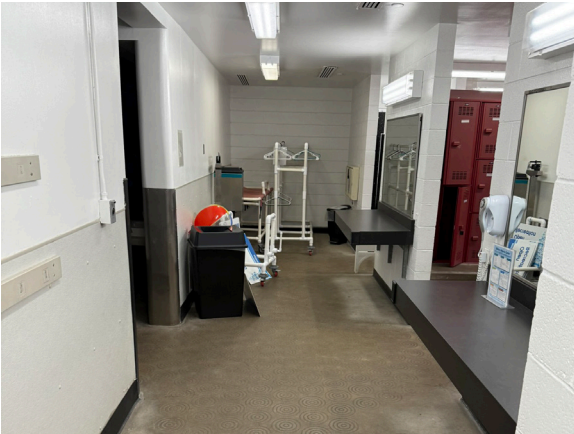
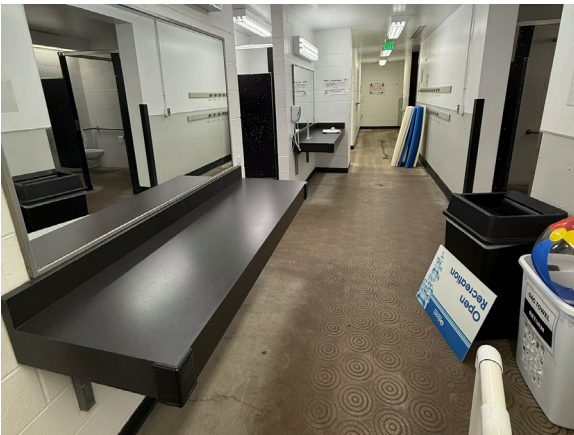
Locker hall includes access to toilets, showers, lockers, and pool entry.

- At the time of SEA's in-person assessment it was indicated that the hairdryers at each mirrored counter tend to overheat and brake frequently, and wall mounted dryers would be preferred.
- FRP, wall base, and door backers need to be replaced. Lighting needs to be upgraded.
- Replace existing hair dryers with wall mounted dryers.

- The operable parts of the swimsuit spinner need to be located between 34"-46" from the floor for an obstructed high side reach. Currently at 51" from floor.
- The diaper changing table needs to have 38"x42" clear space for a forward approach.

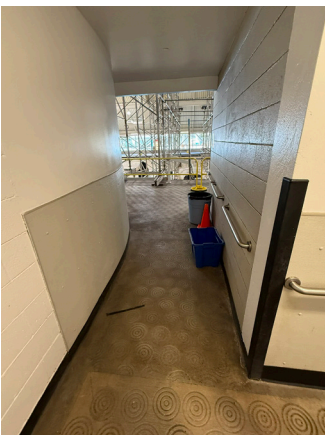
Entry to natatorium within Mens Locker Room.

- Add a door for separation of conditioned areas.

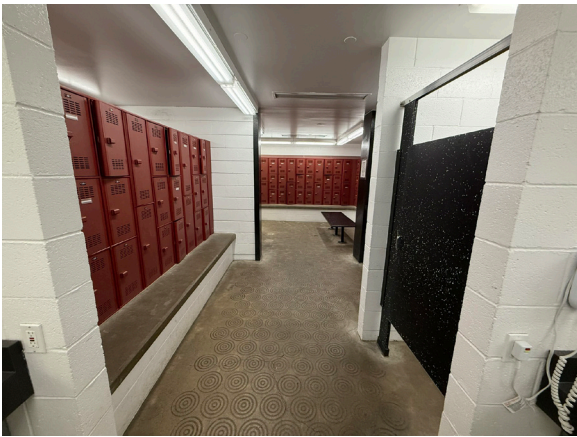
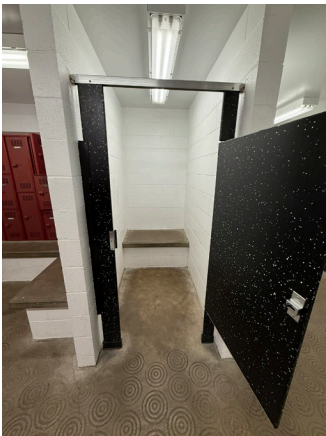
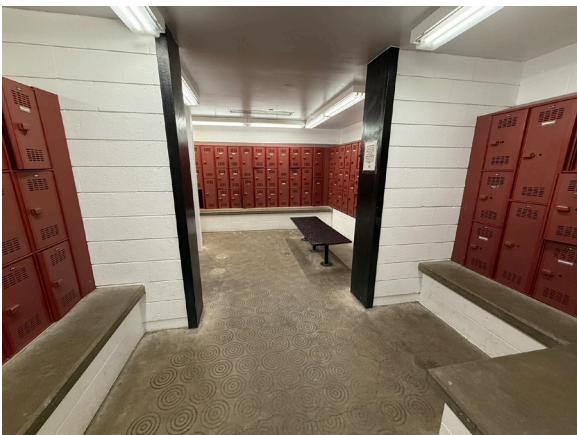
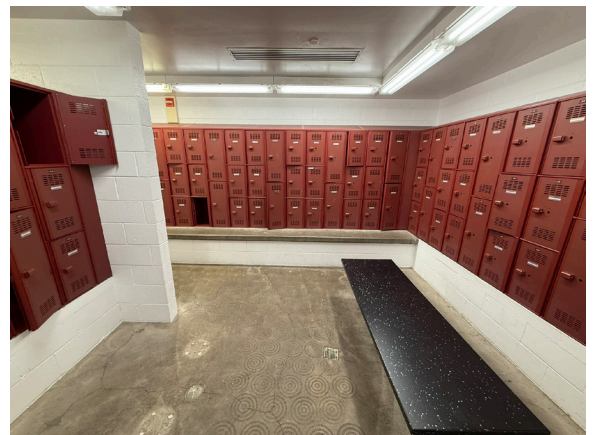
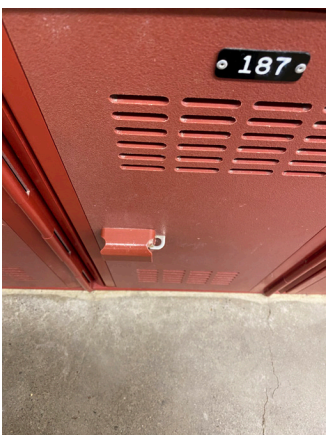
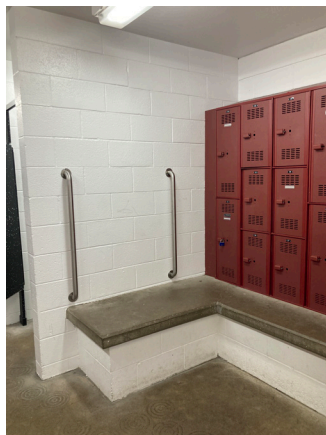
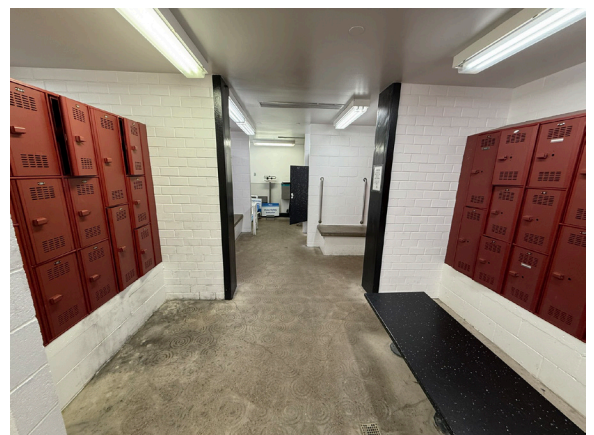
17. MENS LOCKER ROOM LOCKERS

The Mens Locker Room locker area contains multiple benches, towel hooks, and two private changing rooms.

- The private changing rooms are often utilized.
- Facility staff indicated that they are interested in a locking solution for lockers that does not require a padlock or keys.
- Plastic lockers should be replaced.
- Provide locking system that is digital or numeric code based.

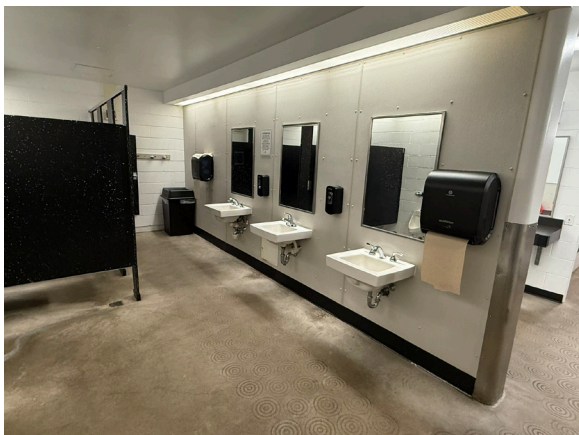
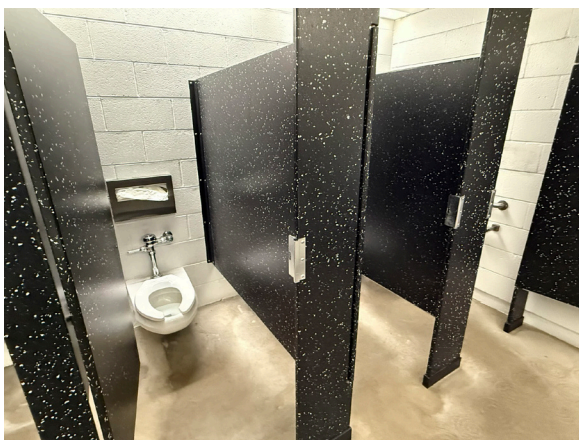
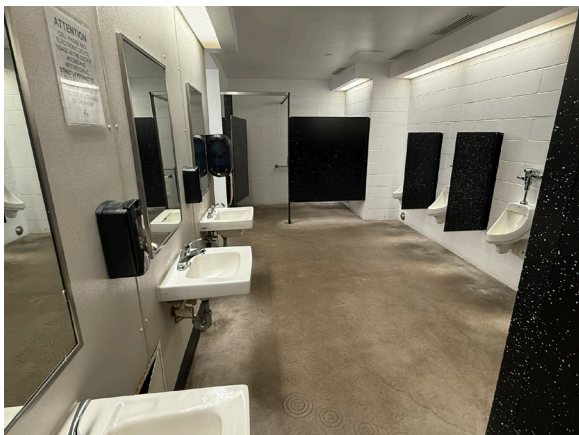
18. MENS LOCKER ROOM TOILETS

There are four toilet stalls, four urinals, and three sinks within the Mens Locker Room.

- Lavatory fixtures should all be the same model.
- Rusty access panels need to be replaced.
- Lighting fixtures need to be upgraded.

- All under-sink piping must be covered with a temperature controlled slip-covers.
- Replace existing grab bar with updated set of grab bars, at accessible toilet stall should including 18" vertical grab bar.
- Confirm that clear floor area from masonry wall to inside of stall partition is indeed 60" clear.
- Toilet accessories, including TP dispenser, toilet seat cover dispenser, and sanitary napkin disposal container must be within accessible reach range - meeting ANSI Sec 604.7 Dispenser Outlet Location.

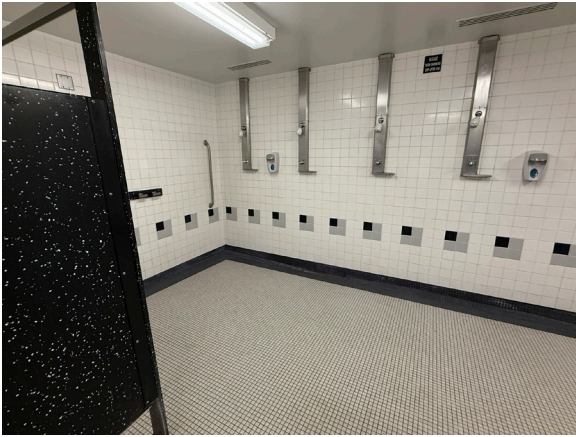
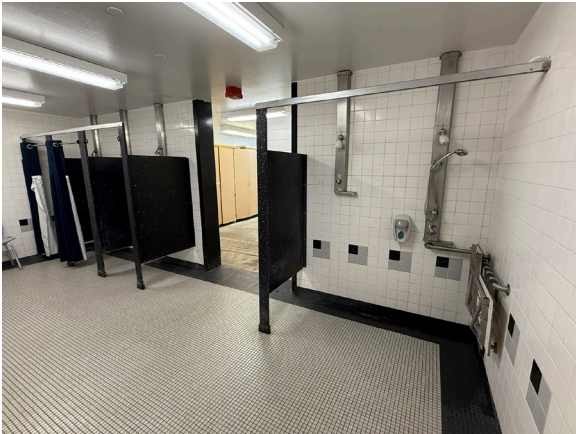
19. MENS LOCKER ROOM SHOWERS

The Mens Locker Room showers contain seven open shower heads with a trench drain, and five shower heads with shower curtain and separation panels.

- At the time of SEA's in-person assessment it was indicated that the shower controls are Italian and are hard to fix or replace.
- Soap frequently runs out.
- Replace shower controls.
- Replace rusty bases.

- The transfer-style shower does not actually provide a full, clear 36" opening for a transfer from a chair. 48" of clear space is needed from the control wall for a transfer.
- Controls needs to be on opposite wall of seat.
- Confirm operable parts of soap dispensers are no higher than 48" from the floor.
- Operable parts of shower controls should be between 36"-48" from the floor.

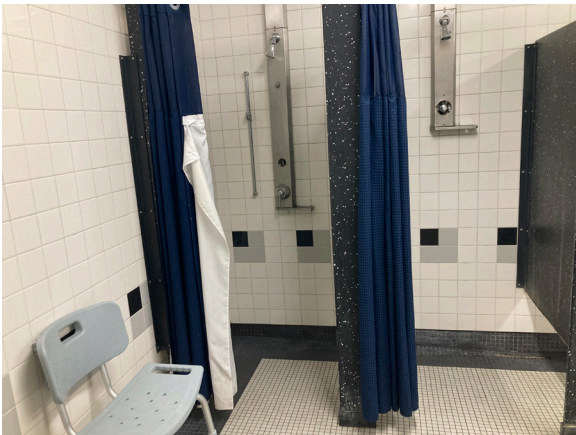
Seat transfer style shower without fold-able seat bench (shower chair provided)

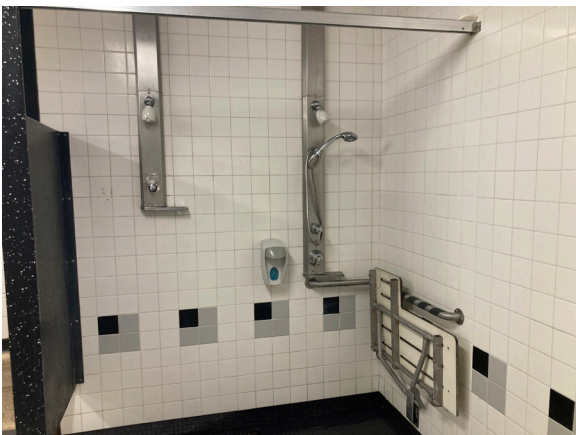
Roll-in style shower

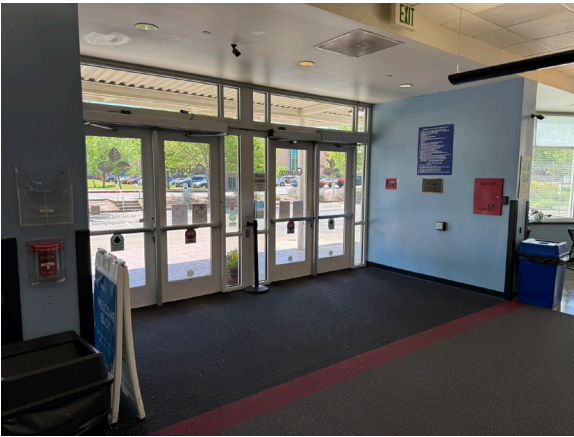
20. VESTIBULE

The building vestibule is not enclosed, and creates a direct connection to the lobby.

- Install storefront glazing and storefront doors to create an enclosed vestibule.
- At the time of SEA's in-person assessment it was indicated that the walk off mats at the vestibule work well, but queuing to the reception desk can go all the way back to the doors on busy days.

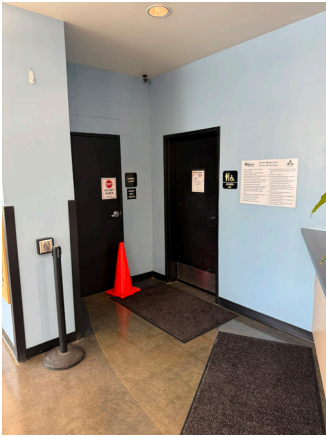
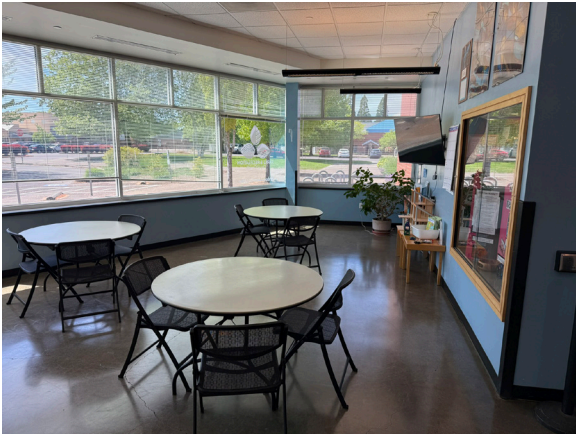
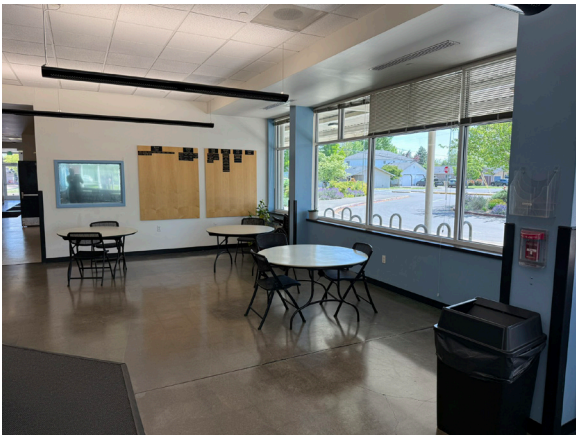
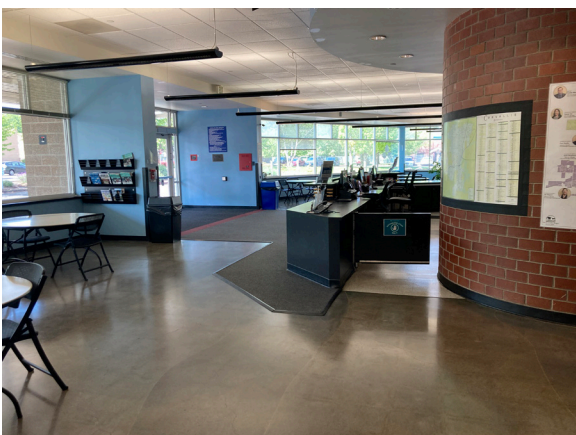
21. LOBBY

The lobby includes non-fixed seating and tables, as well as direct access to the Womens Restroom and Locker Room.

- Underutilized area within the lobby could be used as a new location for the pro shop.
- Specific area should be designated for swim meet vendor sale location.
- Facility staff indicated that the polished concrete flooring tends to be slick, and that the walk off mat is much more functional for the space.
- 3-4 vendors set up in the Lobby during swim meets.
- Refinish the faded concrete floor.
- Automated door button to Mens Locker Room was not working at the time of SEA's in-person assessment.

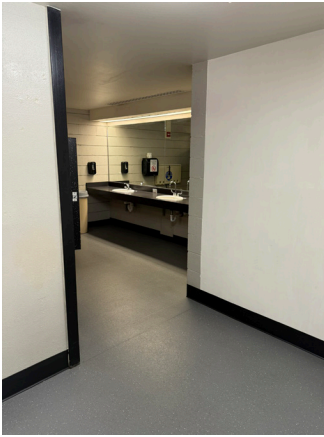
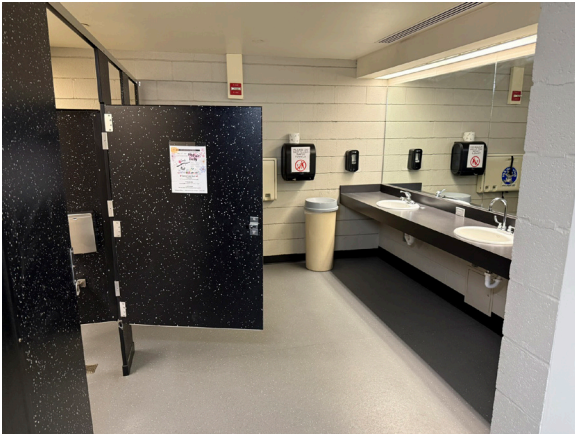
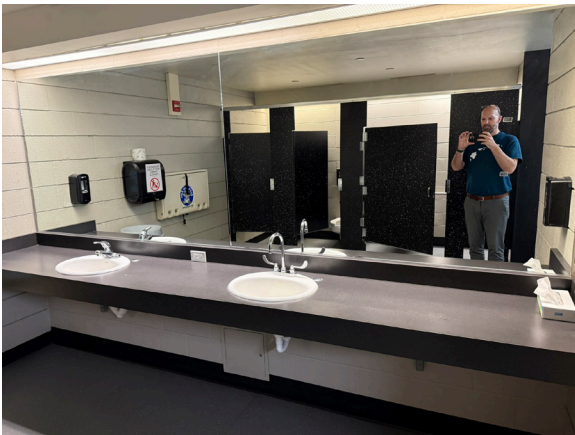
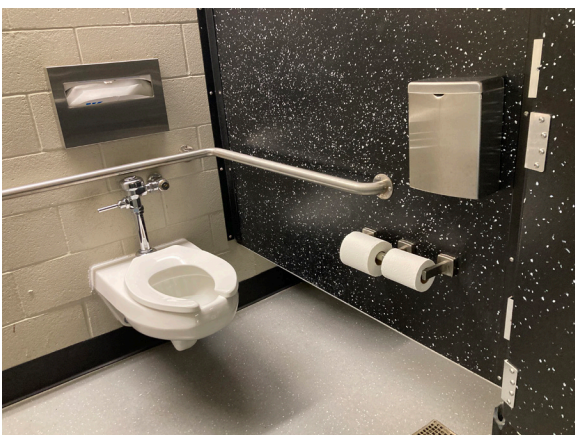
22. WOMENS LOBBY RESTROOM

The Womens Restroom is accessible from the Lobby.

- Confirm there is less than 8" of clear space between front of counter and sink bowl. Sink bowl need to be moved back to provide clear knee space. Overhang lip of counter needs to be at least 27" from the floor.
- All under-sink piping must be covered with a temperature controlled slip-cover.
- Replace existing grab bar at accessible stall with updated set of grab bars, including 18" vertical grab bar.
- Confirm that clear floor area from masonry wall to inside of stall partition is indeed 60" clear.
- Toilet accessories, including toilet paper dispenser, toilet seat cover dispenser, and sanitary napkin disposal container must be within accessible reach range - meeting ANSI Sec 604.7 Dispenser Outlet Location.

- Additional womens water closets need to be added to the Aquatic Center to meet minimum fixture counts based on calculated occupancy.

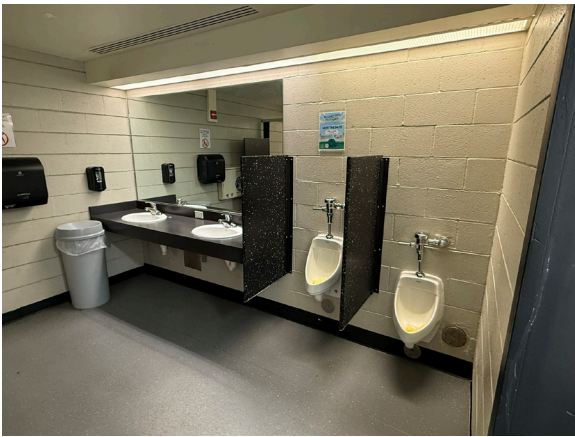
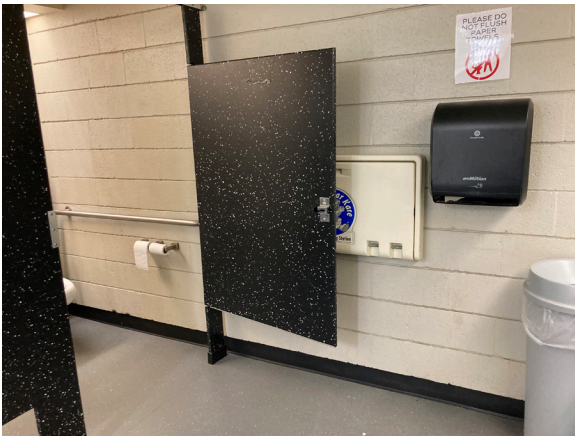
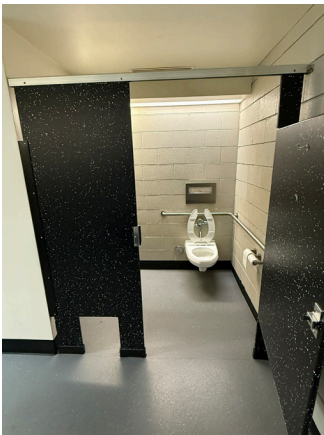
23. MENS LOBBY RESTROOM

The restroom includes one accessible toilet stall, two urinals, two sinks, and one baby changing station.

- Accessible height urinal needs a clear front approach of 36" from masonry wall to surface of partition panel. Measures only 28".
- Replace existing grab bar at accessible stall with updated set of grab bars, including 18" vertical grab bar.
- Confirm that clear floor area from masonry wall to inside of stall partition is indeed 60" clear.
- Toilet accessories, including toilet paper dispenser, toilet seat cover dispenser, and sanitary napkin disposal container must be within accessible reach range - meeting ANSI Sec 604.7 Dispenser Outlet Location.
- Confirm there is less than 8" of clear space between front of counter and sink bowl. Measures only 3". Sink bowl need to be moved back to provide clear knee space.
- Overhang lip of counter needs to be at least 27" from the floor.
- All under-sink piping must be covered with a temperature controlled slip-cover.

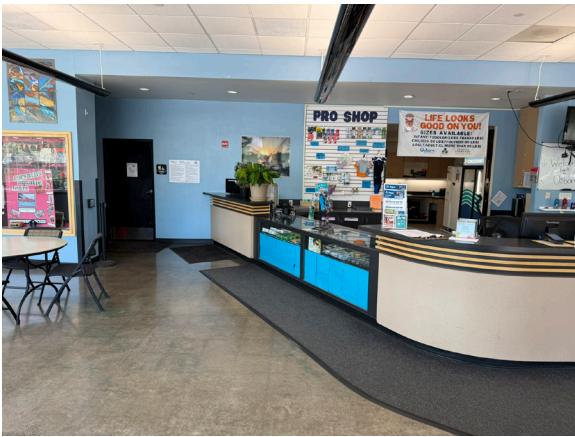
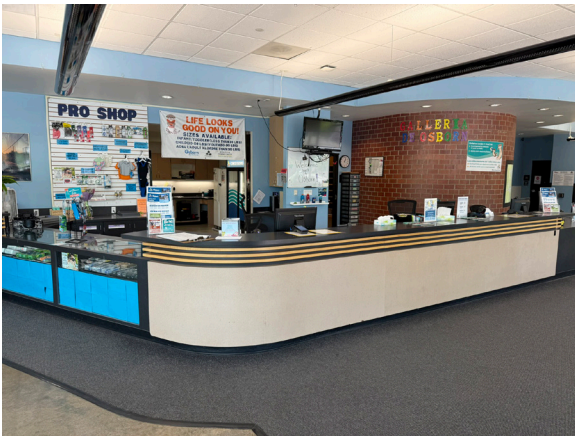
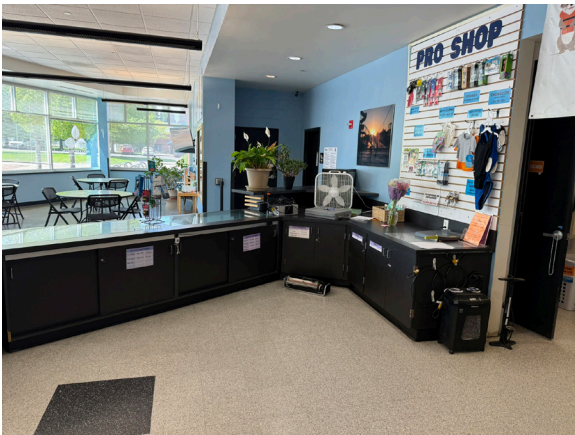
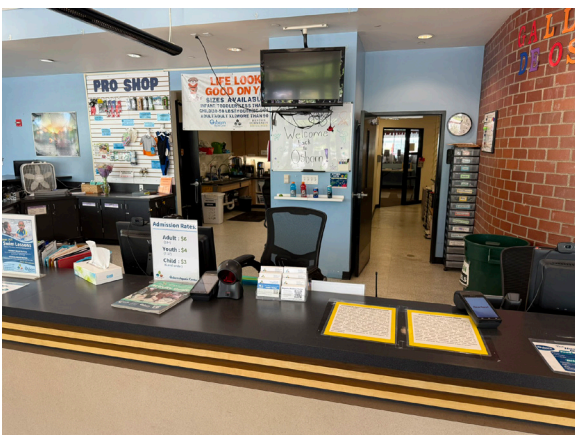
24. RECEPTION

The reception area includes the front desk and pro shop with a staff work area behind the desk, and access to the hallway leading to staff office space.

- At the time of SEA's in-person visit, facility staff indicated that the reception desk stations were not very ergonomic, and it would be preferred that working stations were lower.
- It was also indicated that security and control of check-in was a concern, as there is plenty of room on either side of the desk to breeze through.
- The polished concrete flooring tends to be slick
- The walk off mat is much more functional for the space.
- Way-finding signage could be improved in the lobby.
- Damaged Formica on desk should be replaced.
- Vinyl composition tiles should be replaced where cracked.
- Overhead lighting fixtures should be upgraded.
- Concessions should be relocated to be made more visible.
- Locate television screens in this area to stream swim meet coverage, entry prices, and other information.

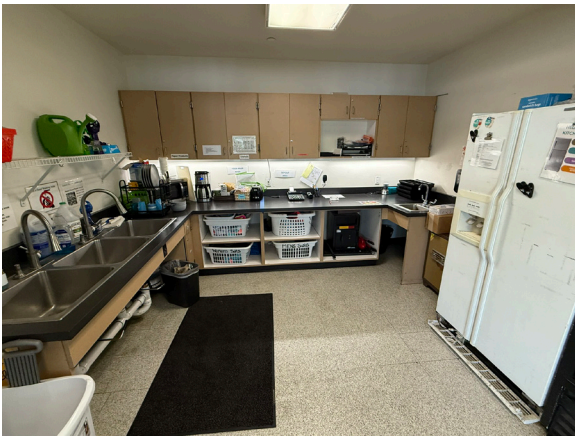
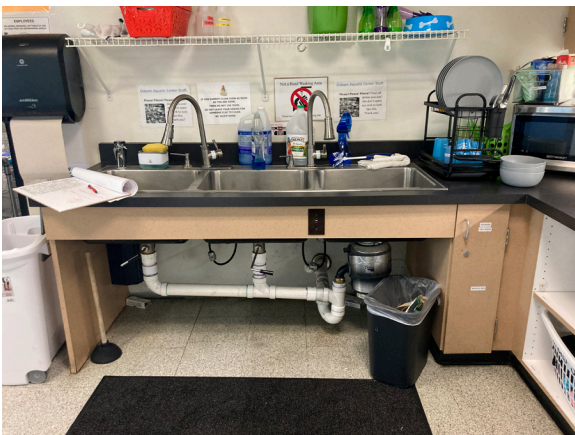
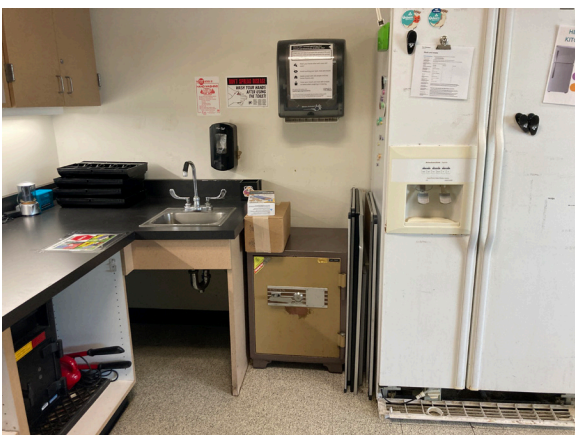
- Clear floor space positioned for a forward approach is not provided at sinks. Knee and toe clearance needs to be provided.
- Tops of working surfaces for accessible staff use should only be between 28"-34" from the floor.

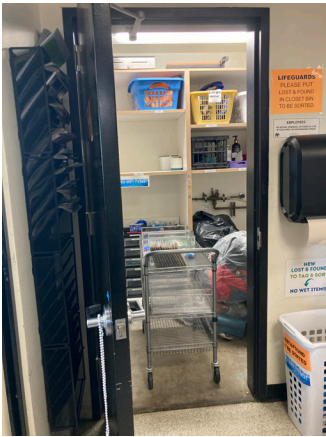
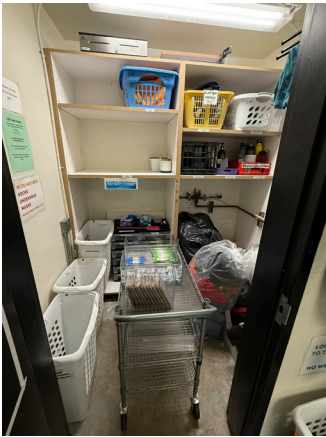
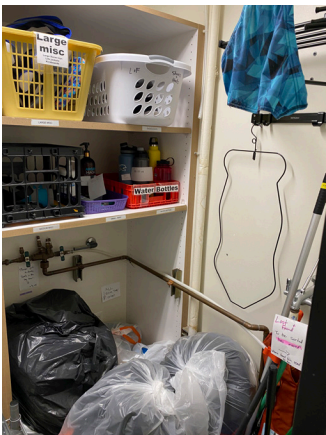
26. RECEPTION STORAGE ROOM

This space was originally designated as a Janitor Room but is currently being used as a Storage Room.

- Merge room into renovation of administrative area.
