City of Corvallis
Corvallis School District

Osborn Aquatic Center Facilities Assessment

Scott
Edwards
Architecture

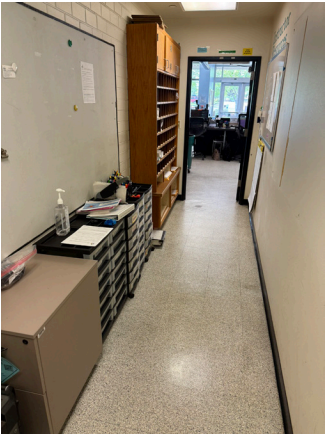
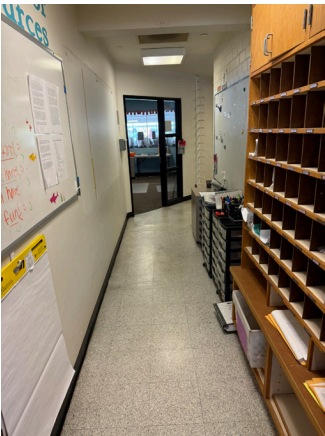
27. STAFF HALLWAY

The hallway can be accessed from behind the reception desk, and connects the reception area to the Aquatics Office and Staff Space.

- Relocate staff document storage.
- Hallway may be relocated for more direct access to staff space and offices in central administrative suite renovation.
- Shelving for staff documents creates a cramped condition.

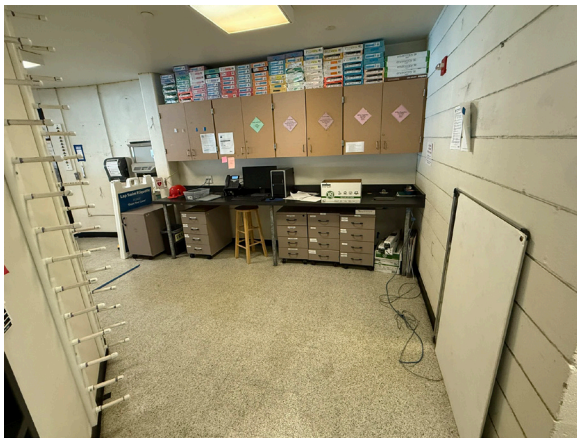
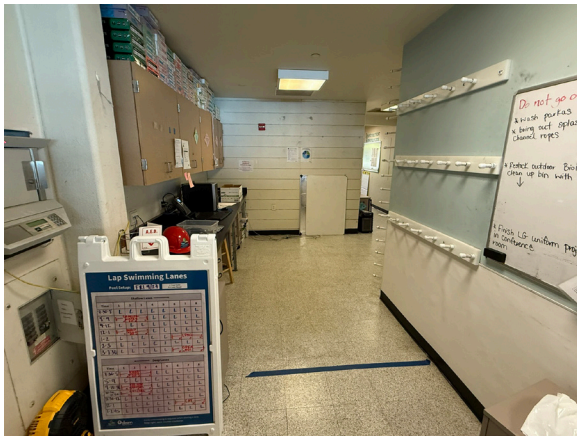
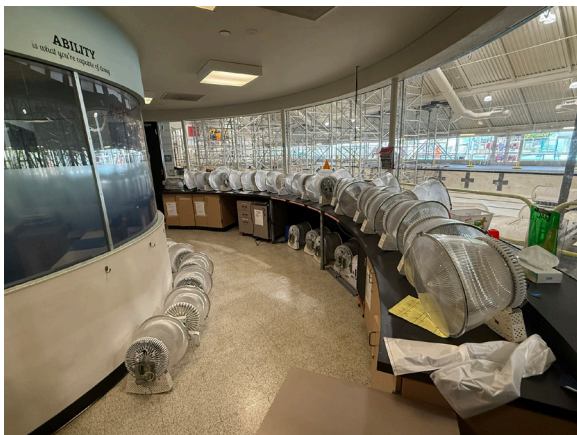
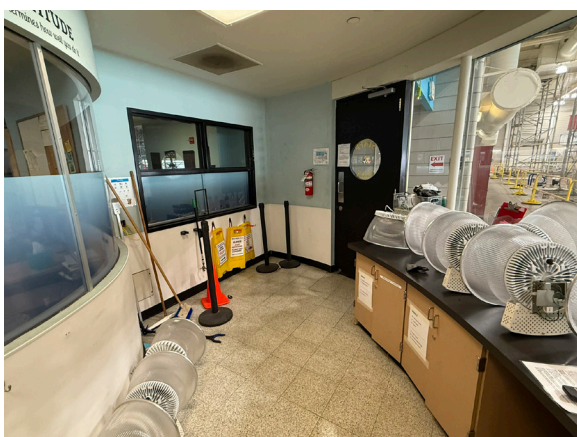
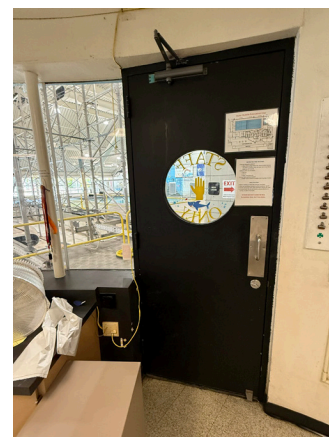
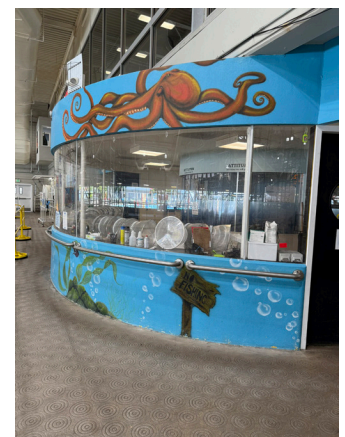
28. STAFF POOL VIEWING AREA

The staff area, accessed via the hallway behind the reception desk, had shelving and casework space, as well as a view out to the natatorium.

- Lifeguards using space to do their time-sheets creates bottleneck.
- It is recommended that the central administrative areas be redesigned and renovated. The reworked space would include:

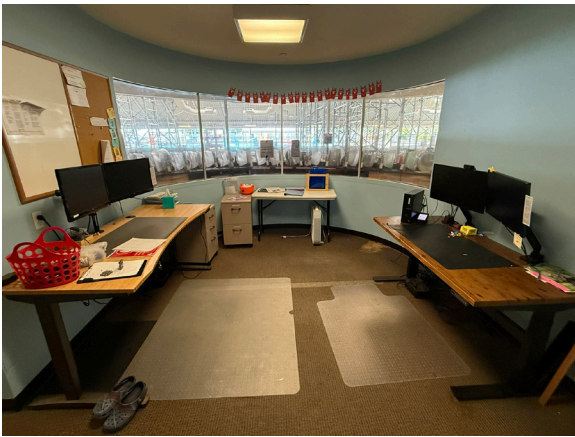
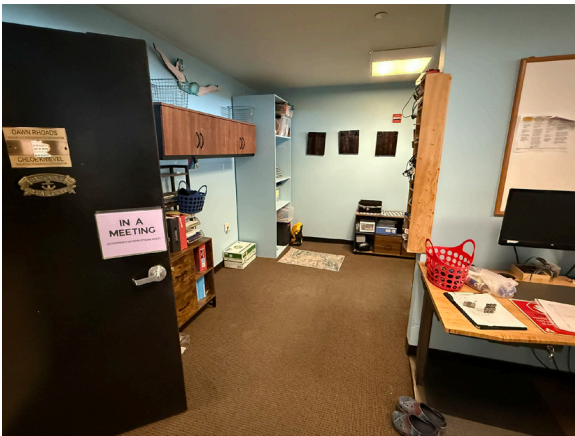
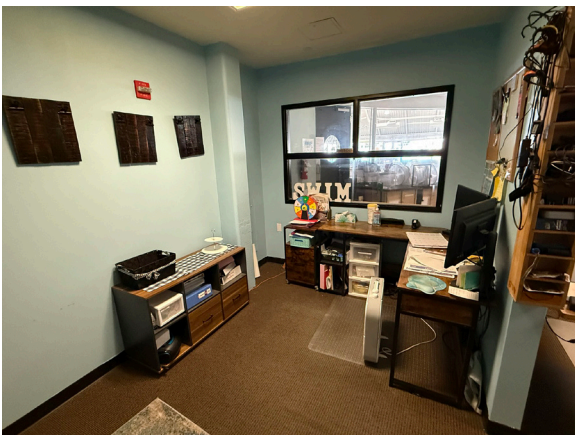
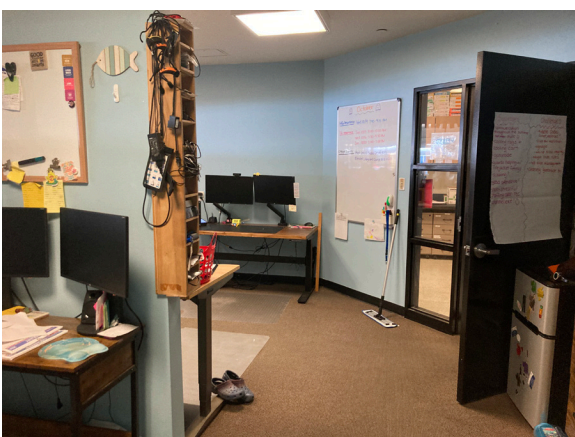
29. AQUATICS OFFICE

The aquatics office has been used by the Operations Coordinator and the Instructional Programs Coordinator, as well as multiple part-time program assistants.

- Space should be separated into individual staff offices high STC rated walls.
- Offices need to be adjacent to a small conference room.

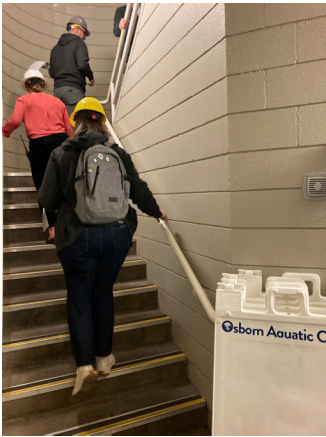
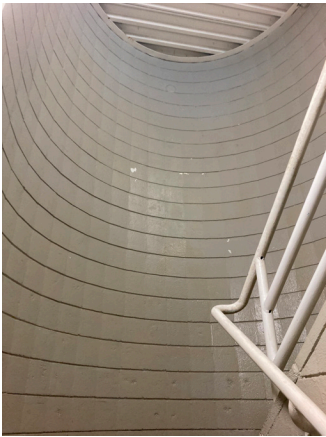
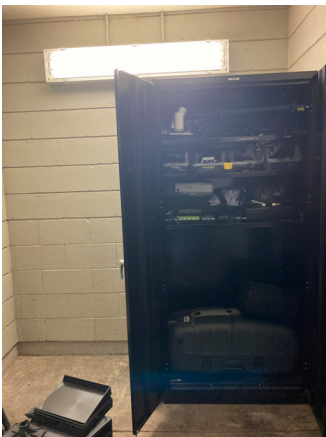
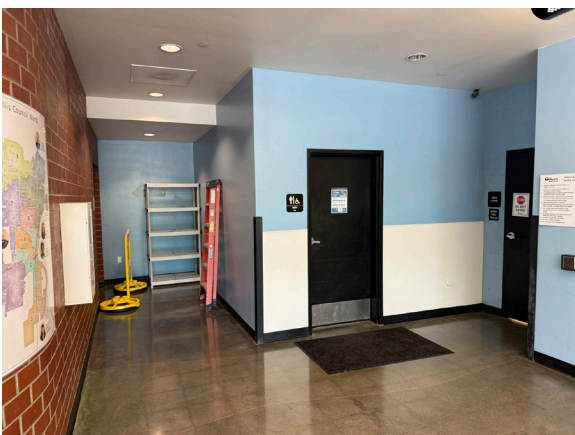
30. STAIR 1

One set of stairs connects the lobby to the mezzanine floor viewing area.

- There is no accessible access to second floor/mezzanine level.

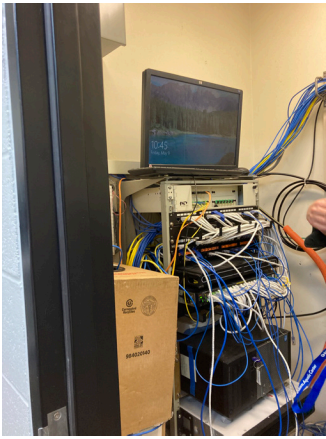
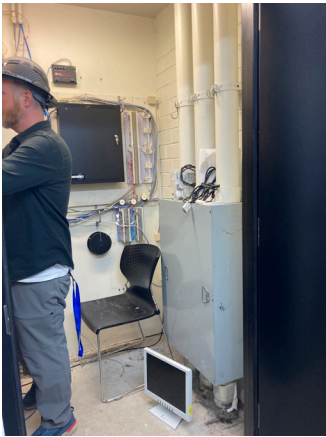
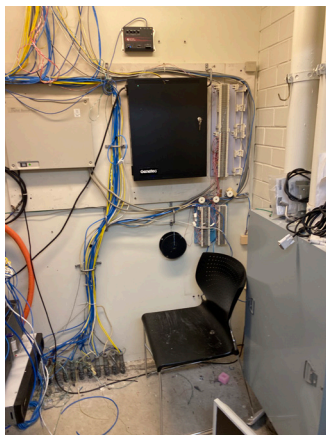
31. DATA/COMM ROOM

EMS System is located within this room

- Provide access from outside of Mens Locker Room or relocate to another part of the building.

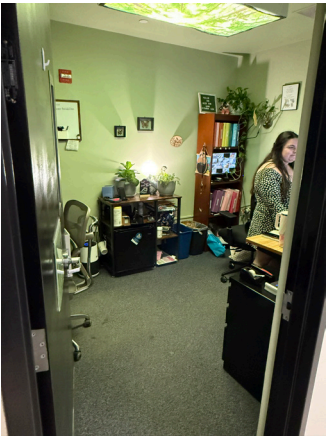
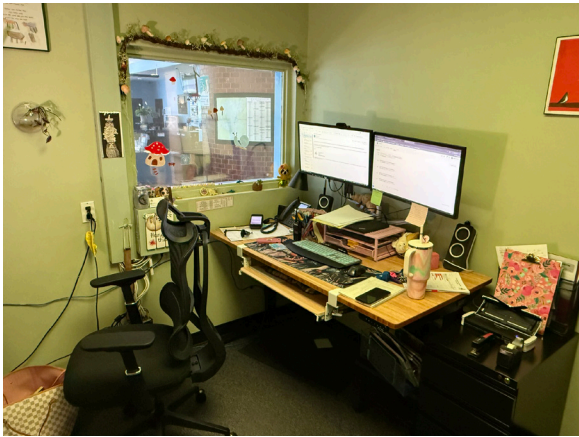
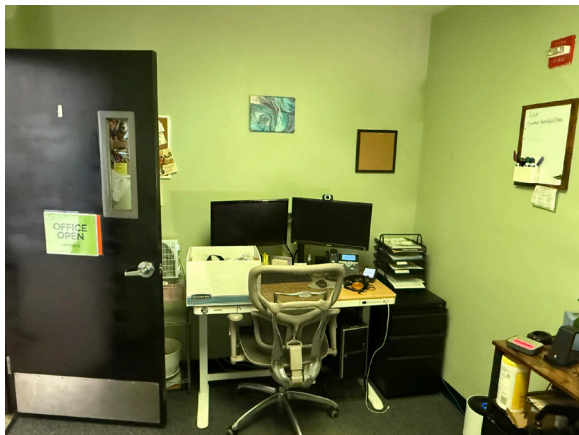
32. LOBBY OFFICE

While the space had been indicated to be a physical therapy office in original building plan drawings, it is used as a staff office for the Aquatics Support Specialist and the Office Assistant.

- Business occupancy spaces required 150 gross sq ft per worker.

- Offices for staff should integrate into revised administrative suite.
- Replace carpet with alternative flooring material.

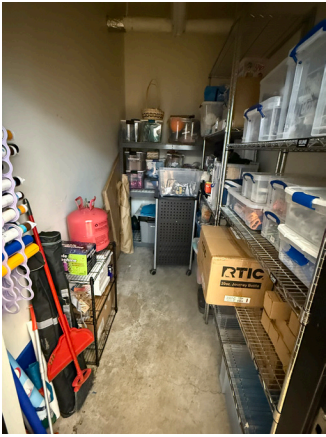
33. ACTIVITY ROOM STORAGE

Used to store equipment for activity room functions.
Accessed from inside Activity Room 1.

- Upgrade lighting.
- Relocate general building storage elsewhere in the building.

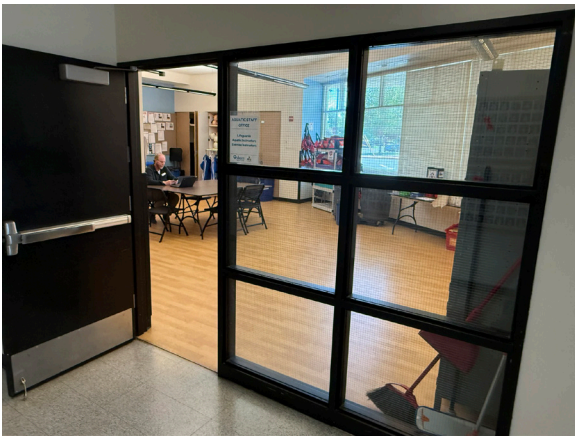
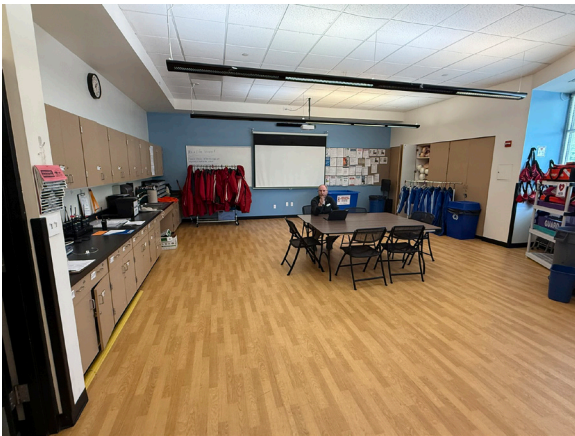
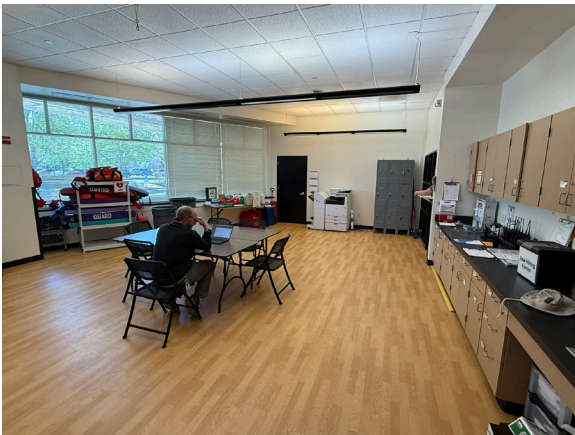
34. ACTIVITY ROOM 1

The room is currently used for staff operations, but can be used for birthday parties, lifeguard or first-aid training, and exercise classes.

- Install blinds for privacy needs depending on type of class.
- Upgrade audio/visual components.
- Upgrade lighting.

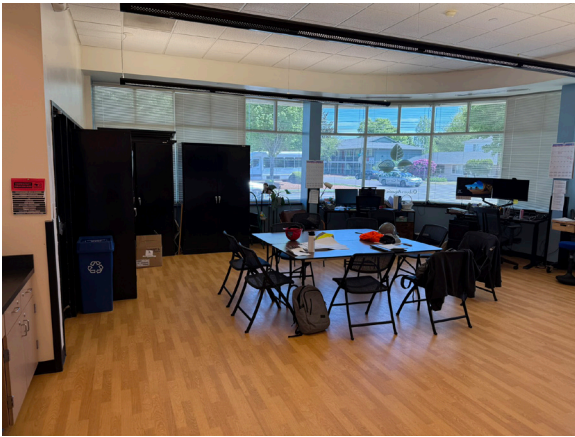
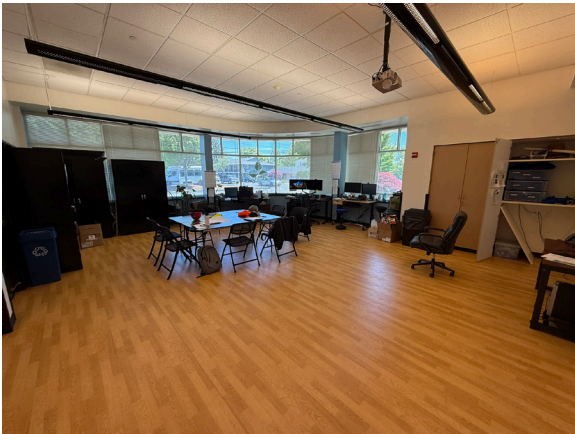
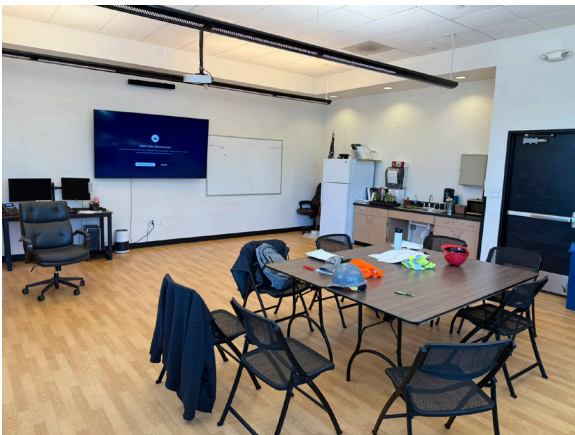
35. ACTIVITY ROOM 2

The room is currently serving as the as the main administrative office, but can be used for exercise classes, birthday parties, lifeguard/first-aid training, etc.

- Upgrade blinds and overhead lighting in room.
- Repaint room.
- Upgrade audio/visual components.

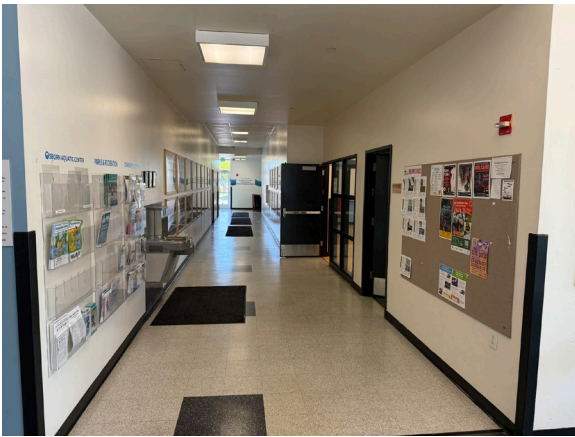
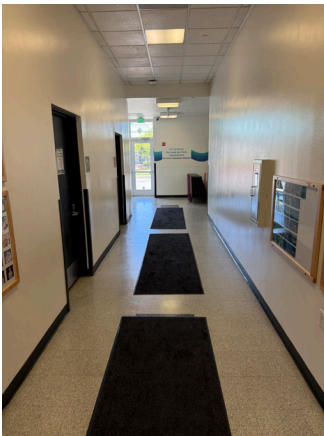
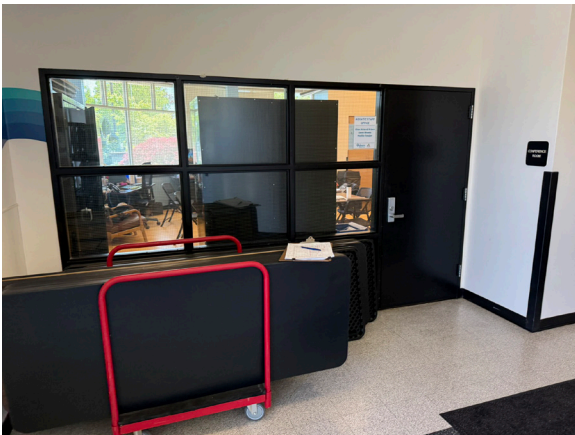
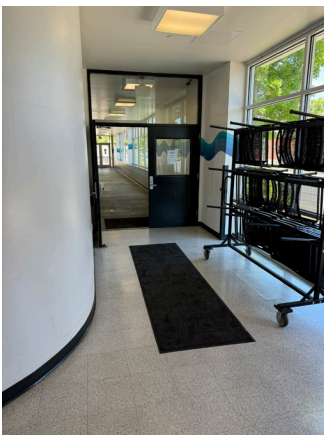
36. LOBBY HALLWAY

This hallway connects the lobby and reception area to the family changing wing.

- Drinking fountain requires cane detection, as it is protruding more than 4" into an accessible circulation route.

- Replace poor condition ACT flooring with a wet/dry carpet material.
- Replace overhead lighting fixtures.

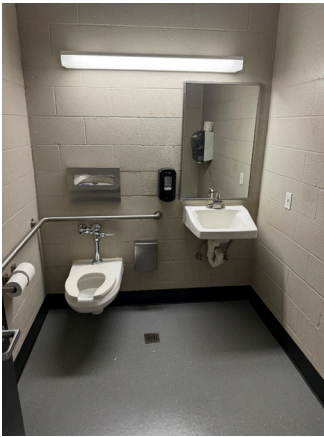
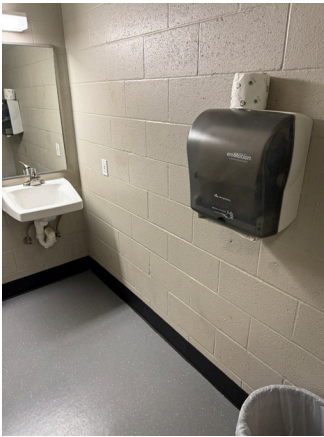
37. SINGLE-USER RESTROOM

SPACE DESCRIPTION AND ASSESSMENT:
Non-accessible, single occupancy toilet room.

- Room should get a new coat of paint.
- Vanity light fixture should be replaced and an overhead light added.

- Sink protrudes into 60"x 56" clear space required at toilet.
- Replace existing grab bar with updated set of grab bars, including 18" vertical grab bar.
- Toilet accessories, including toilet paper dispenser, toilet seat cover dispenser, and sanitary napkin disposal container must be within accessible reach range - meeting ANSI Sec 604.7 Dispenser Outlet Location.
- Install automated door opener.

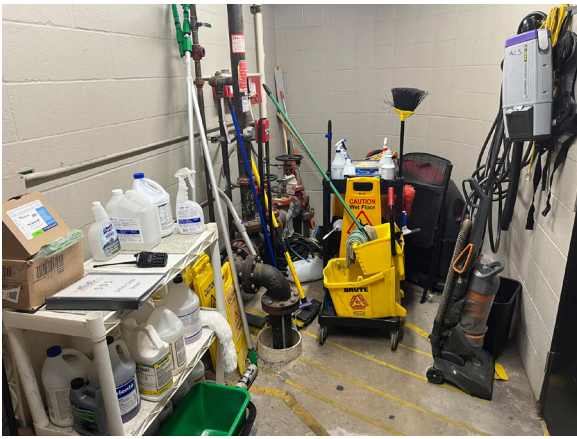
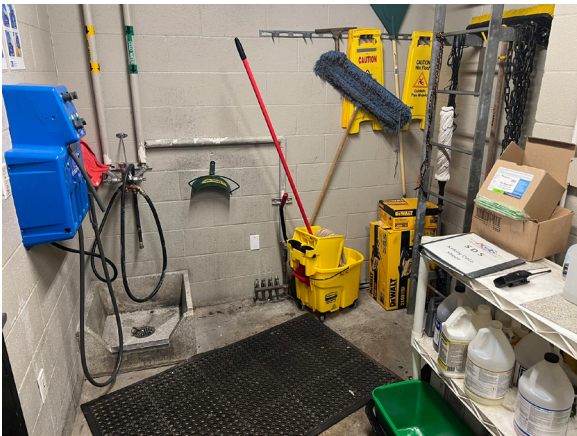
38. CUSTODIAL CLOSET

Room includes mop sink floor drain, steel ladder to access roof hatch, and fire sprinkler system controls.

- Install upper cabinets, equipment hooks, and other organizational systems to address clutter and intrusion into fire sprinkler system control clearance.

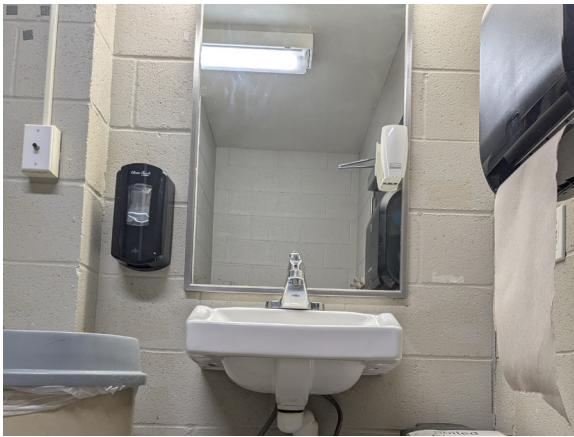
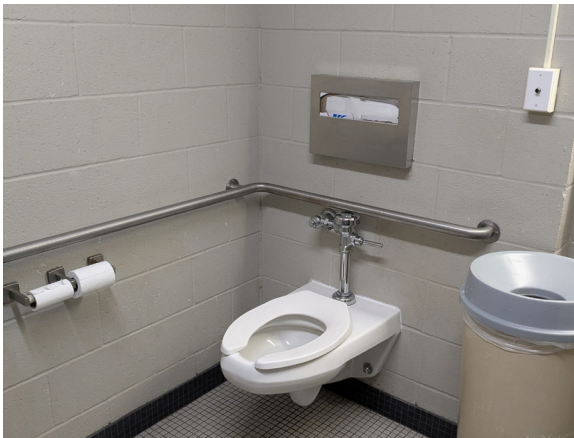
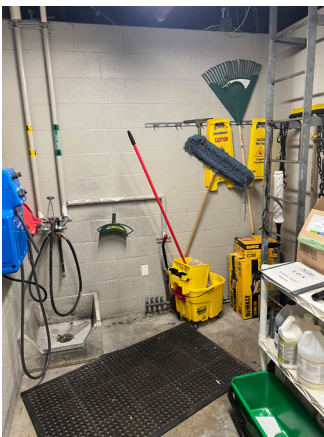
39. FAMILY CHANGING ROOM 1

Family changing room with door lock includes bench, transfer-style shower, baby changing station, toilet, and sink.

- All family changing room showers should receive liners. New coat of paint needed.
- Door is difficult to open at all changing rooms.
- Locking hardware at doors should be consistent.
- Vanity light should be replaced, and overhead lighting added.

- Sink protrudes into 60"x 56" clear space required at toilet.
- Replace existing grab bar with updated set of grab bars, including 18" vertical grab bar.
- Toilet accessories, including toilet paper dispenser, toilet seat cover dispenser, and sanitary napkin disposal container must be within accessible reach range - meeting ANSI Sec 604.7 Dispenser Outlet Location.

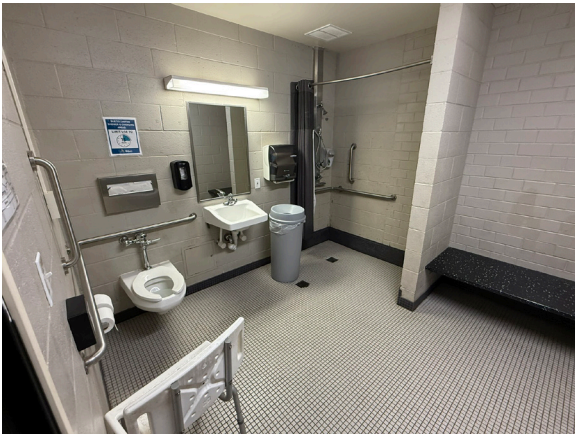
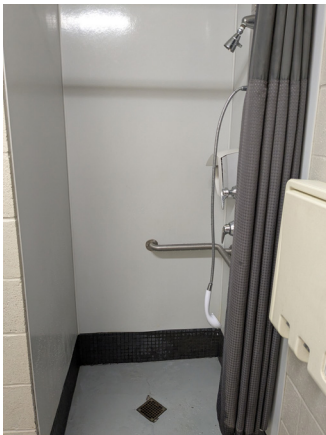
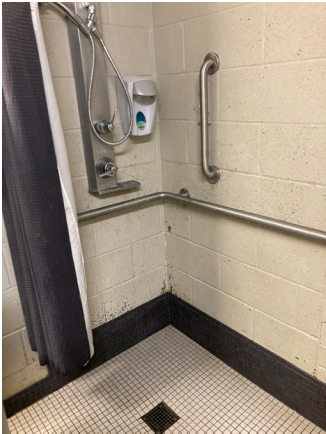
40. FAMILY CHANGING ROOM 2

Family changing room with door lock includes bench, roll-in-style shower, baby changing station, toilet, and sink.

- All family changing room showers should receive liners. New coat of paint needed.
- Door is difficult to open at all changing rooms.
- Locking hardware at doors should be consistent.
- Vanity light should be replaced, and overhead lighting added.

- Sink protrudes into 60"x 56" clear space required at toilet.
- Replace existing grab bar with updated set of grab bars, including 18" vertical grab bar.
- Toilet accessories, including toilet paper dispenser, toilet seat cover dispenser, and sanitary napkin disposal container must be within accessible reach range - meeting ANSI Sec 604.7 Dispenser Outlet Location.

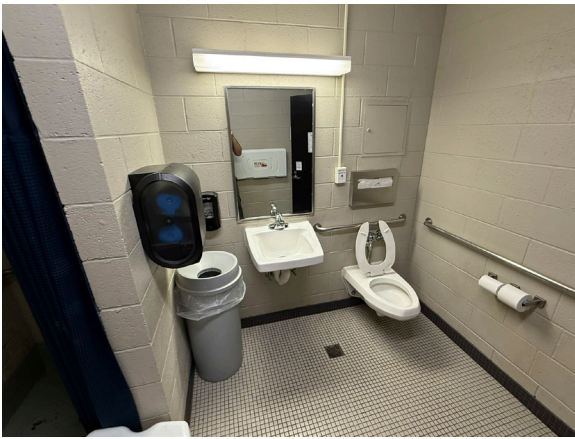
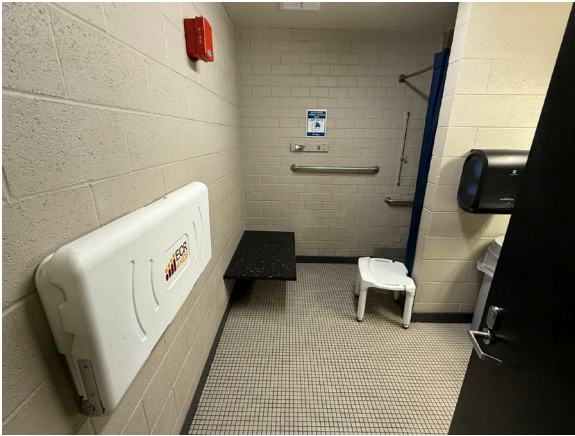
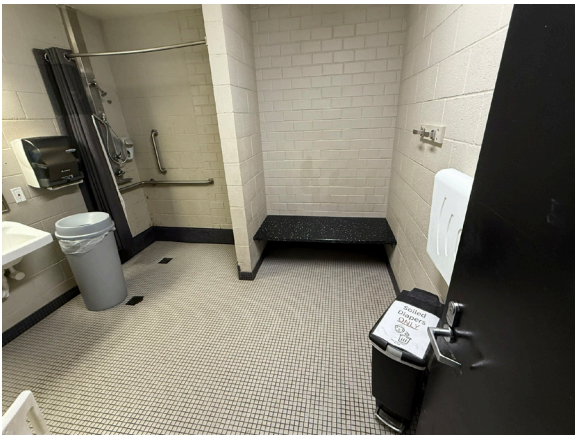
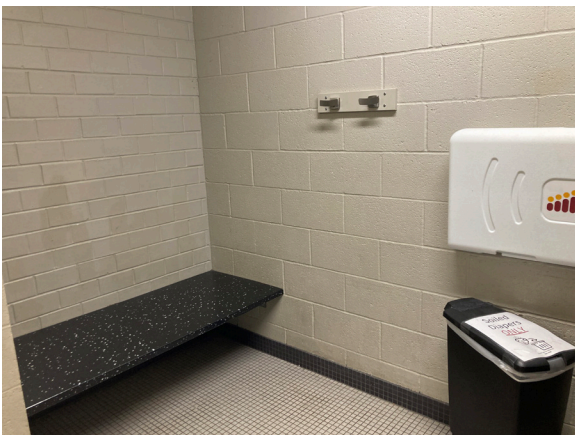
41. FAMILY CHANGING ROOM 3

Family changing room with door lock includes bench, transfer-style shower, baby changing station, toilet, and sink.

- All family changing room showers should receive liners. New coat of paint needed.
- Door is difficult to open at all changing rooms. Locking hardware at doors should be consistent.
- Vanity light should be replaced, and overhead lighting added.

- Sink protrudes into 60"x 56" clear space required at toilet.
- Replace existing grab bar with updated set of grab bars, including 18" vertical grab bar.
- Toilet accessories, including toilet paper dispenser, toilet seat cover dispenser, and sanitary napkin disposal container must be within accessible reach range - meeting ANSI Sec 604.7 Dispenser Outlet Location.

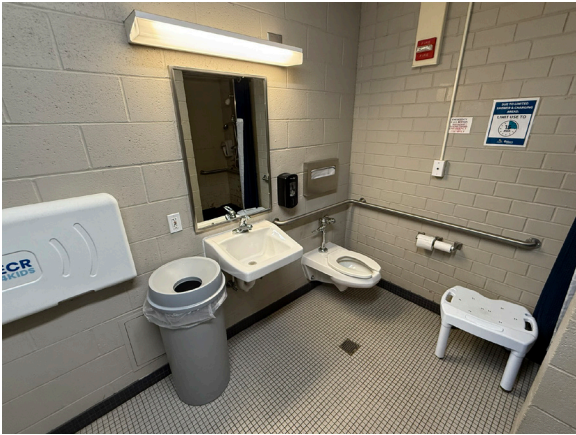
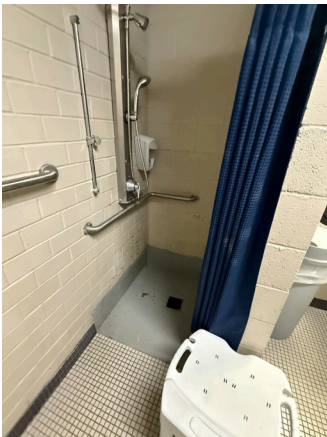
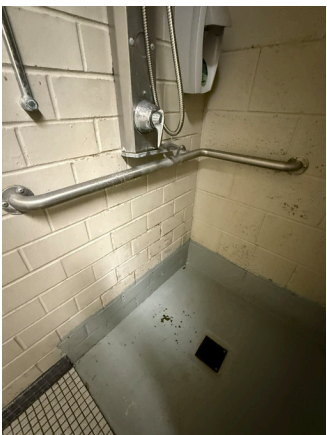
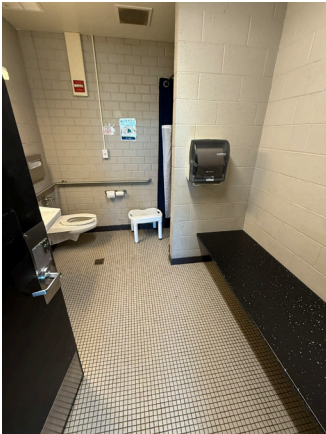
42. FAMILY CHANGING ROOM 4

Family changing room with door lock includes bench, transfer-style shower, baby changing station, toilet, and sink.

- All family changing room showers should receive liners. New coat of paint needed.
- Door is difficult to open at all changing rooms.
- Locking hardware at doors should be consistent.
- Vanity light should be replaced, and overhead lighting added.

- Sink protrudes into 60"x 56" clear space required at toilet.
- Replace existing grab bar with updated set of grab bars, including 18" vertical grab bar.
- Toilet accessories, including toilet paper dispenser, toilet seat cover dispenser, and sanitary napkin disposal container must be within accessible reach range - meeting ANSI Sec 604.7 Dispenser Outlet Location.

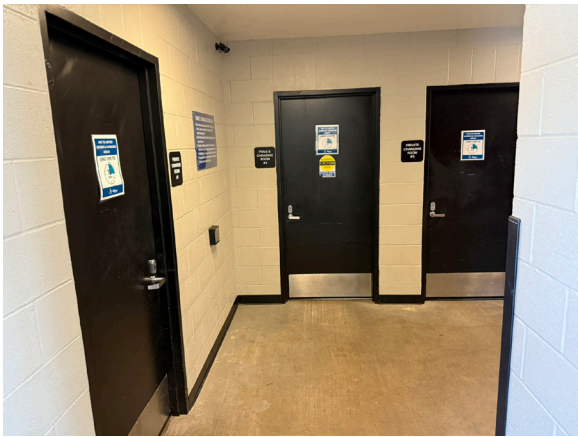
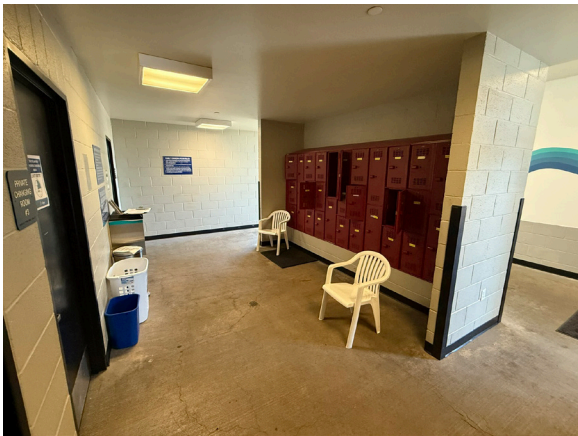
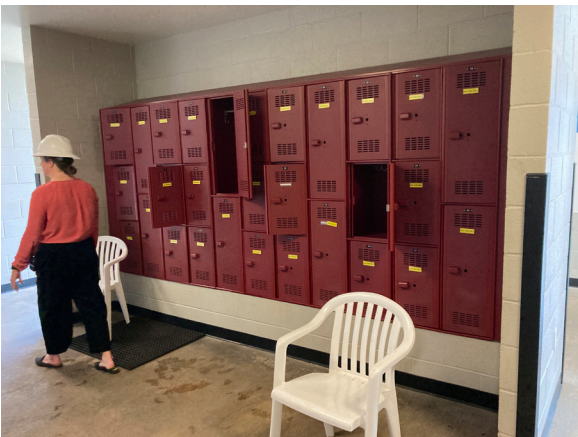
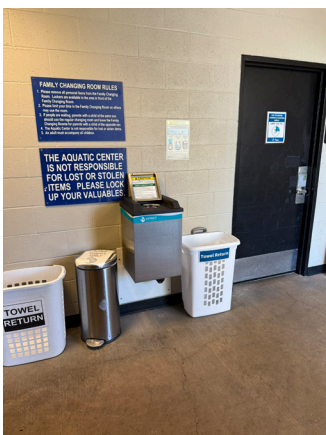
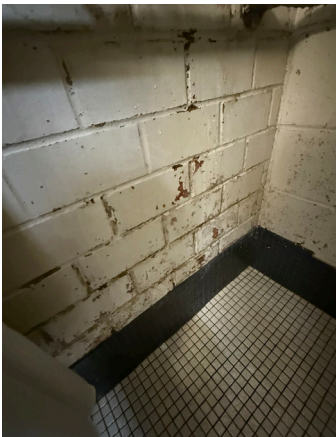
43. FAMILY CHANGING LOCKERS

The area includes access to the four family changing rooms, lockers, and a swim suit spinner.

- Plastic lockers should be replaced.
- Locking system should not require padlocks or keys.
- Upgrade overhead lighting fixture.

- An accessible bench is required within any dressing room or locker room.

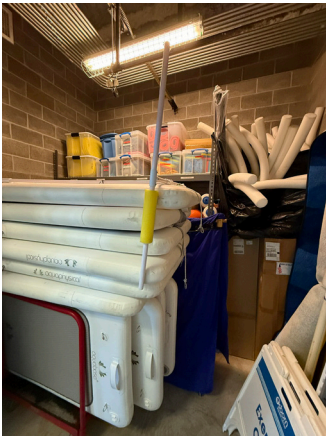
44. STORAGE ROOM

This space is used for pool equipment storage.

- Overhead lighting should be upgraded.

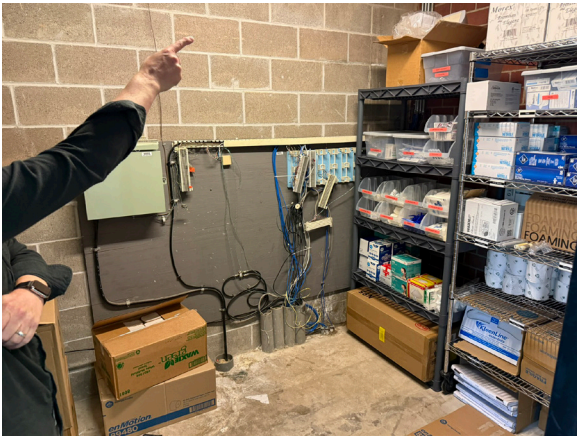
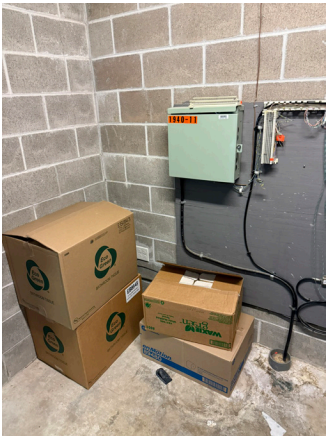
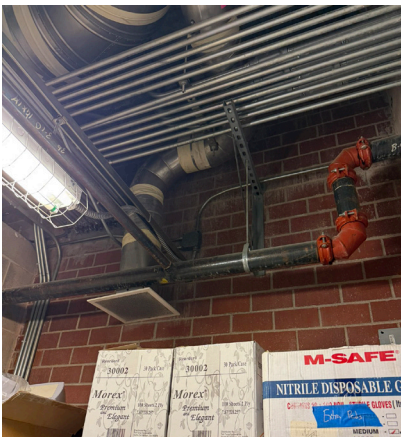
45. CUSTODIAL SUPPLIES STORAGE

This space is used for storage and previously utilized telecom wiring.

- Overhead lighting should be upgraded.
- Remove defunct telecom wiring.
- Could be utilized as office or operational space.

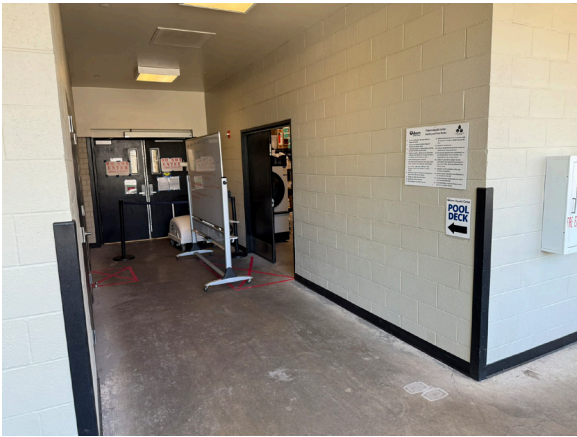
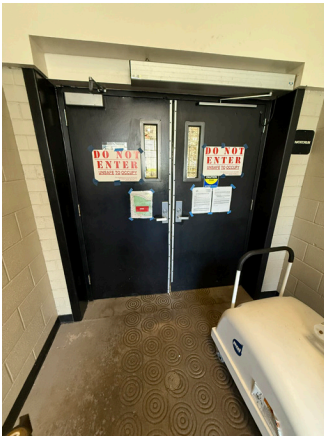
46. NATATORIUM ENTRY/EXIT CORRIDOR

Provides connection between main east building corridor and natatorium through double doors.

- Wall needs repairs in a few locations.
- A new coat of paint should be applied.
- Apply signage to rooms 44, 45, 47, and 48 that reflects current functions.

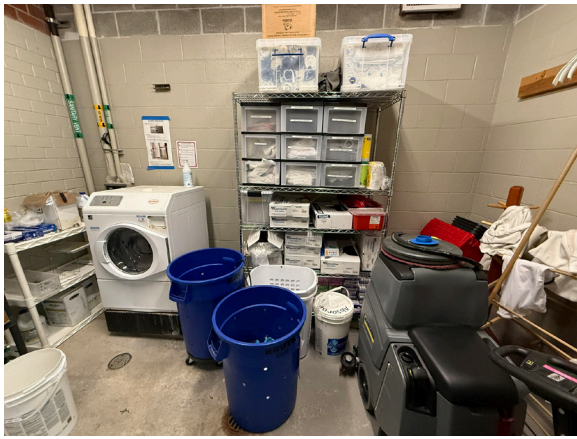
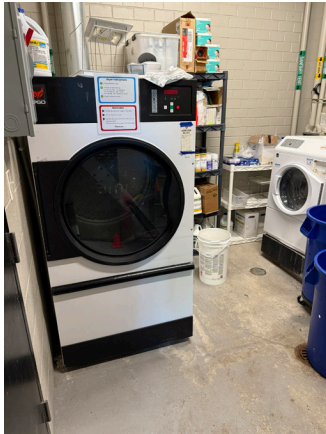
47. POOL STORAGE & LAUNDRY

This space is used for laundry and pro-shop storage.

- Front loading laundry machines require 36" x 48" clear space offset 24" max from center of door opening.

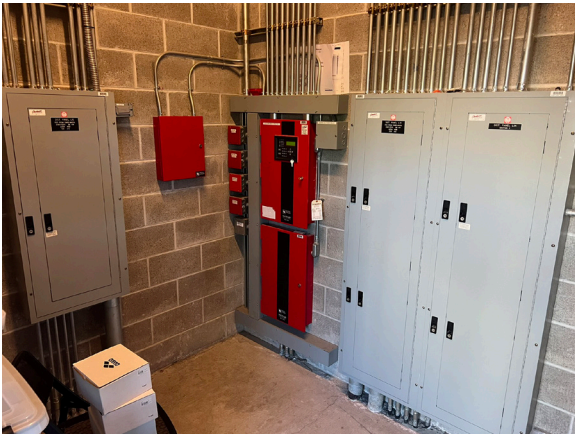
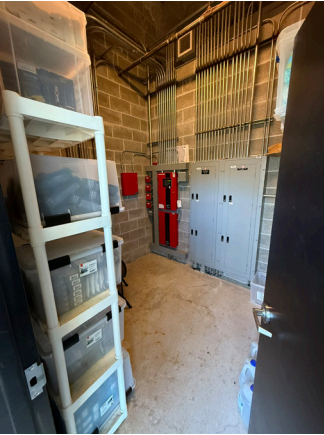
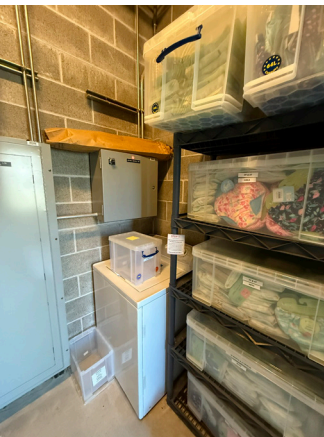
48. EAST WING ELECTRICAL ROOM

SPACE DESCRIPTION AND ASSESSMENT:
Room contains wall mounted electrical panels serving the adjacent rooms.

- Remove stored equipment not used for primary space function.

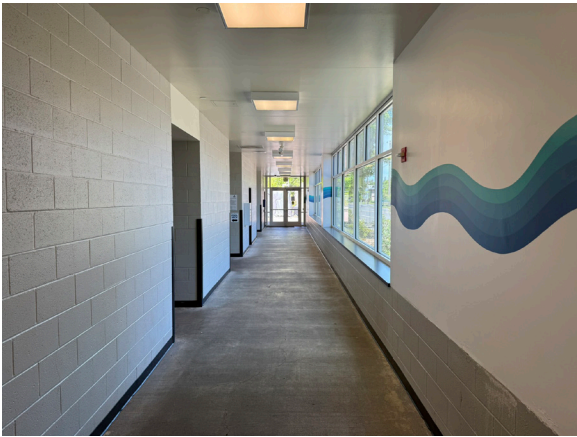
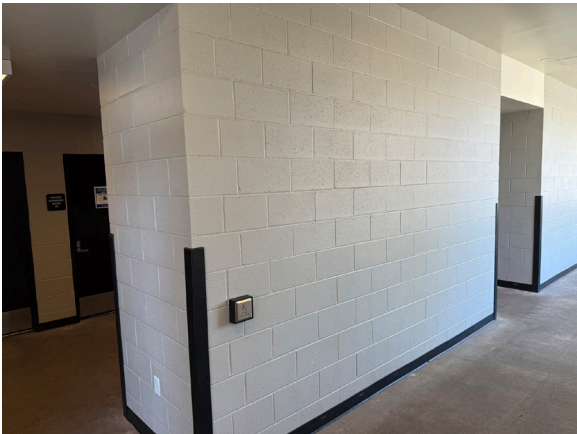
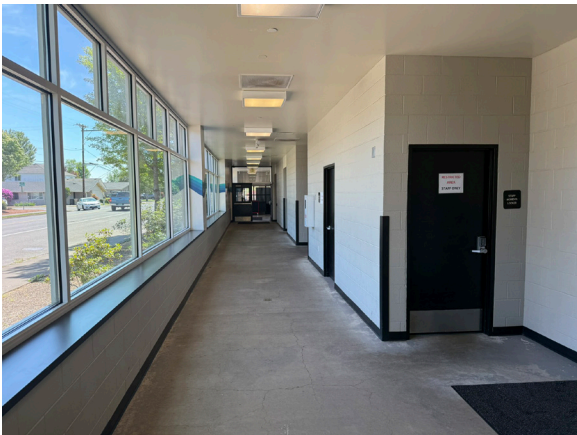
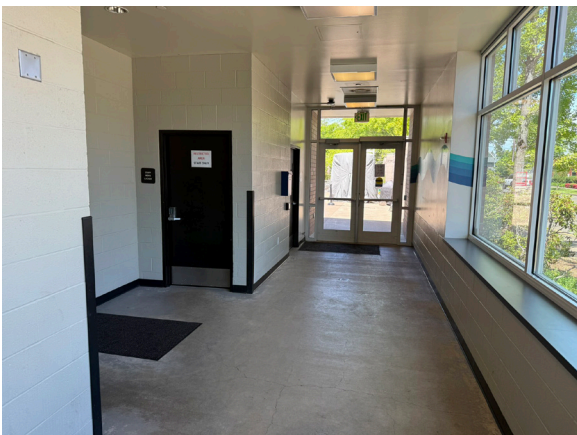
49. EAST WING CORRIDOR

This corridor provides connection between the hallway coming from the lobby to the family changing area, the east natatorium exit, the staff locker rooms, and the outdoor pools.

- Windows are located along the east side of the building, with visibility out to NW Highland Dr.
- The concrete floor has lots of cracks

- Upgrade the lighting fixtures along the ceiling.
- Add an enclosed vestibule at the exterior door.
- The fire extinguisher cabinet should be recessed so as to not project more than 4" into an accessible circulation route.
- Window sills and windows need repairs.
- Provide slip-resistant material cover along floor.

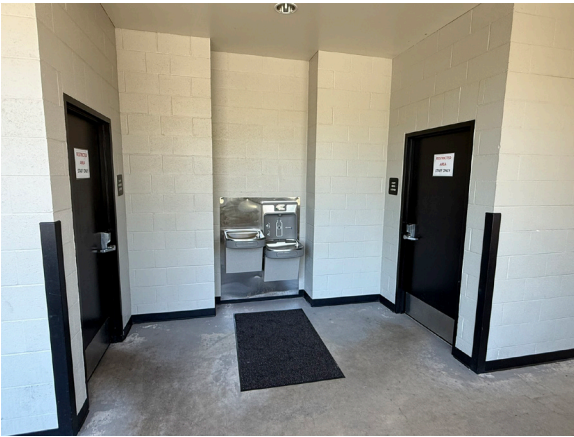
50. STAFF LOCKER VESTIBULE

Entry/exit area outside of staff locker rooms.

- Upgrade overhead lighting.

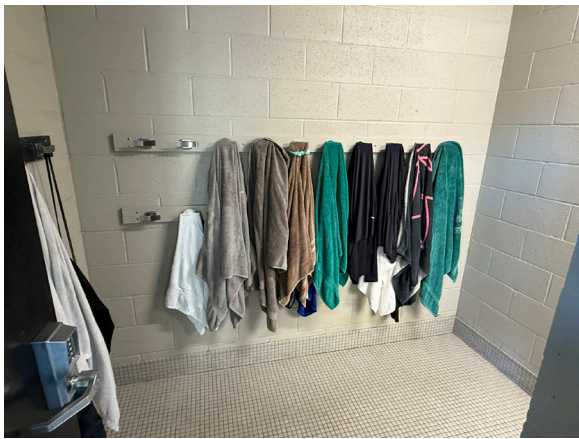
51. WOMENS STAFF LOCKER ROOM

The staff lockers, utilized by lifeguards and swim instructors, include lockers, benches, a mirror and counter, and two showers, one of which is a transfer-style shower with a fold-down seat.

- Add sinks and toilet stalls.
- Upgrade lighting fixtures.
- Replace existing hair driers with wall mounted fixtures.

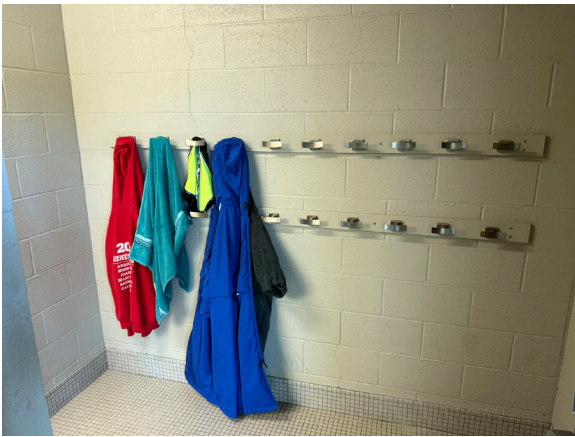
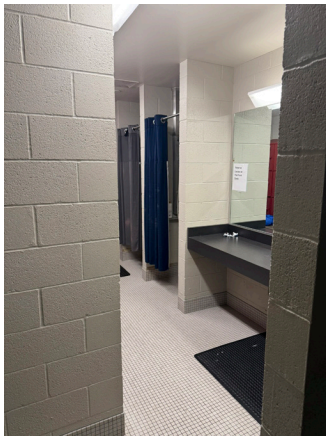
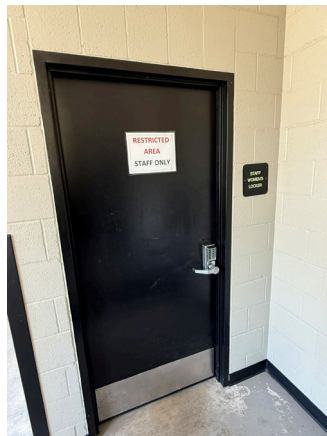
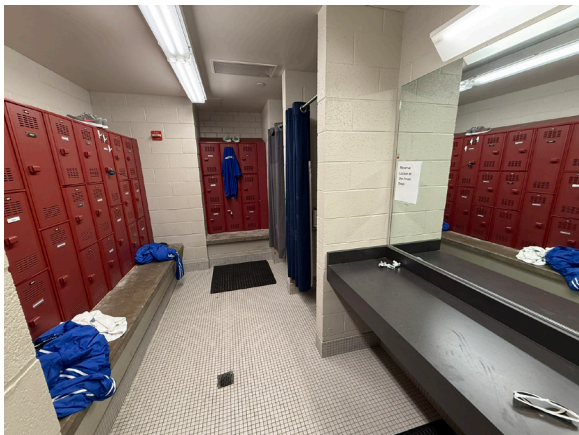
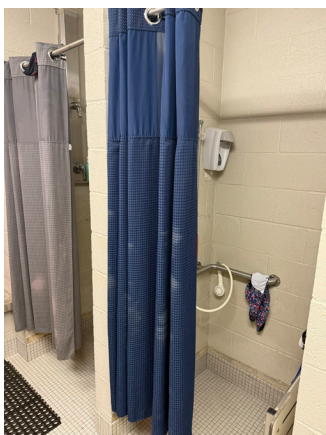
52. MENS STAFF LOCKER ROOM

The staff lockers, utilized by lifeguards and swim instructors, include lockers, benches, a mirror and counter, and two showers, one of which is a transfer-style shower with a fold-down seat.

- Add sinks and toilet stalls.
- Upgrade lighting fixtures.
- Replace existing hair dryers with wall mounted dryers.

- Confirm operable parts of soap dispensers are no higher than 48" from the floor.
- Operable parts of shower controls should be between 36"-48" from the floor.

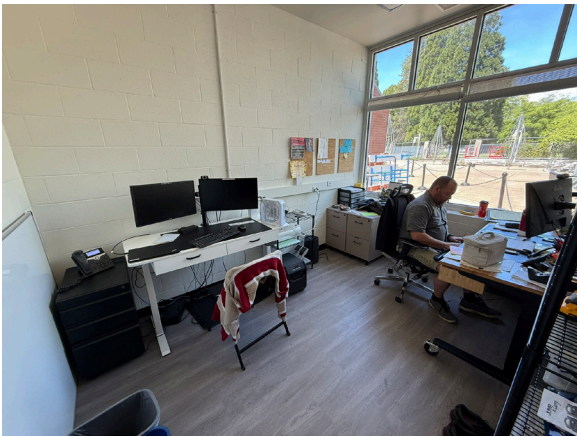
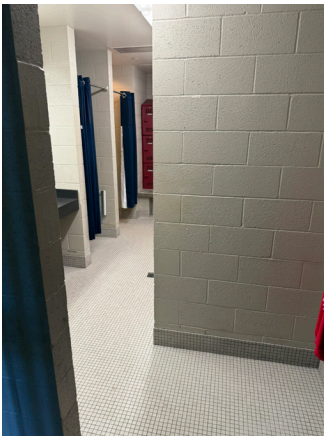
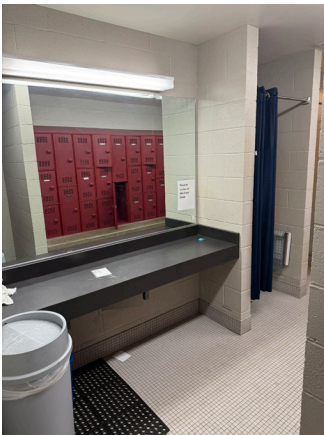
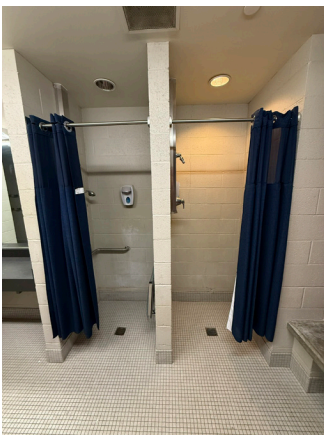
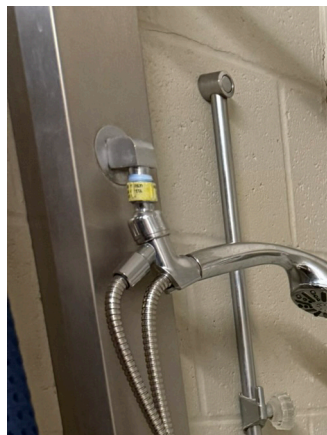
53. EAST WING OFFICE

Serves as office space for facilities and marketing.

- Business occupancy spaces required 150 gross sq ft per worker.

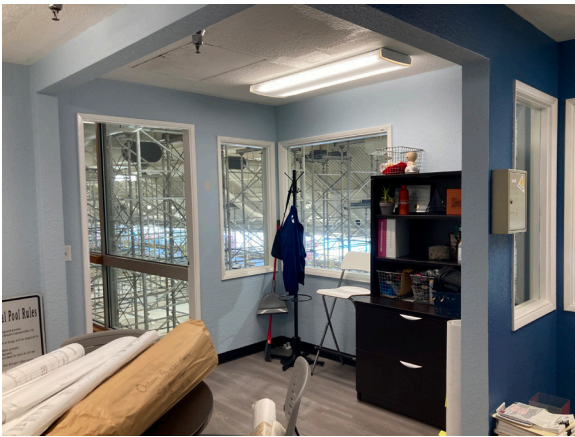
56. MEZZANINE OFFICE

Admin area currently used by Aquatics Supervisor.

- Business occupancy spaces required 150 gross sq ft per worker.

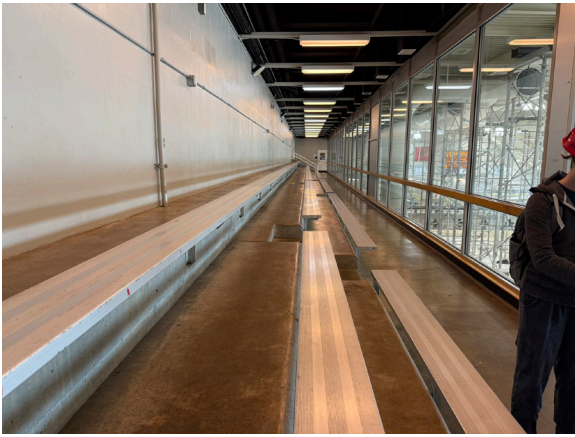
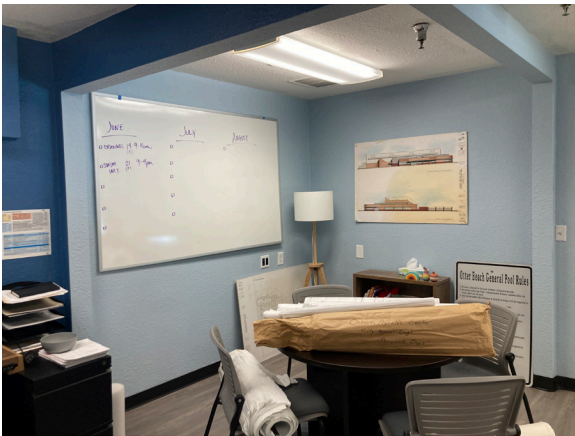
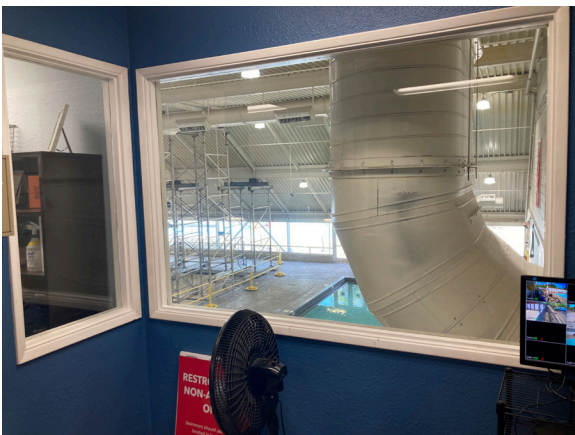
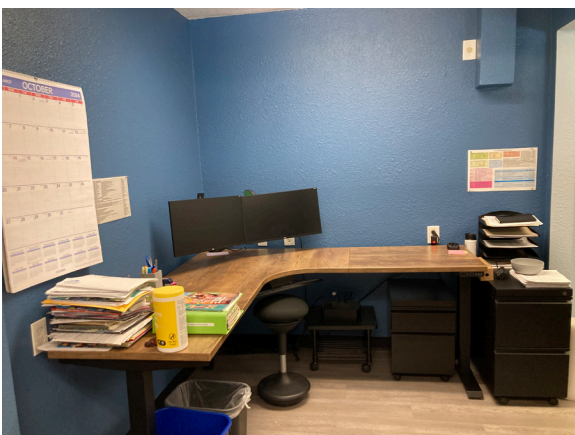
57. MEZZANINE VIEWING AREA

- Three rows of metal bleacher seats accessed via tiered polished concrete stairs.
- Seating is underutilized adjacent to Supervisor's Office where the view is furthest away from the starting blocks.
- Offices are located at each end of the viewing area, which require a step up into the rooms.
- Right in the middle of the viewing area, a metal panel replaces the glass where ductwork is visible.

- In assembly areas with 301 to 500 seats, the OSSC requires a minimum of 6 wheelchair spaces.
- At least one companion seat shall be provided for each wheelchair space.
- They must be dispersed evenly with opportunities for premium viewing choice.

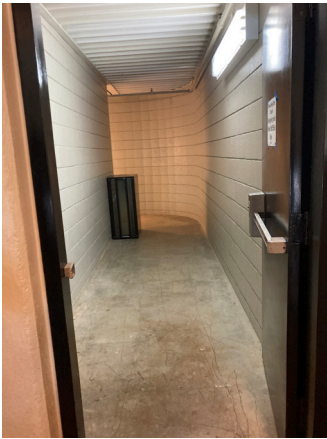
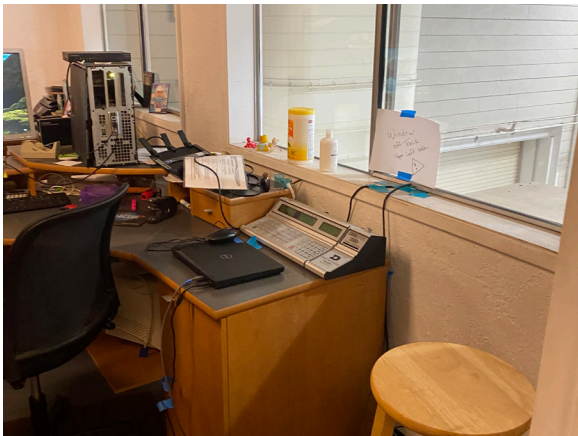
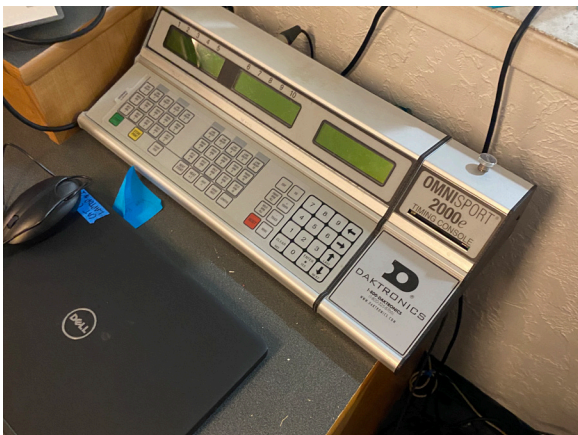
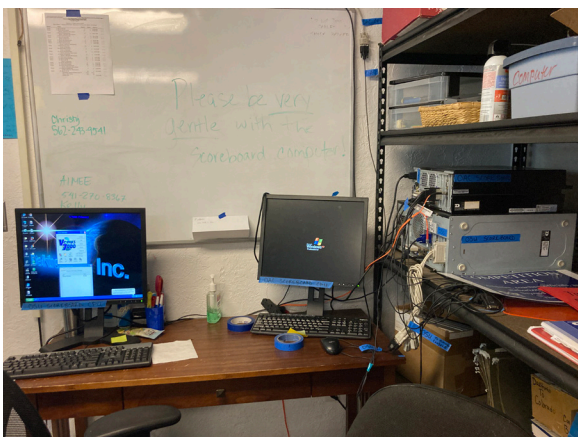
59. STAIR 2

Includes hallway to stairs, and an exterior exit out to the front of the building.

- No accessible egress from second floor (no accessible entry to begin with though).

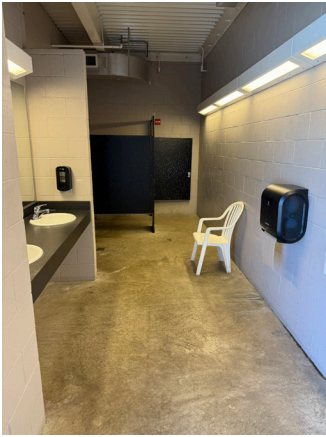
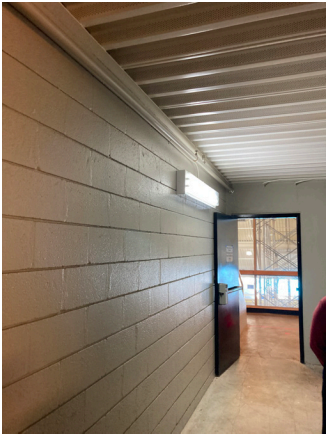
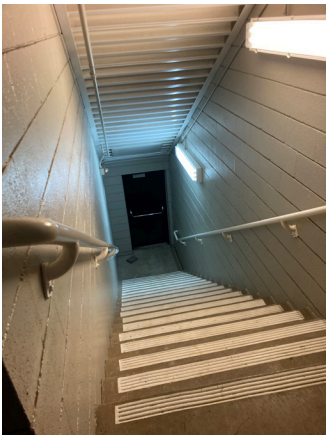
60. OUTDOOR POOL BUILDING MENS RESTROOM

Restroom space includes two sinks, two urinals (one at accessible height), and one toilet stall are provided.

- All under-sink piping must be covered with a temperature controlled slip-cover.
- Wheelchair toilet compartments with a door swinging in from of the wall partition are required to have 42" clear of walkway space outside of the stall from surface of partition to surface of wall. Floor plans indicate only 38" is provided. Verify in field. Could replace with a compartment that extends all the way to the masonry wall in front, with a door from the side swinging into the compartment.

- Replace existing grab bar in accessible stall with updated set of grab bars, including 18" vertical grab bar. Confirm that clear floor area from masonry wall to inside of stall partition is indeed 60" clear.

- Toilet accessories, including toilet paper dispenser, toilet seat cover dispenser, and sanitary napkin disposal container must be within accessible reach range - meeting ANSI Sec 604.7 Dispenser Outlet Location.
