City of Corvallis
Corvallis School District

Osborn Aquatic Center Facilities Assessment

Scott
Edwards
Architecture

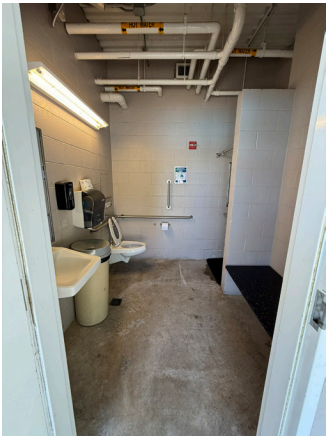
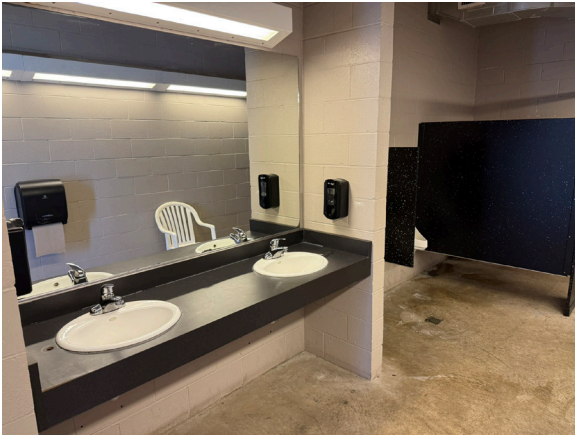
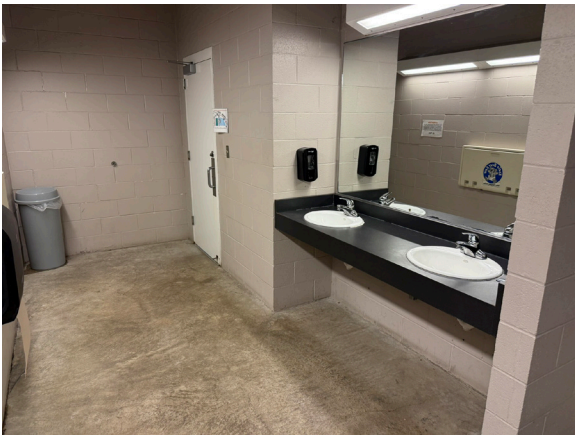
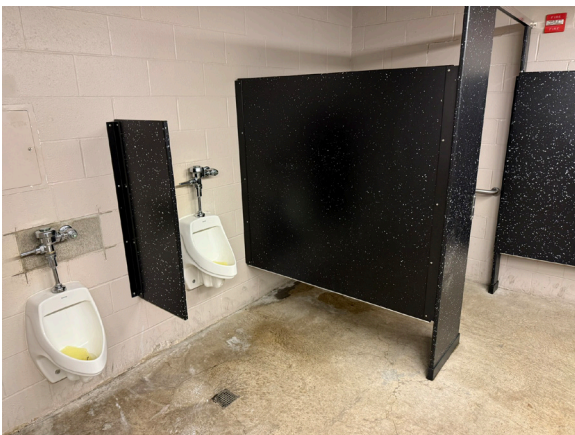
61. OUTDOOR POOL BUILDING FAMILY CHANGING ROOM

Restroom space includes bench, shower, sink, and toilet.

- Replace existing grab bar with updated set of grab bars, including 18" vertical grab bar.
- Toilet accessories, including toilet paper dispenser, toilet seat cover dispenser, and sanitary napkin disposal container must be within accessible reach range - meeting ANSI Sec 604.7 Dispenser Outlet Location.
- Paper towels dispenser should not protrude more than 4" into 60" x 56" toilet clearance.

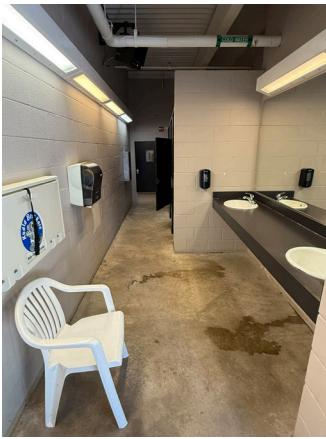
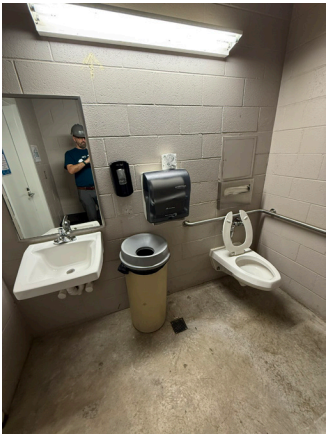
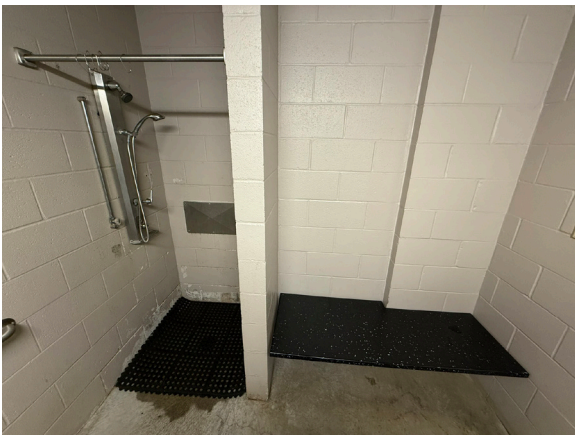
62. OUTDOOR POOL BUILDING WOMENS RESTROOM

Restroom space includes two sinks and three toilet stalls are provided.

- All under-sink piping must be covered with a temperature controlled slip-cover.
- Wheelchair toilet compartments with a door swinging in from of the wall partition are required to have 42" clear of walkway space outside of the stall from surface of partition to surface of wall. Floor plans indicate only 41" is provided. Verify in field. Could replace with a compartment that extends all the way to the masonry wall in front, with a door from the side swinging into the compartment.

- Replace existing grab bar in accessible stall with updated set of grab bars, including 18" vertical grab bar. Confirm that clear floor area from masonry wall to inside of stall partition is indeed 60" clear.

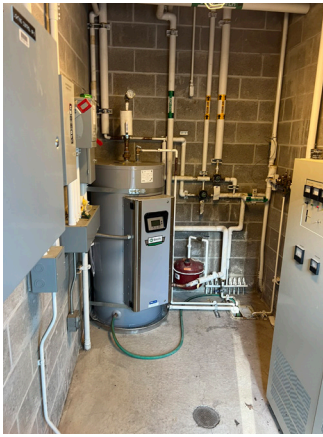
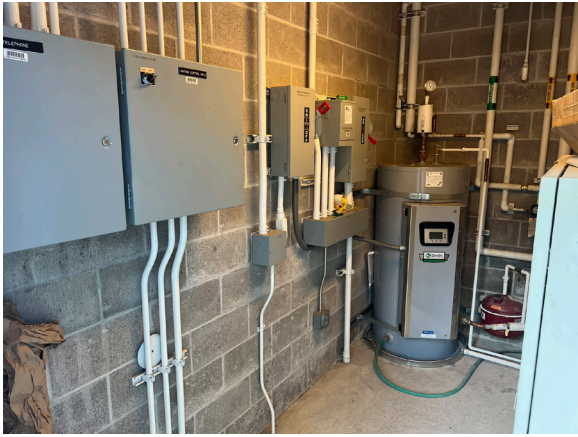
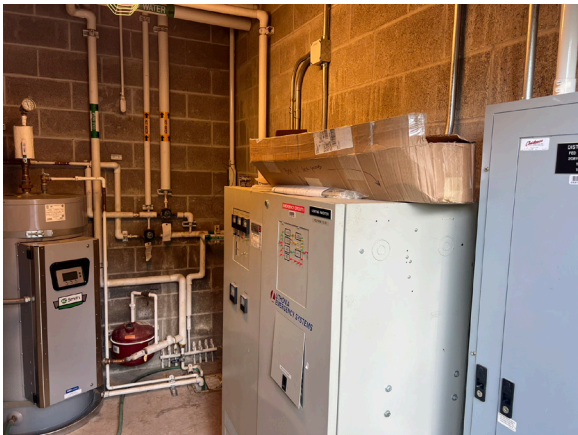
63. OUTDOOR POOL BUILDING ELECTRICAL ROOM

This room is used to house the hot water boiler for the adjacent restrooms and changing room.

- Multiple electrical panels are wall-mounted to serve the outdoor pool building.
- There is no additional pool equipment storage in this room.

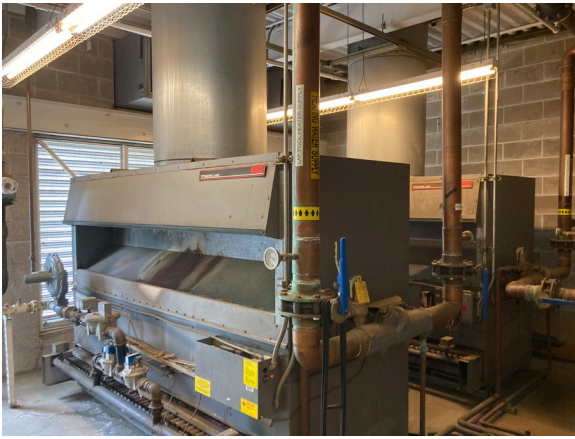
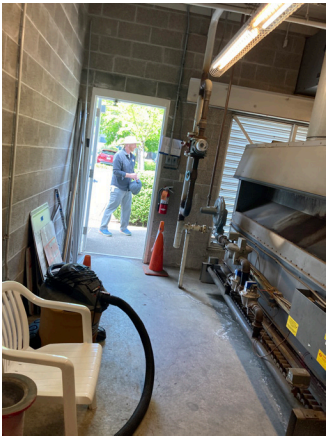
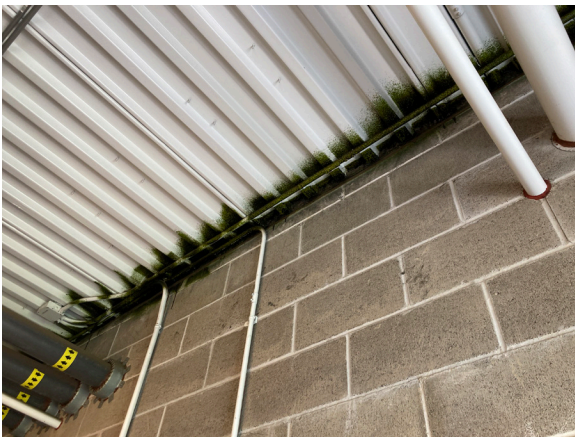
64. OUTDOOR POOL BUILDING BOILER ROOM

Space includes heating mechanical units for outdoor pools.

- Accessible from within Pool Building Storage Room.
- Single man-door access out to exterior on west side.

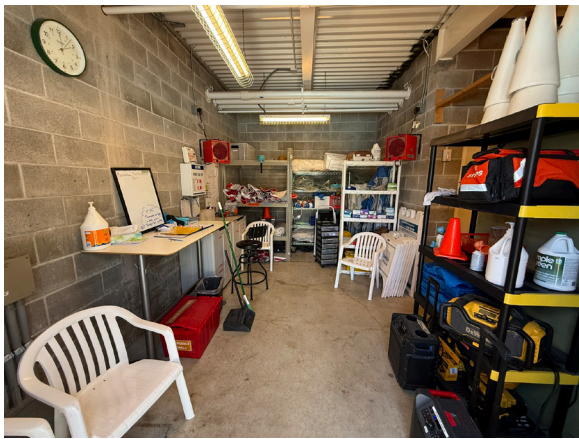
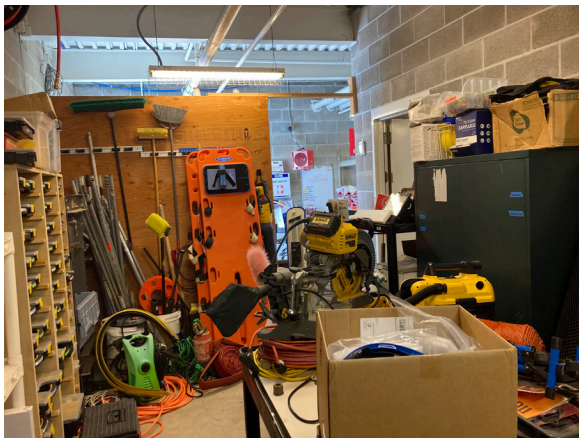
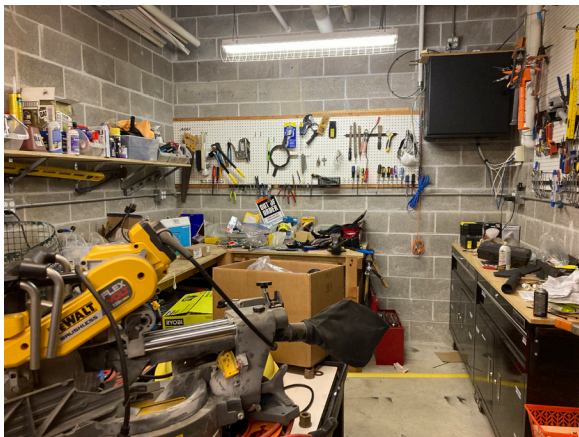
65. OUTDOOR POOL BUILDING STORAGE ROOM

Currently used as a staff break area, a first-aid supplies storage area, and a workshop.

- Install wall-mounted storage systems for tool and equipment organization.

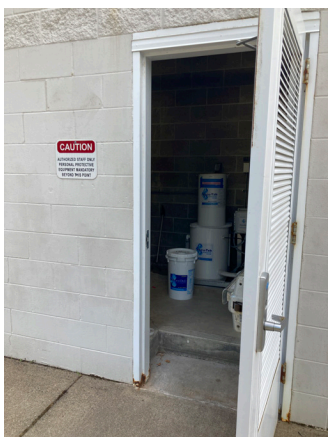
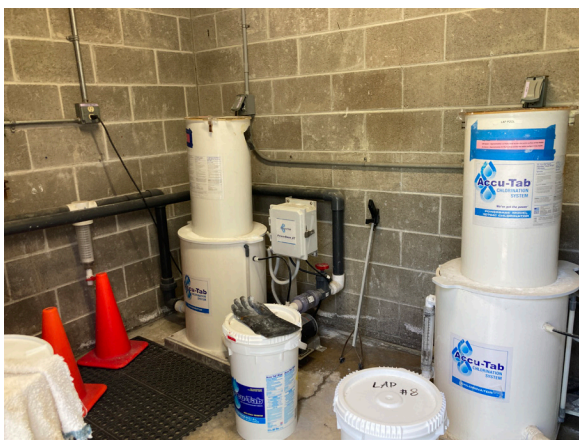
67. OUTDOOR POOL BUILDING MECHANICAL ROOM

Space holds MEP equipment for outdoor pools.

- Accessed from outdoor pool deck.

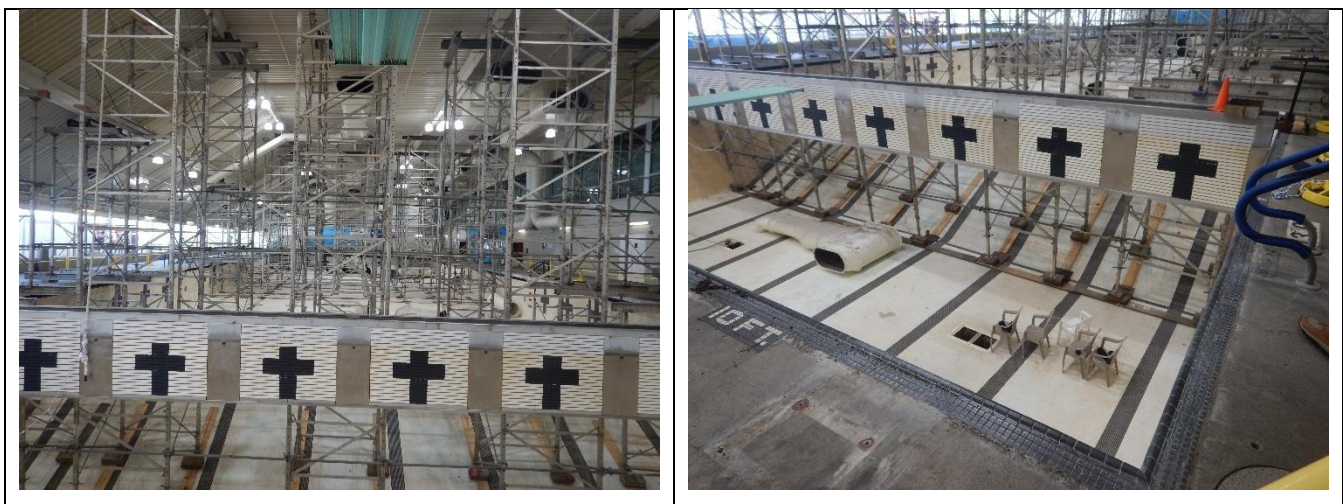
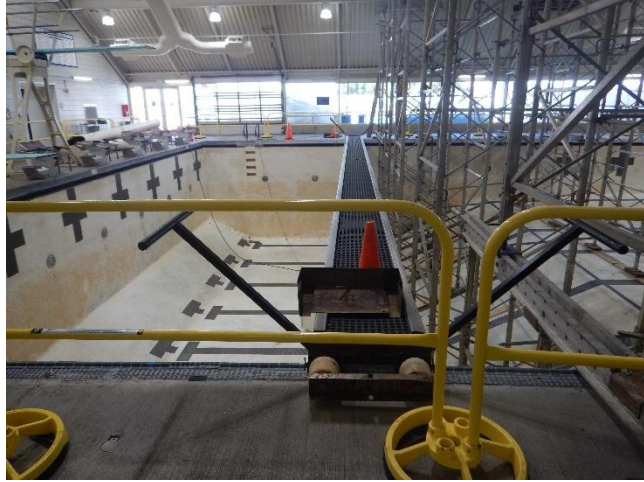
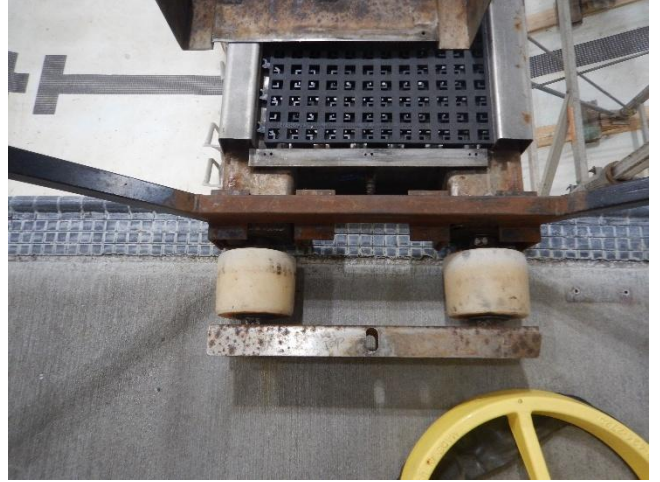
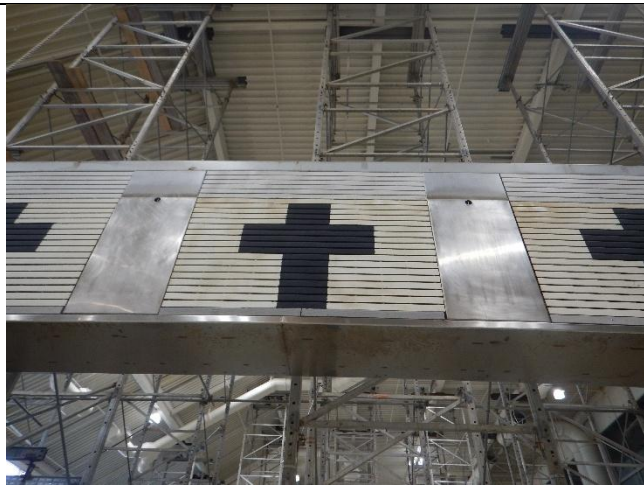
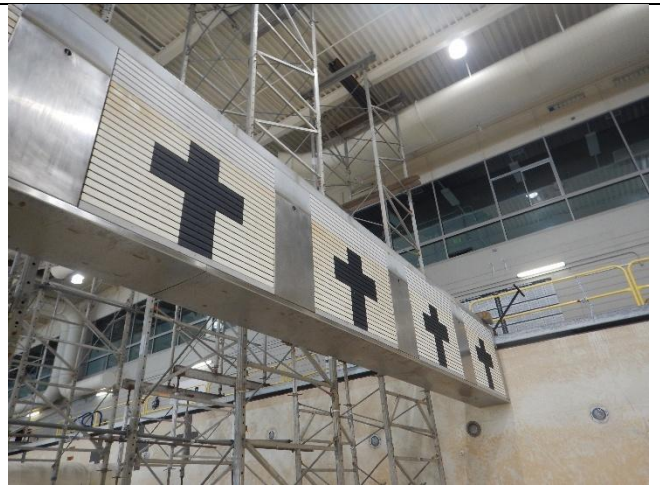
6. Movable Bulkhead (50-Meter Pool)

- a) The 50-Meter Pool is equipped with a moveable flow-through stainless steel bulkhead that is two feet wide. The bulkhead is critical for pool programming as it allows for several configurations for competition swimming, lap swimming, and diving. The bulkhead is in generally poor condition.

- i. The bulkhead is moved by inflating a floating assembly on each end to reduce bulkhead weight from the pool walls via buoyant force. The bulkhead can then be shifted along the length of the pool on rollers to the desired park location. Osborn Aquatic Center operators reported that the floating assemblies leak, preventing the bulkhead from floating appropriately. This makes the bulkhead difficult to move and has caused significant wear and tear on the roller components.

- ii. The bulkhead also has cosmetic issues including staining on the flowthrough grating and corrosion on the stainless-steel finish. This creates an unsightly condition that is not desirable in a pool that hosts statewide and livestreamed competitions.

- a) Due to the critical nature of the bulkhead for Osborn Aquatic Center operations, it is recommended to replace the entire bulkhead for both ease of operation and aesthetic reasons. A properly operating bulkhead will also help to protect the pool shell and any new finishes applied to the pool perimeter. Engage an aquatics consultant and bulkhead manufacturer to ensure the replacement bulkhead meets the necessary tolerances to preserve swimming course integrity and accommodates timing system needs.

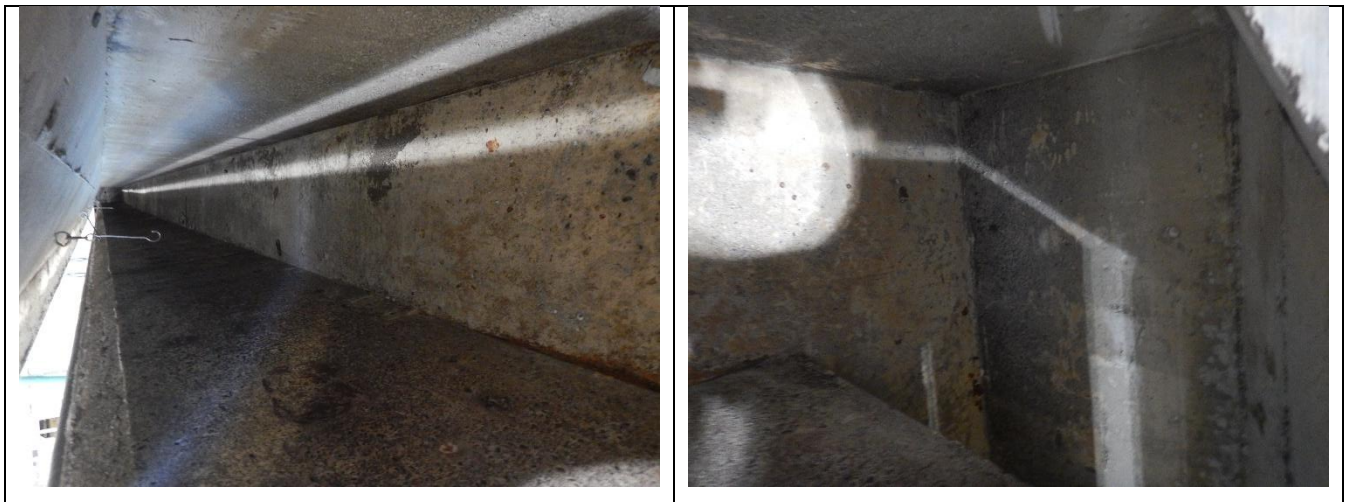
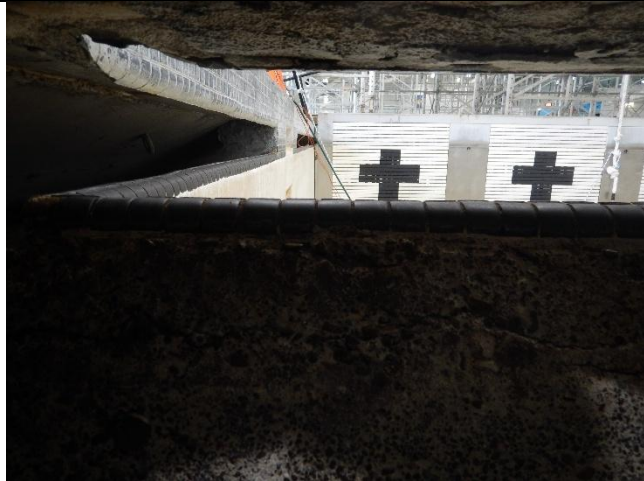
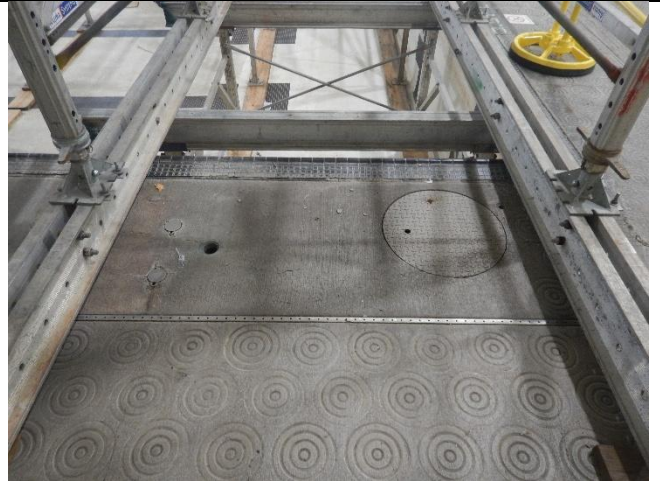
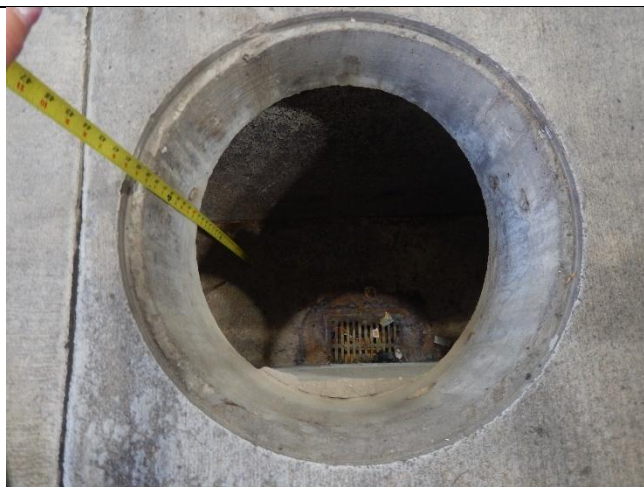
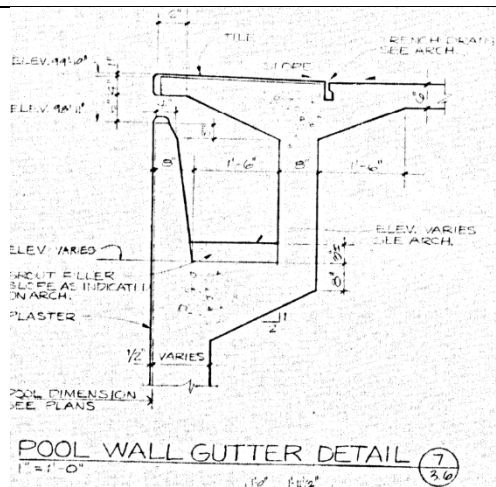
7. Perimeter Overflow System (50-Meter Pool)

- b) Skimming action could not be verified at the time of inspection due to the pool being drained, but operators noted that prior to draining, the pool had very reliable and even skimming action around the entire perimeter, indicating that the gutter system is level and stable.

- d) There are four gravity drain outlets with metallic grates, one in each corner of the perimeter gutter. According to archive pool plans, each grate connects to an 8" drain pipe. The drains combine from east and west as two 10" drains into the DE filter tank. The drain grates appear to be original to the pool and are heavily corroded. Each drain is accessed for cleaning by a round steel lid.

- a) Replace drain grates. Monitor skimming performance after pool renovations and continue to clear gutters of debris.

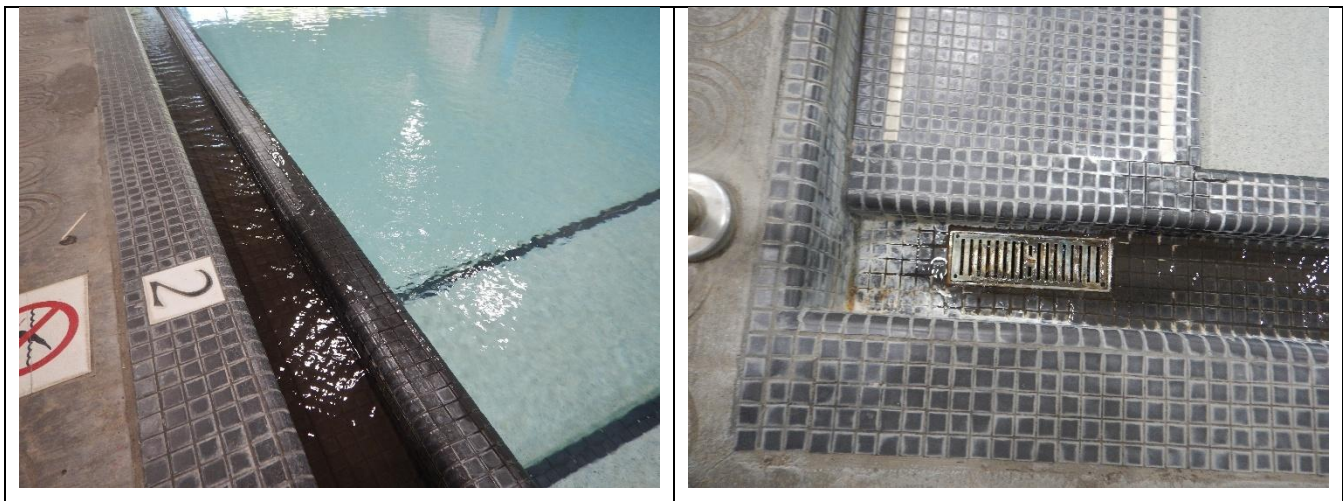
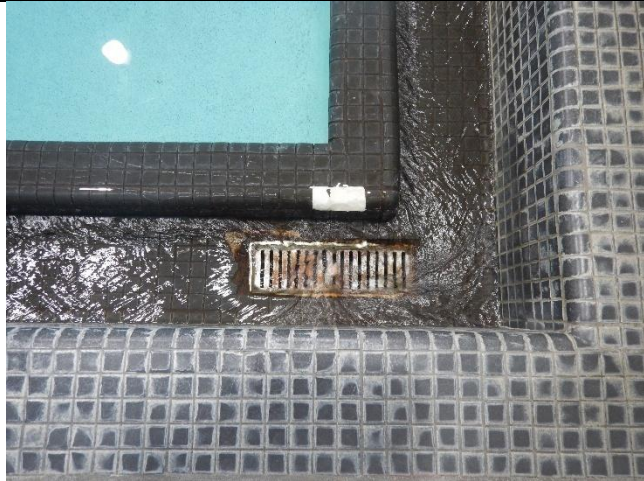
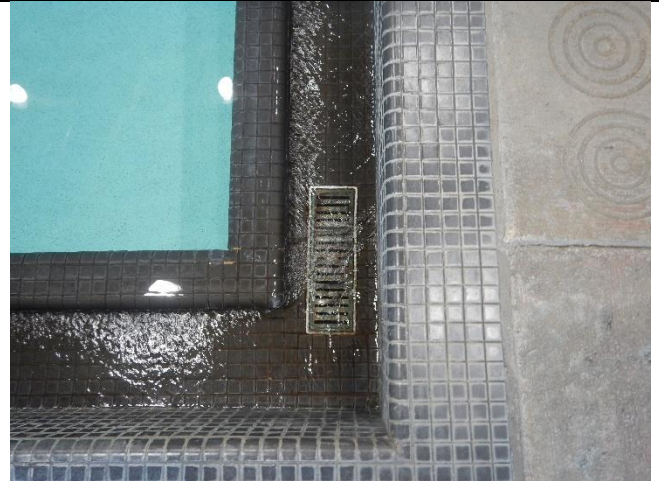
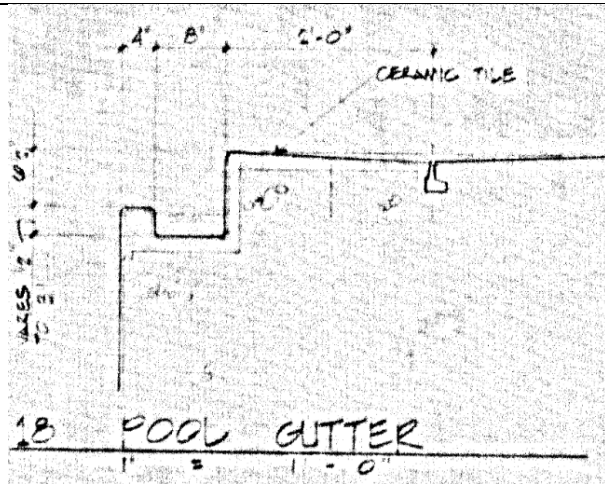
8. Perimeter Overflow System (Therapy Pool)

- b) Skimming action was observed to be occurring around the perimeter of the pool, but slightly unevenly due to minor fluctuations in height of the gutter lip. The pool was empty and calm at the time of inspection due to the natatorium closure, and the uneven skimming action would not be noticeable with bathers in the pool.

- c) The Therapy Pool overflow trough is only 8" wide by 3" deep, which is less capacity than current standards would call for. Gutter flooding due to bather surge was not an issue noted by the operators.

- d) There are four exposed gravity drain outlets in the gutter trough, one in each corner of the pool. Each has a metallic grate connecting to an 4" gravity pipe. The pipes combine to a 6" gutter drain pipe to the DE filter tank, according to archive pool plans. The drain grates are in fair condition with only minor surface corrosion. The two gutter drains at the north (deep) end of the pool were observed to be accepting noticeably more flow than the two gutter drains at the south (stair) end.

- a) In the case of perimeter refinishing (refer to section "Pool Shell Structure and Finish (Therapy Pool)" ensure that the new finishes create a level flood rim for even and effective skimming action.
- b) Replace drain grates with non-corroding material.

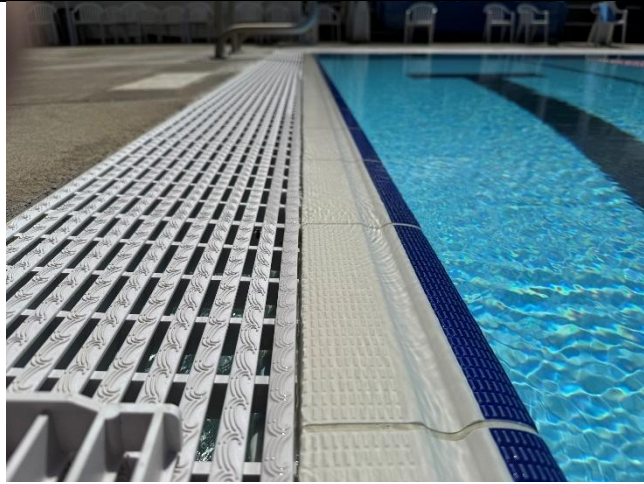
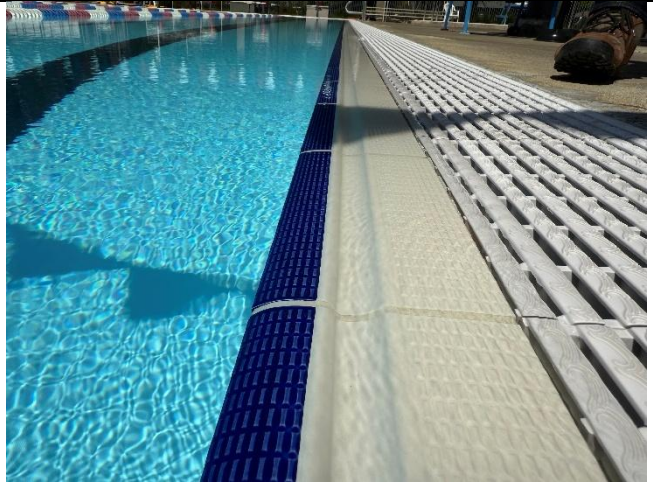
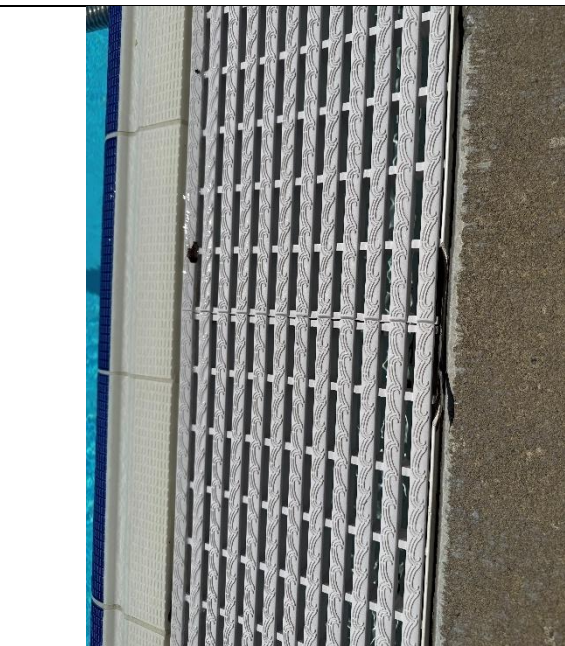
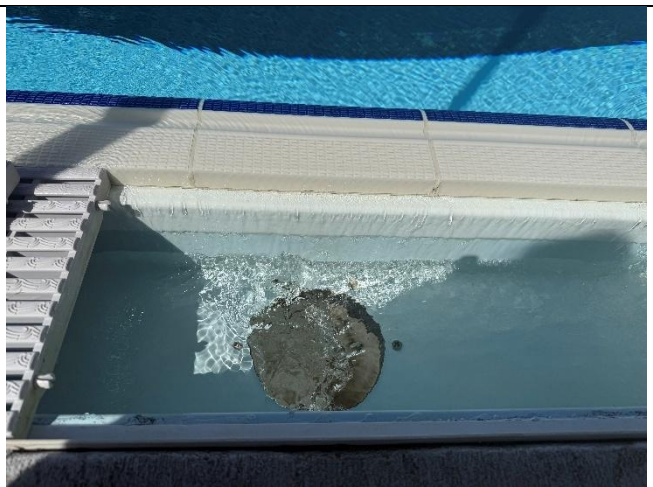
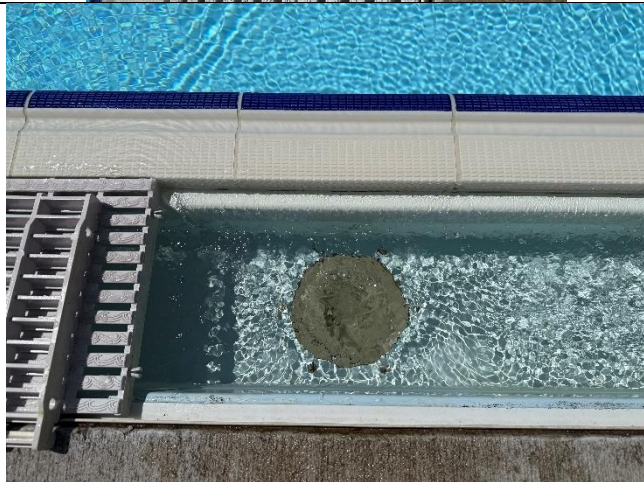
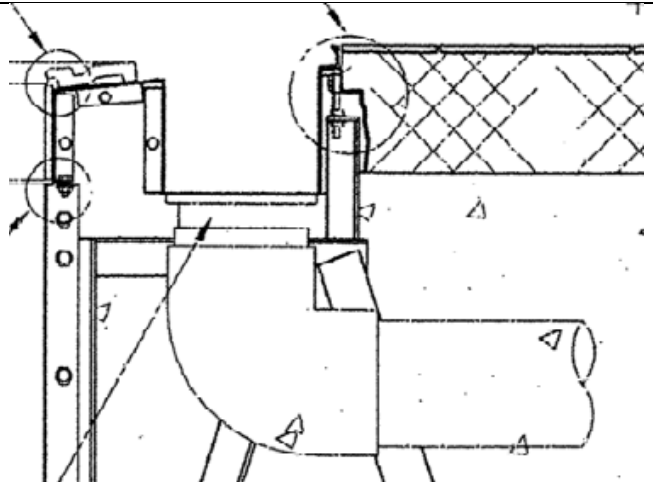
9. Perimeter Overflow System (25-Meter Pool)

- a) The 25-Meter Pool has full perimeter overflow with a deck-level Myrtha stainless-steel gutter that is integrated with the stainless-steel wall system. The gutters drain to four gutter dropout boxes, two on each long side of the pool. These drain by gravity to the pool's surge tank beneath the mechanical room floor.

- b) The gutter trough is covered with a parallel PVC Myrtha grating that was replaced in recent years and is in very good condition. Only minor material failures were seen in isolated locations around the pool.

- c) Operators pointed out an issue with the gutter dropout near the southeast corner of the pool that was observed during the site visit. Over the course of one to two minutes, the dropout would slowly flood, bubble, then flush all at once. The bubbling and rush of water would splash out of the gutter trough onto the deck.

- i. The splash out on the deck after the flushing action is particularly an issue in the winter when the consistent splashing accumulates in a hazardous sheet of ice.

- a) Continue maintaining the gutter trough and grating per manufacturer recommendations. Replace grating again when material failures create a hazardous or unsightly condition.
- b) A camera probe inspection is recommended from the gutter dropout pipe in the southeast corner. If a blockage is present, a resolution may be possible without costly repairs.

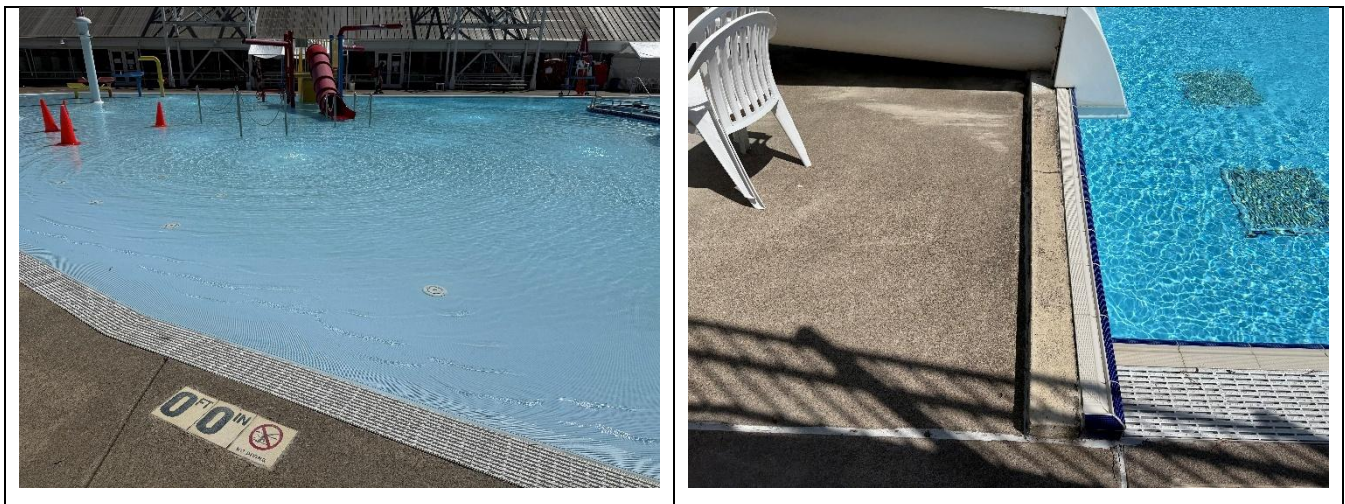
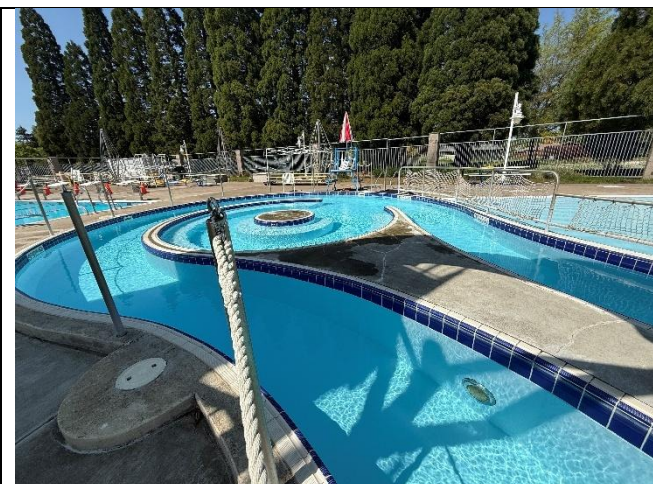
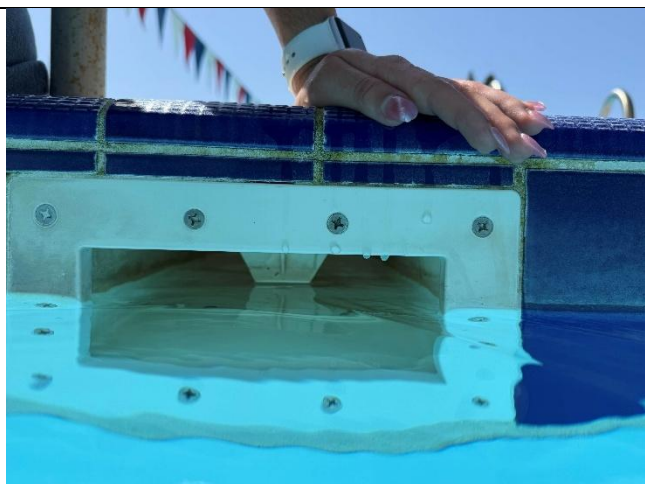
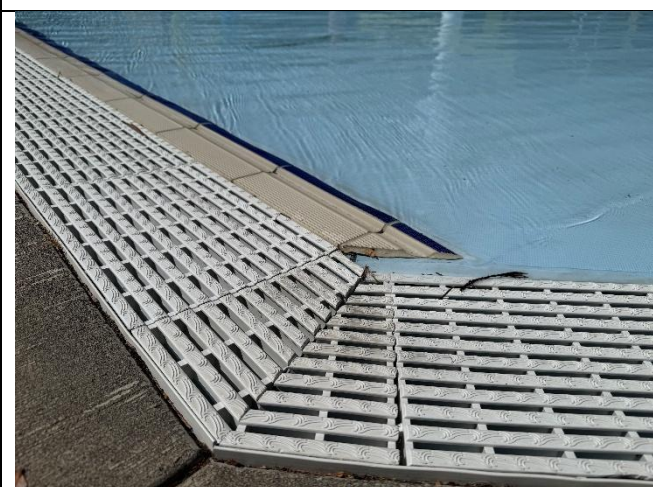
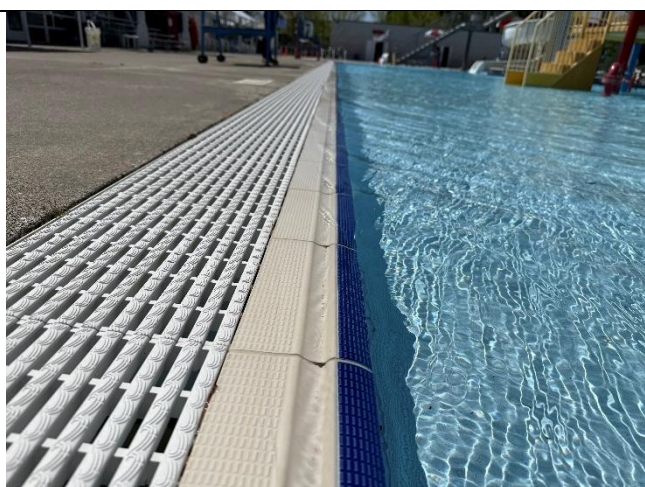
10. Perimeter Overflow System (Leisure Pool)

- a) The Leisure Pool, like the 25-Meter Pool, has full perimeter overflow with a deck-level Myrtha stainless-steel gutter that is integrated with the stainless-steel wall system. The gutters drain to dropout boxes, the quantity of which could not be determined by available plans. These drain by gravity to the pool's surge tank beneath the mechanical room floor. Additionally, four skimmers provide surface skimming in the current channel area where there is no deck level gutter.

- b) As in the 25-Meter Pool, the gutter trough is covered with a parallel PVC Myrtha grating that was replaced in recent years and is in very good condition.

- c) The skimmer under the slide tower was observed to be missing its weir. Most pool contaminants float on the surface. The skimmer weir allows for only the very surface of the water to flow into the skimmer throat, simultaneously directing contaminants into the recirculation system and drawing additional surface water toward the skimmer. Without the weir, the skimmer is flooded with subsurface water and contaminants are not removed from the pool as effectively.

- a) Continue maintaining the gutter trough and grating per manufacturer recommendations. Replace grating again when material failures create hazardous or unsightly conditions.
- b) Replace missing skimmer weir. Monitor skimming performance in the current channel area.

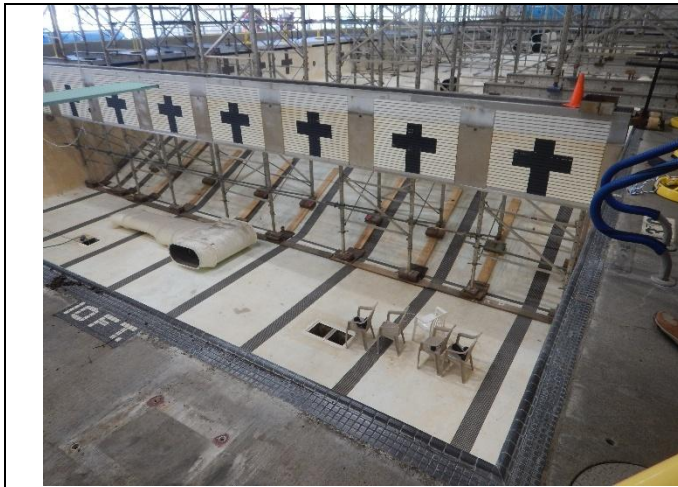
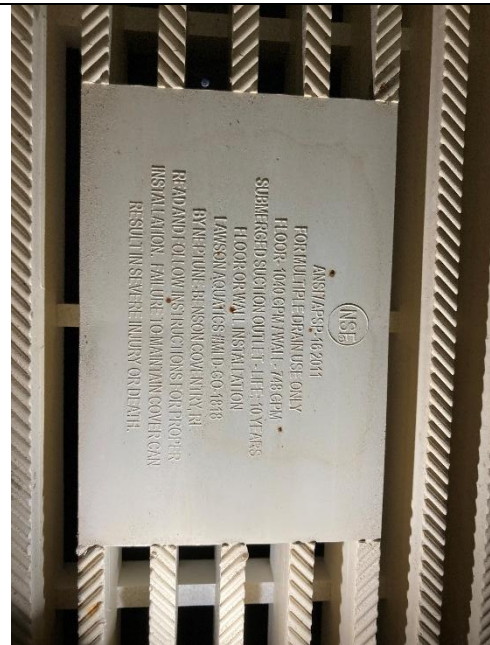
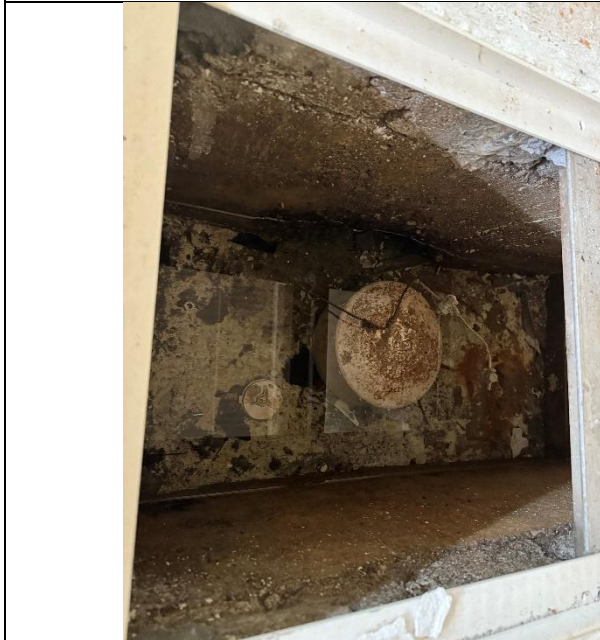
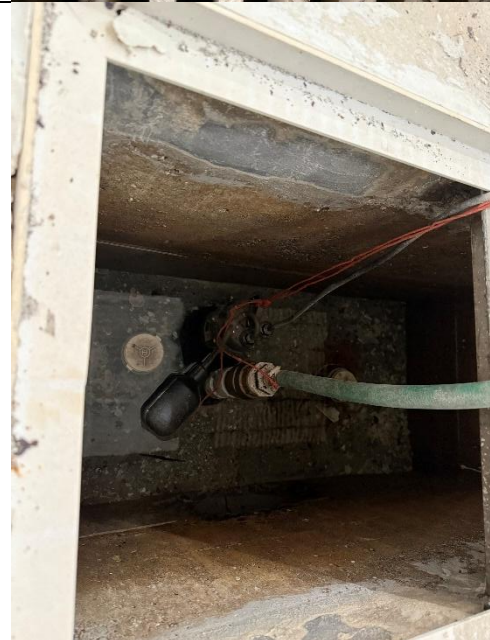
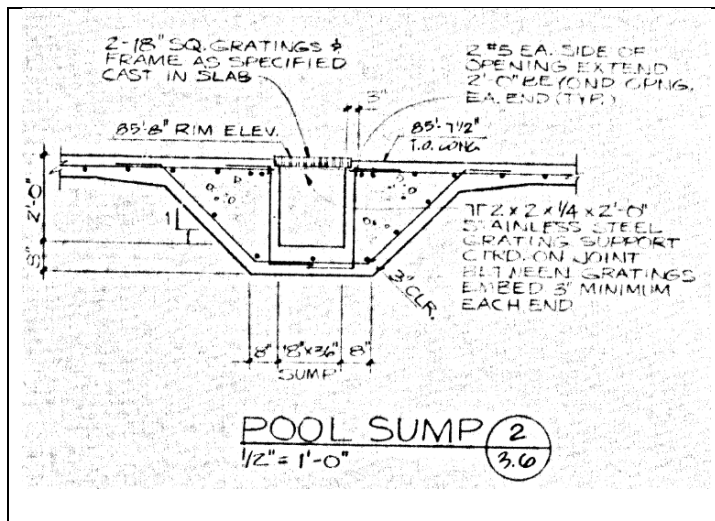
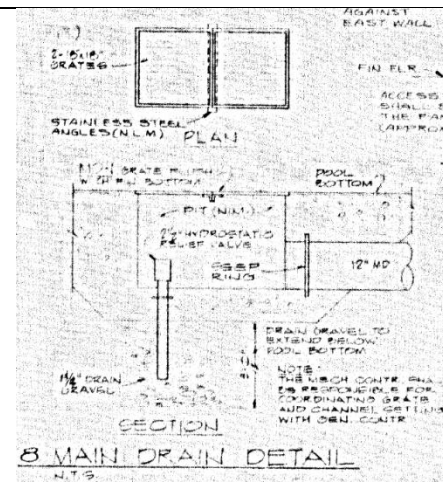
11. Main Drains (50-Meter Pool)

- c) Each main drain sump is equipped with a hydrostatic relief valve to allow groundwater into the pool vessel, protecting the pool structure against a pressure differential. This is critical for the 50-Meter Pool in its current long-term empty condition without pool water counteracting hydrostatic pressure. The hydrostatic relief valves were functioning as intended at the time of the visit. A temporary sump pump was placed in the north main drain to remove groundwater.

- d) The sump interiors appear to be bare concrete in fair condition, but their watertightness is unknown.

- a) Replace main drain covers. Covers certified as non-blockable are always recommended even in a multiple-drain configuration. Ensure new covers comply with VGBA/ANSI and follow manufacturer instructions, with special attention to allowable flow rate through the cover. According to ANSI/APSP/ICC-16 2017 Section 3.3.2, "Replacement cover/grates for existing pools. Manufacturer's of replacement cover/grates and other SOFA components intended for installation on existing pools with unknown sumps and mud frames shall provide replacement specific instructions for identifying when it is acceptable to attach the new cover/grate and how to confirm the attachment was successful."

- b) Continue to replace covers prior to manufacturer expiration (typically 10 years) or if they become damaged in any way. Maintain installation records and VGBA letters of compliance for all installed covers.
- c) Apply new waterproofing to sump interiors to prevent water loss to surrounding grade. Standard main drain sump finishes include epoxy paint and crystalline waterproofing.
- d) Confirm the function and condition of hydrostatic relief valves and replace as necessary.

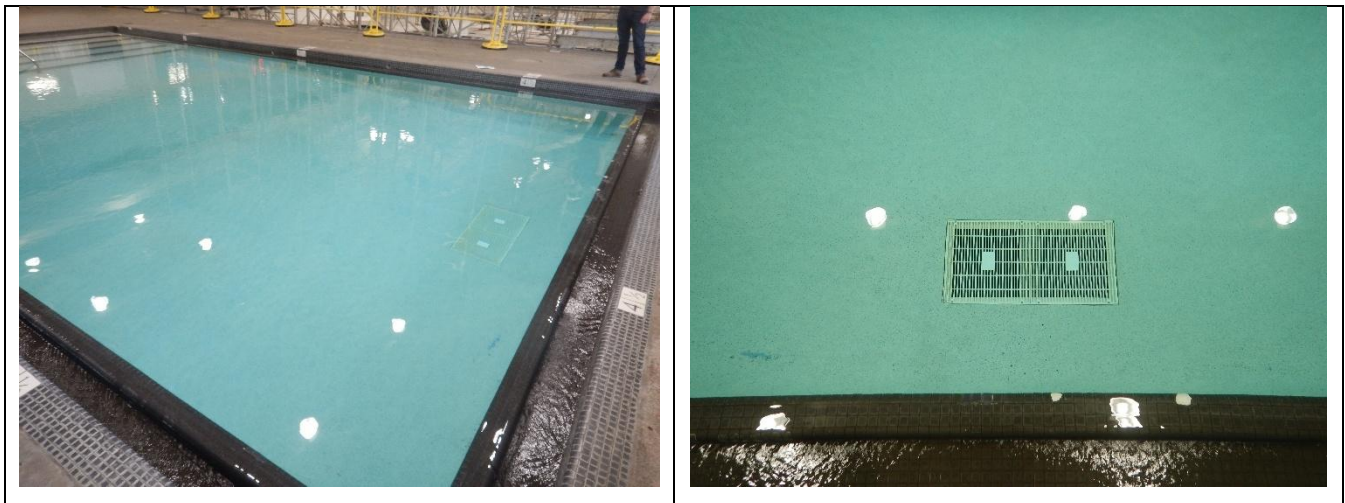
12. Main Drains (Therapy Pool)

- a) The Therapy Pool has one (1) main drain sump, measuring 18"x36"x24" deep (according to plans), cast into the reinforced concrete pool floor. The sump is connected to a 6" pipe that flows to the pool filter's stilling chamber.
- b) Refer to VGBA/ANSI/APSP requirements noted in section "Main Drains (50-Meter Pool)". This pool's drain would also be categorized as a SOFA under indirect suction. However, there is only a single main drain sump. Current design standards always include SOFA redundancy.
- c) Original plans indicate that this sump is equipped with a hydrostatic relief valve. This could not be verified on site.

- a) Verify that the main drain cover is not expired and replace if necessary. Non-blockable covers are critical for this pool because there is only one SOFA.
- b) Continue to replace covers prior to manufacturer expiration (typically 10 years) or if they become damaged in any way. Maintain installation records and VGBA letters of compliance for all installed covers.
- c) Apply new waterproofing to sump interiors to prevent water loss to surrounding grade. Standard main drain sump finishes include epoxy paint and crystalline waterproofing.
- d) Confirm the function and condition of hydrostatic relief valves and replace as necessary.

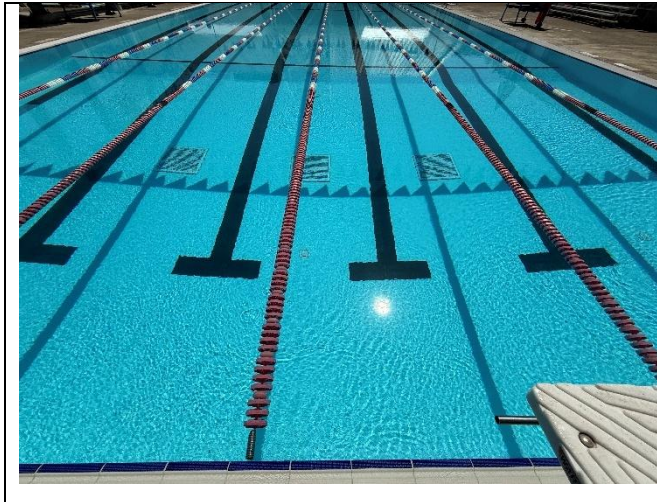
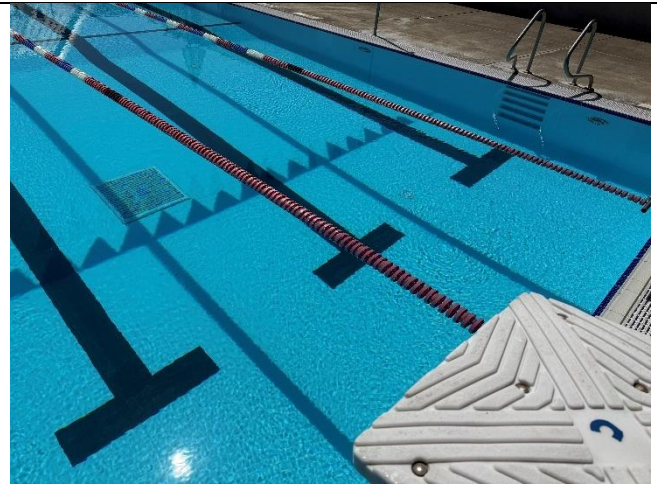
13. Main Drains (25-Meter Pool)

- a) The 25-Meter Pool has three (3) main drain sumps, each roughly 18"x18" and covered by a single drain cover. The depth of the sumps and size of the connecting recirculation piping could not be verified by available plans, but the suction piping was seen terminating in the pool's surge tank.
- b) Refer to VGBA/ANSI/APSP requirements noted in section "Main Drains (50-Meter Pool)". Because the main drain pipe terminates in a vented surge tank, this pool's main drains are classified as an indirect-suction SOFA. The drain covers did not appear to be common industry-standard VGBA/ANSI/APSP SOFA covers.
- c) Operators confirmed that the 25-Meter Pool main drains are equipped with hydrostatic relief valves, but their function and condition could not be verified while the pool system was running.

- a) Ensure that the drain covers are compliant with the current ANSI standard.
 - i. If documentation cannot be found to support compliance, replace all covers immediately with an NSF-listed ANSI-certified drain cover appropriate for the sump size and recirculation flow rate.
 - ii. For a three-drain configuration, each drain cover must be rated for half of the recirculation flow rate per VGBA and Oregon code.
- b) Continue to replace covers prior to manufacturer expiration (typically 10 years) or if they become damaged in any way. Maintain installation records and VGBA letters of compliance for all installed covers.
- c) Confirm the function and condition of hydrostatic relief valves and replace as necessary.

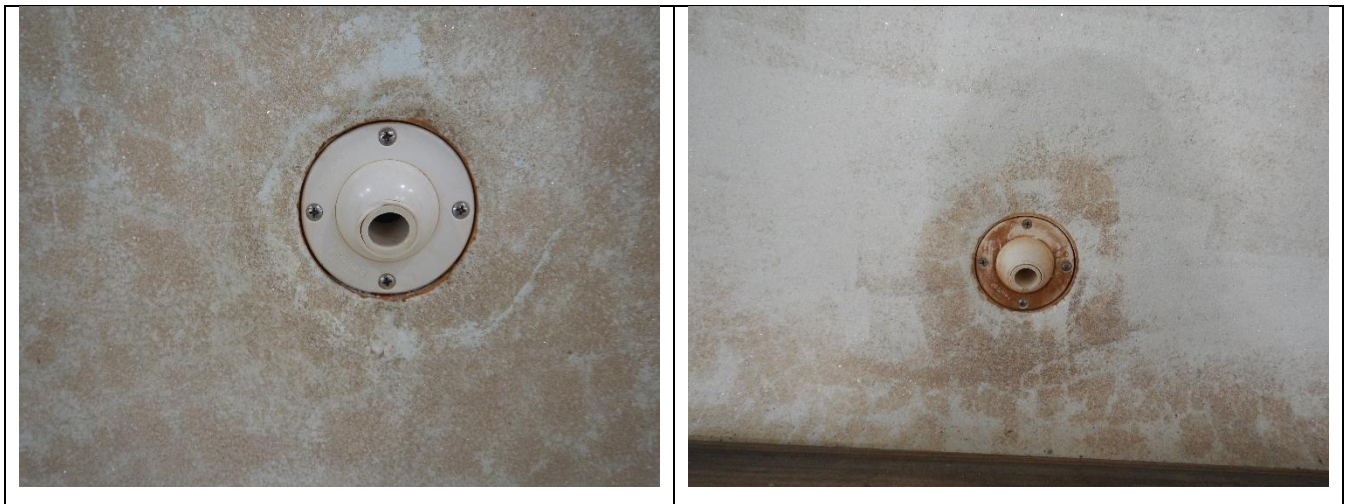
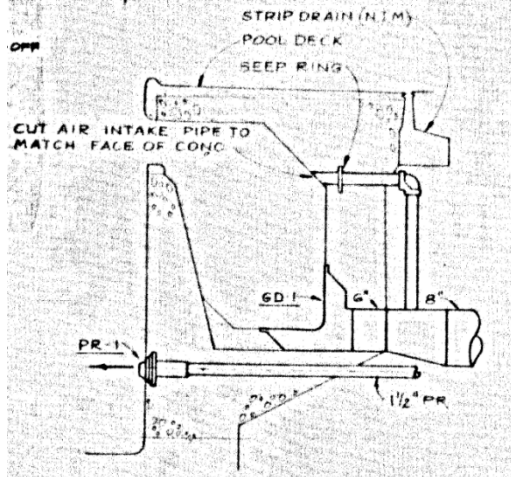
15. Inlets (50-Meter Pool)

- a) Filtered and treated water is provided to the 50-Meter Pool by forty-four (44) wall inlets. According to plan, each inlet connects to the return loop around the pool by a 1-1/2" pipe.
- b) Wall inlets are in varying condition. Many are in good condition, but some are heavily stained. It has been observed that air had been rising through some inlets prior to the pool being drained.
- c) The 50-Meter Pool does not have floor inlets, which is **not in compliance with state code**. OAR 333-060-1000 states, "4.7.1.3.1.3.1 Greater Than Fifty Feet Wide For POOLS greater than 50 feet wide (15.2 m), floor INLETS shall be required."

- a) It is recommended to replace all inlet fittings with eyeball inlet fittings for the best possible distribution of filtered and chemically treated water throughout the pool.
- b) If the 50-Meter Pool undergoes substantial renovation, it may be possible to pursue a variance to accept the lack of floor inlets. The pool is 56 feet wide, only 6 feet over the criteria to require floor inlets, and has operated with exceptional water quality for decades.

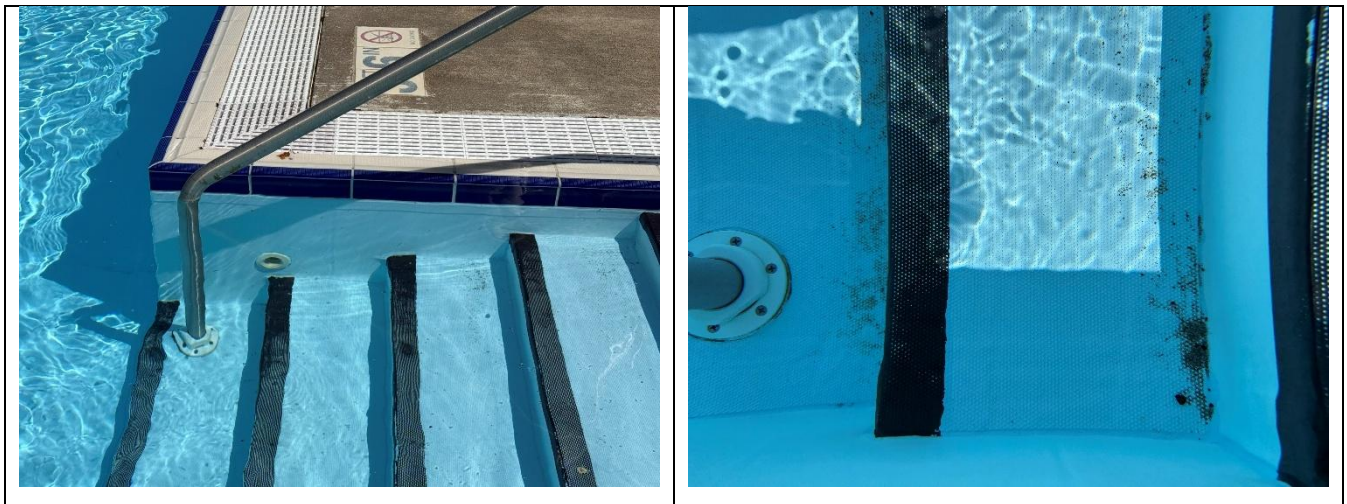
- a) The Leisure Pool receives filtered, treated water from inlets that are evenly distributed on the pool floor, spaced as evenly as the pool shape allows. Available plans show twenty-three (23) inlets. The inlets appear to be in good condition, meet code spacing, and operators did not note any significant issues with performance.
- b) In addition to the floor inlets, there is one (1) wall inlet located near the second lowest stair tread to supply treated water to the stair entry volume. Some stagnation debris was observed on the higher pool stairs, which is very common around the geometry of stairs.

- a) Consider replacing the wall inlet near the stairs with an eyeball fitting that can be directed to minimize stagnation in the stair volume.
