City of Corvallis
Corvallis School District

Osborn Aquatic Center Facilities Assessment

Scott
Edwards
Architecture

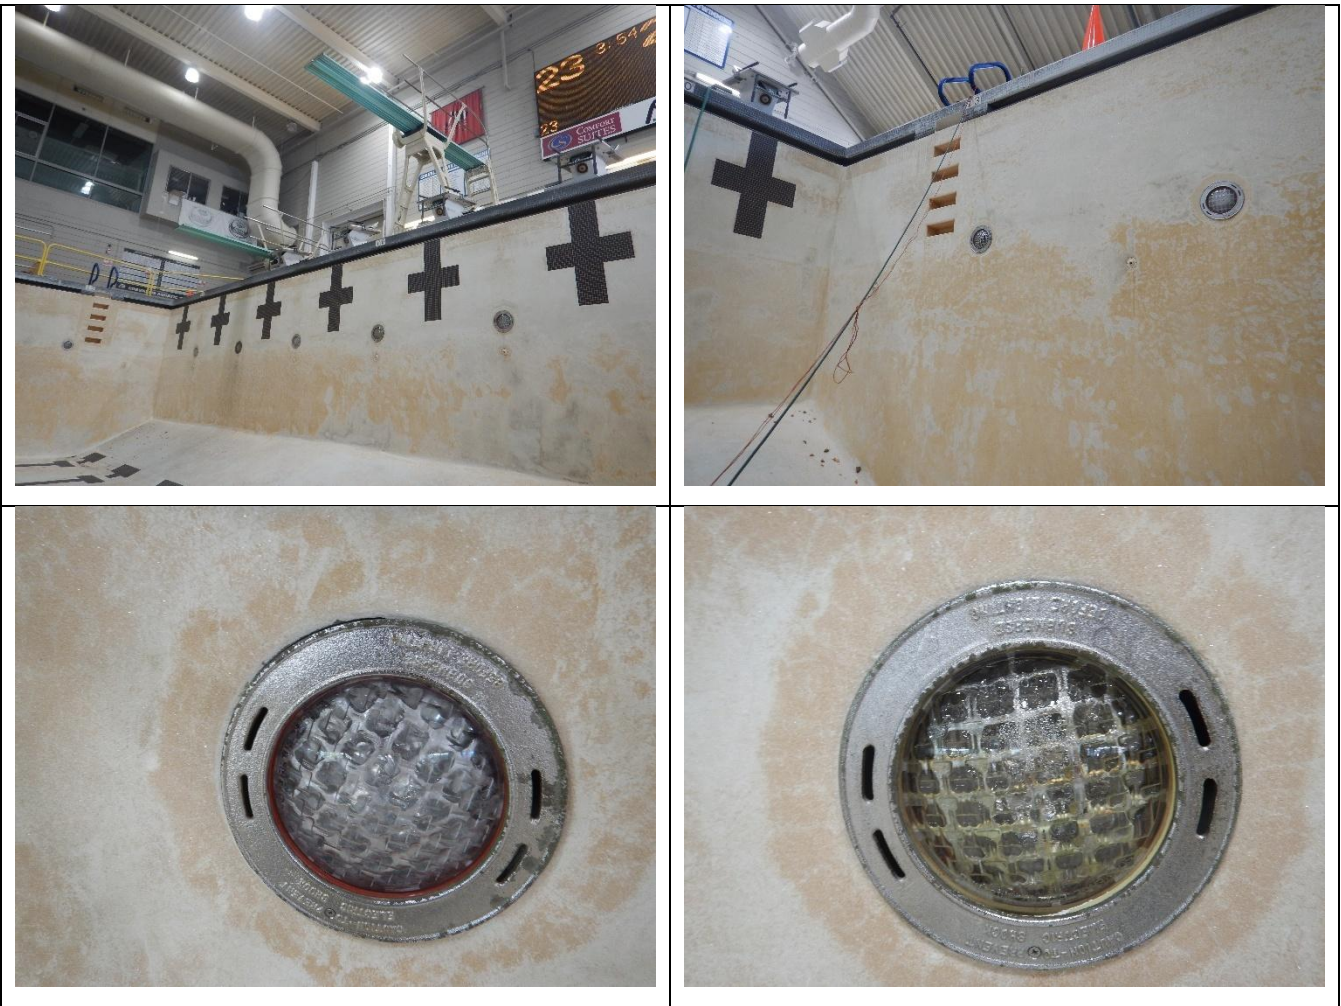
- a) The 50-Meter Pool is equipped with thirty-one (31) underwater lights, seven (7) on the deep end wall and twelve (12) on each long wall. According to operators, the lighting system is operational and is used extensively for competition as well as unique programming like family movie nights in the natatorium.
- b) The light fixtures were observed to be in fair condition at best. Most niche faceplates show significant corrosion, and the outer glass is in varying states of discoloration. At least one niche had water inside. Several of the lamps have gone out according to operators.

- a) Replace underwater lights with new niches and fixtures. Rewire lighting system if necessary.

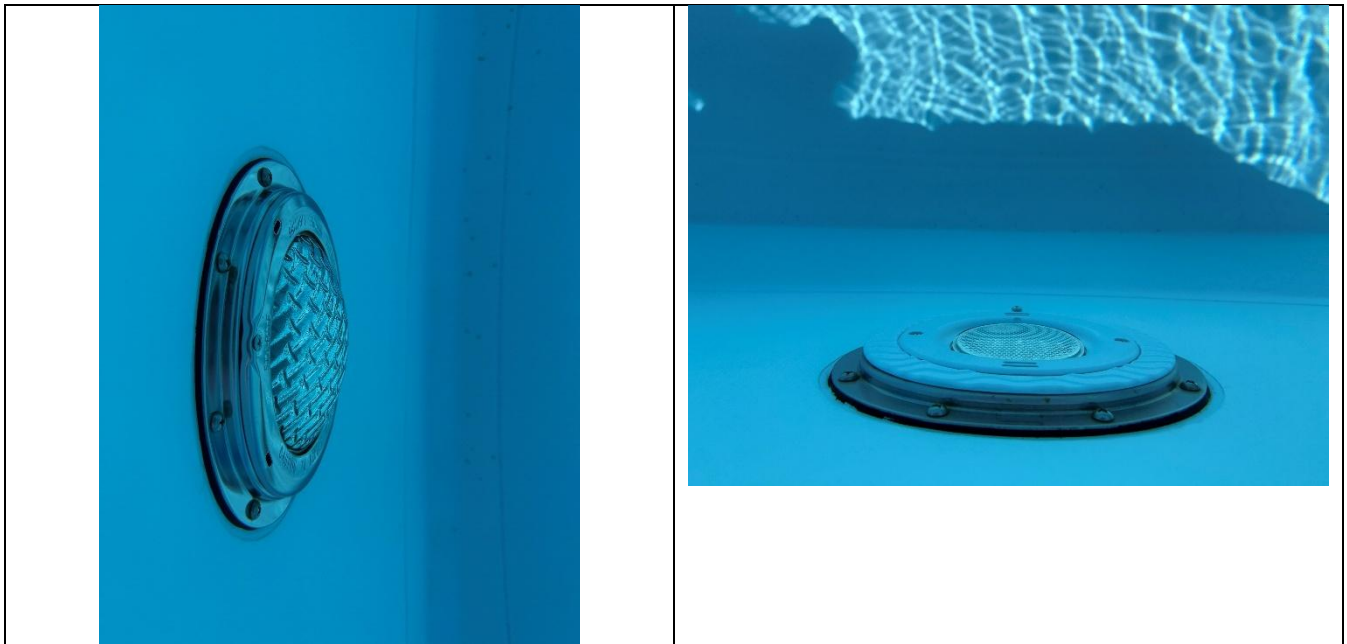
- a) The 25-Meter Pool has eight (8) underwater lights, four on each long side of the pool, and are used extensively. Operators reported the two lights near the south wall of the pool were replaced recently with 12-volt lamps. All niches, fixtures, and lamps were observed to be in excellent condition.

- a) No immediate action recommended. Consider swapping fixtures for uniformity when current fixtures reach their end of life.

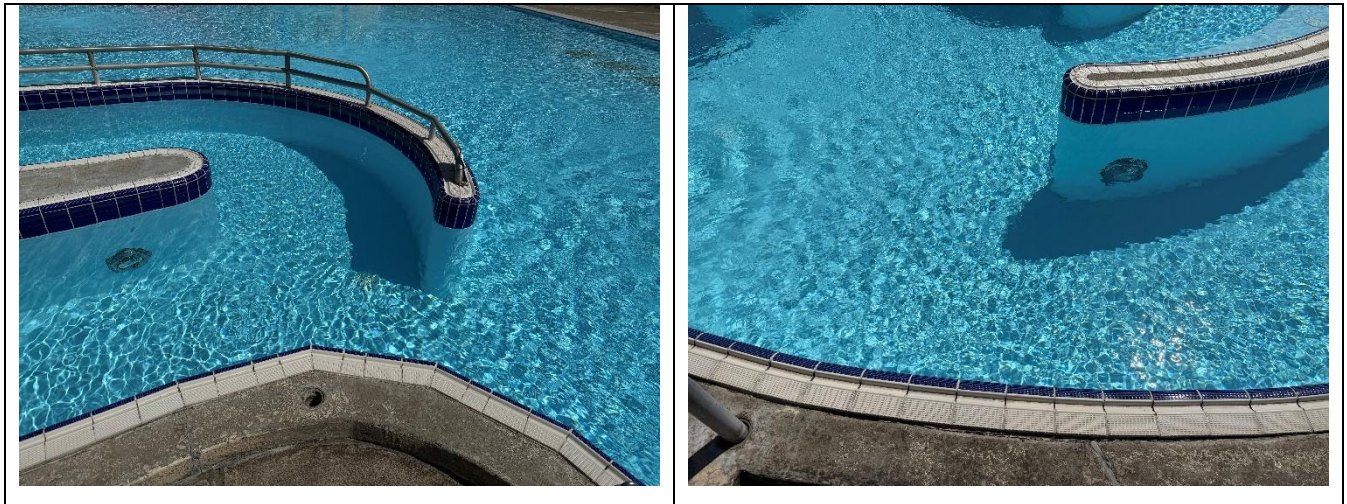
22. Underwater Lights (Leisure Pool)

- a) The Leisure Pool has eleven (11) underwater lights that are original to the pool and in generally fair condition, however a few lights are not operating.

- a) Replace lamps as needed and replace fixtures as they reach their end of life.

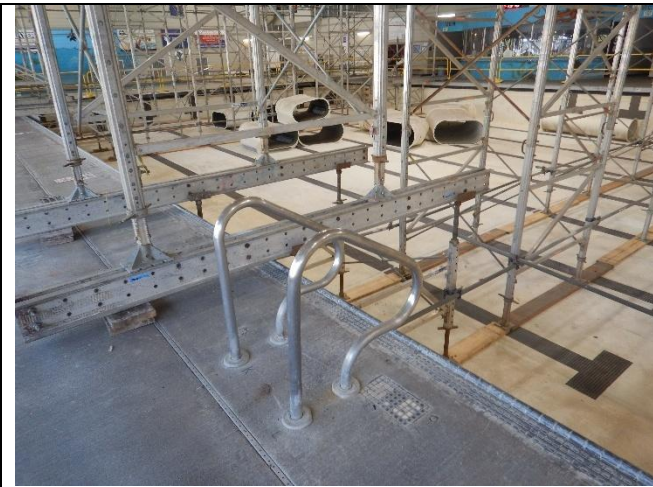
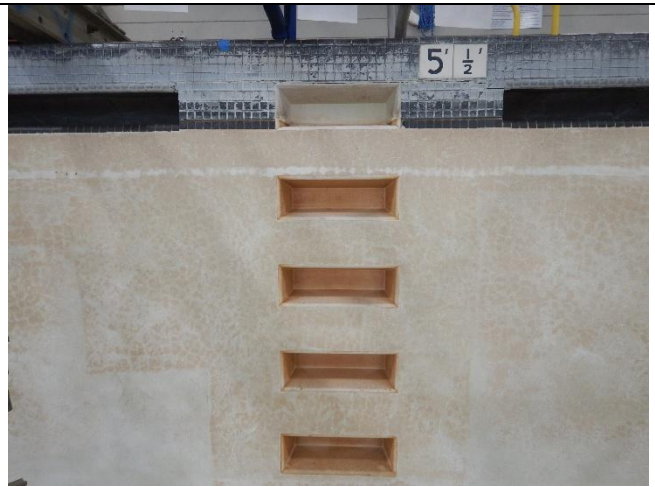
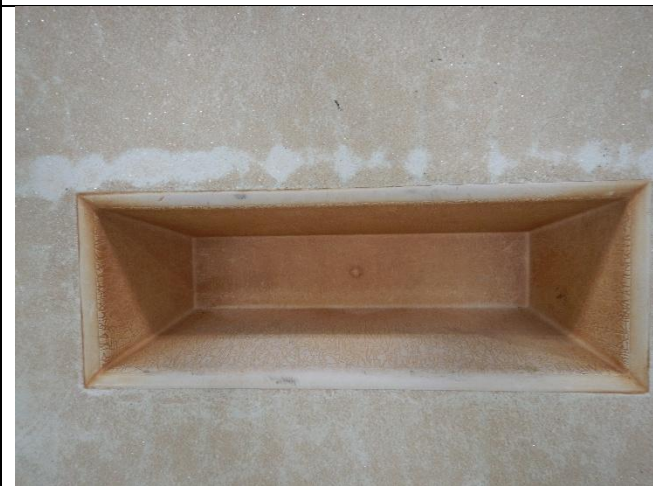
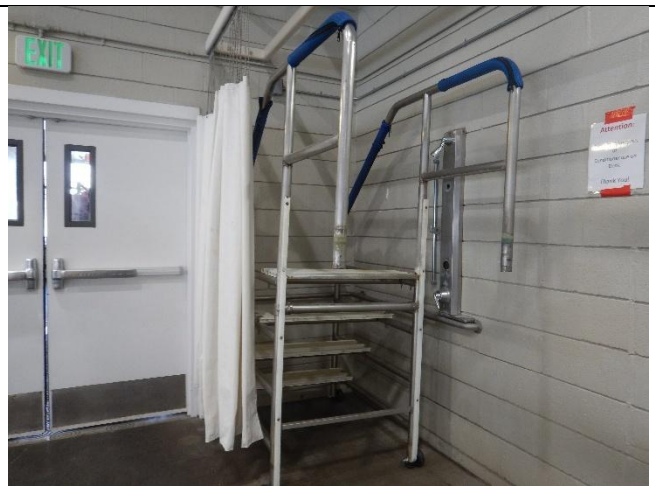
23. Ingress and Egress (50-Meter Pool)

- a) The 50-Meter Pool has one (1) fixed accessible pool lift near the southeast corner of the pool. The lift is anchored in the deck and has been kept functioning by staff, but the design is obsolete, and replacement parts are no longer available.

- b) The natatorium has two (2) additional movable lifts that are shared with the Therapy Pool. These lifts were in storage due to the state of the natatorium but were described as in good working condition. The lifts are typically staged at the pools depending on programming needs. No parking anchors were observed near the 50-meter pool.

- c) The 50-Meter Pool has grab rails and recessed steps at eight (8) locations, four on each long side of the pool. These fulfill code-required means of access/egress. Grab rails are stainless steel anchored into the deck. The grab rails are generally anchored sturdily, but rails show significant surface corrosion. Operators reported difficulty in removing the grab rails from their anchors. The prefabricated recessed steps have complete structural integrity but show significant staining from years of use.

- d) The pool has no permanent ramp or stairs, but there is a removable stainless-steel stair assembly that can be placed in the shallow end and anchors in the deck. The stairs are stored in the corner of the pool deck and appear to be in fair condition.

- a) Replace the fixed lift in the southeast corner of the pool with a new model for reliable performance and improved appearance.
- b) ADA requires that pools over 300 feet in perimeter have two permitted means of pool access. This is currently achieved when at least one moveable lift is placed for use in the 50-Meter Pool. However, movable lifts must be placed in a parking anchor to comply. Therefore, it is recommended to install parking anchors at any locations moveable lifts are used. Park a movable lift in its anchor at all times the 50-meter pool is in use to be in full compliance with ADA.

- c) Replace all grab rails and anchors in kind for ease of operation and a polished appearance. Maintain grab rails with stainless-steel cleaning products. Acid wash all recessed steps to remove staining. Replace steps if they become broken or if appearance cannot be improved.

- d) Continue maintaining removable stair assembly if it is important for programming needs. Replace when it becomes excessively corroded or its structure no longer allows for safe and confident access to the pool.

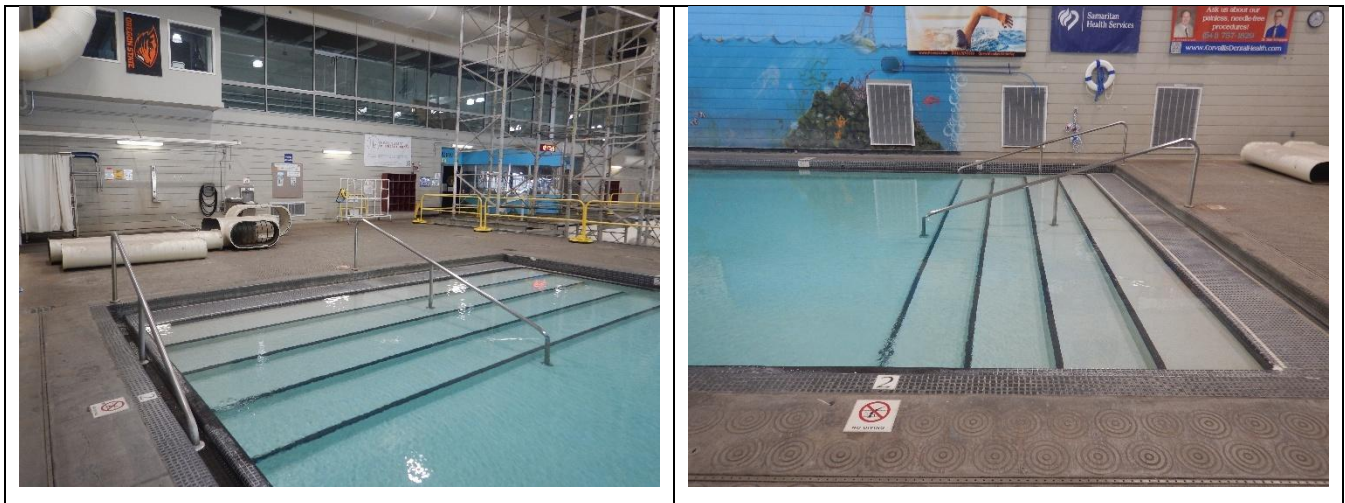
24. Ingress and Egress (Therapy Pool)

- a) The only means of access and egress to the Therapy Pool is a pool stair at the shallow end. The stair features large 24” treads and lands at a depth of two feet. The stairs meet the requirements for general (non-ADA) access and egress because of the small size of the pool.
- b) No ADA access was directly observed in the Therapy Pool, but operators reported that there are two (2) movable lifts shared with the 50-Meter pool that are staged according to programming needs. No parking anchors were observed near the Therapy Pool.

- a) Install a parking anchor for compliant usage of a movable lift. Park a movable lift in the anchor at all times the Therapy Pool is open to be in full compliance with ADA.

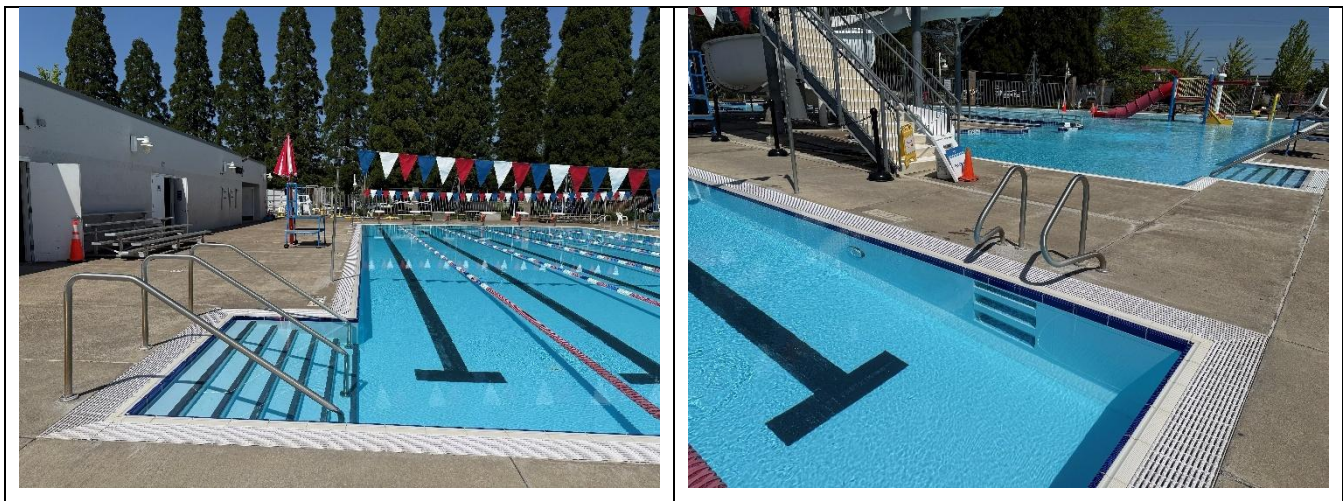
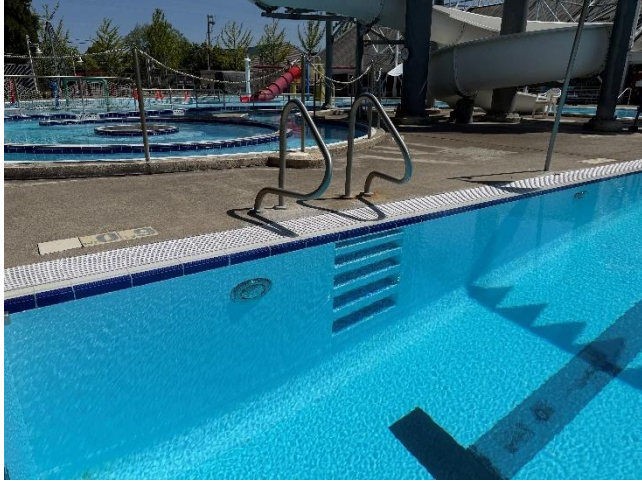
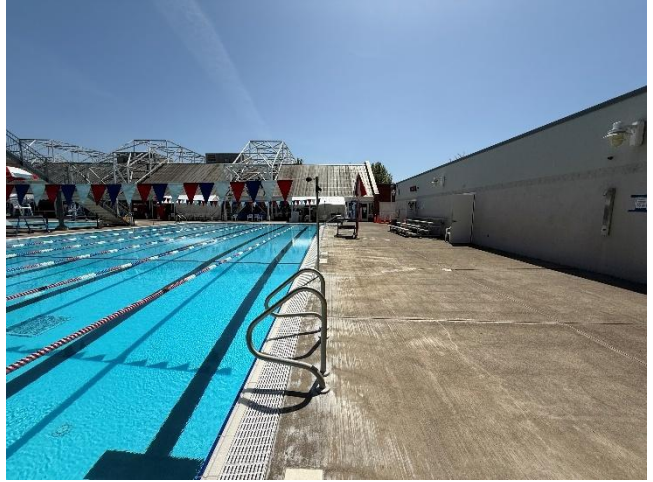
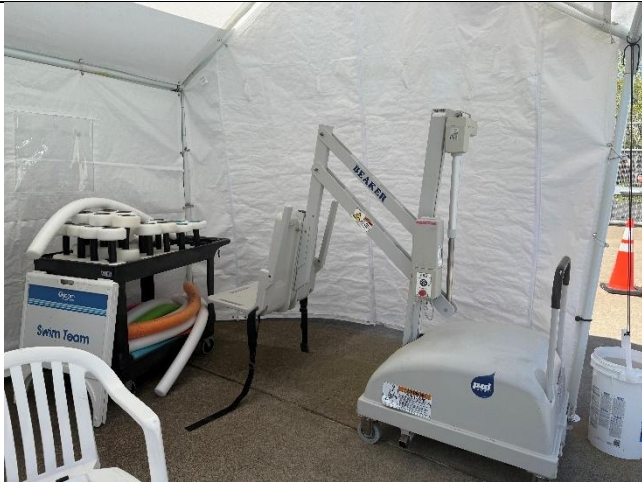
25. Ingress and Egress (25-Meter Pool)

- a) The 25-Meter Pool is accessed by a pool staircase as well as grab rails and recessed steps at three (3) locations. The grab rails show only cosmetic surface corrosion and are anchored very well. The pool stairs, stair railings, and recessed steps are all in very good condition. The entry points meet code required quantity and spacing for general (non-ADA) pool access and egress.

- i. A movable pool lift was present on the pool deck but was not parked by the pool for use. No parking anchors were observed. Therefore, the pool did not have a primary means of ADA access.

- a) Install parking anchors at any locations movable lifts are used. Park the lift in the anchor at all times the pool is in use. Alternatively, install a fixed pool lift to always be in compliance with ADA. A second lift is required if the pool does not have any other secondary permitted means of entry.
- b) Consider relocating the center stair rail to qualify the stairs as a secondary means of entry. The stair treads and risers already comply with ADA requirements.

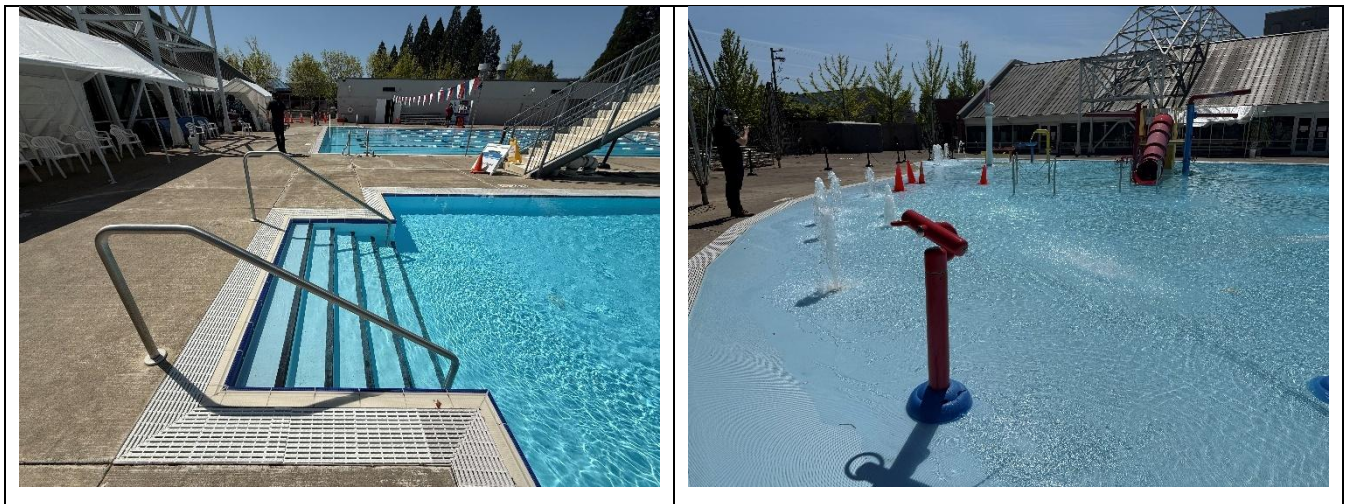
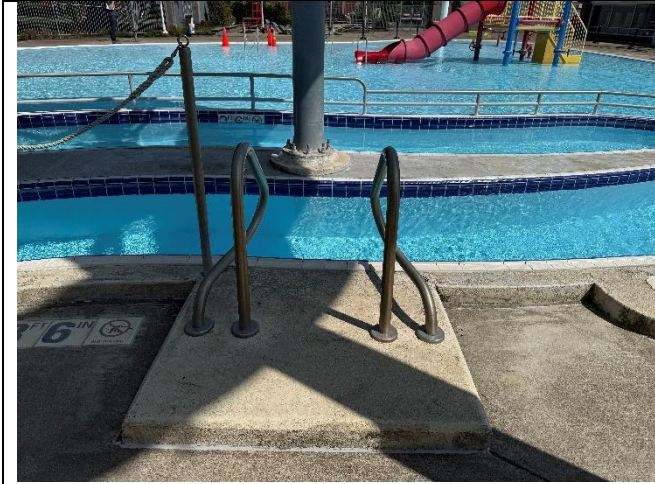
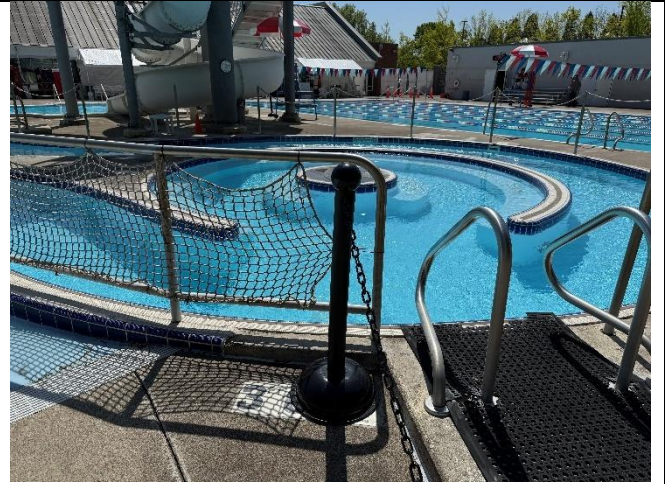
26. Ingress and Egress (Leisure Pool)

- a) The Leisure Pool is accessed by a pool staircase, a zero-depth entry, and three (3) locations with grab rails and recessed steps. All access points are in good working condition and meet the code-requirements for general (non-ADA) access and egress.
- b) There was a movable pool lift on the outdoor pool deck that was in good working condition. The lift was stored under shelter while the Leisure Pool was closed for the season. There were no parking anchors observed near the leisure pool.

- a) It is recommended to install a fixed battery-operated lift near the pool stairs to always have at least one primary accessible means of pool access. Alternatively, a dedicated movable lift could also fill the requirement and allow for more flexibility for maintenance activities. Parking anchors are required for the use of movable lifts.
- b) Consider installing a third railing on the pool stairs to qualify them as a secondary means of access. Install an identical railing and anchors with 20"-24" clear spacing to an existing one to qualify the stairs as a secondary means of ADA-permitted pool entry.
- c) Continue maintaining grab rails and recessed steps. Replace grab rails or anchors if they become loose or excessively corroded.

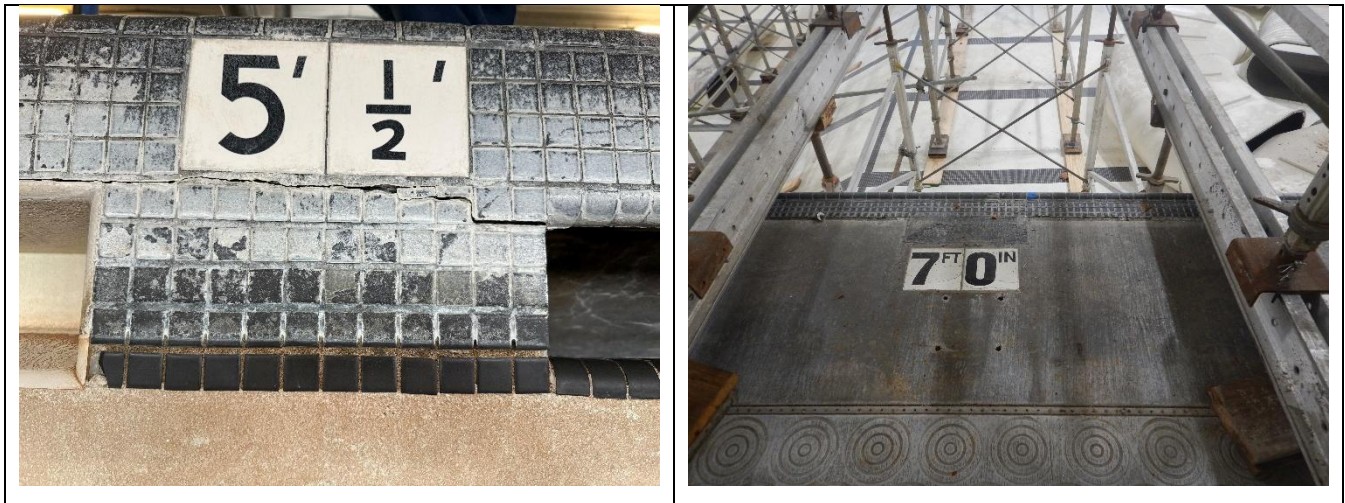
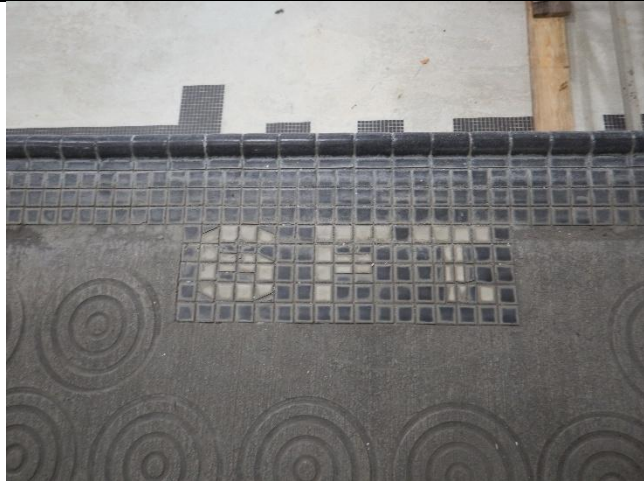
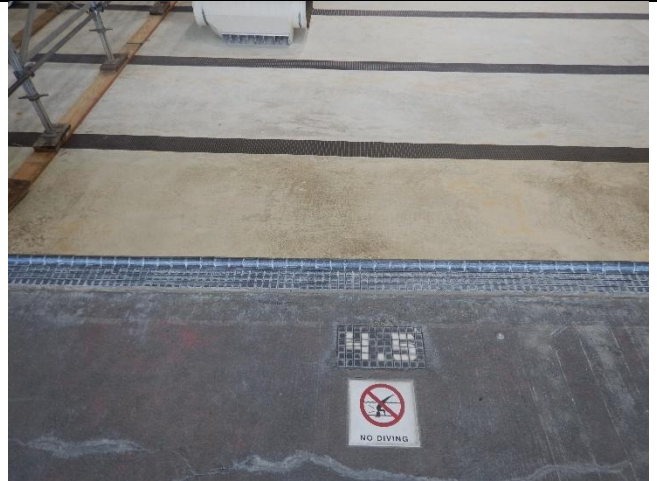
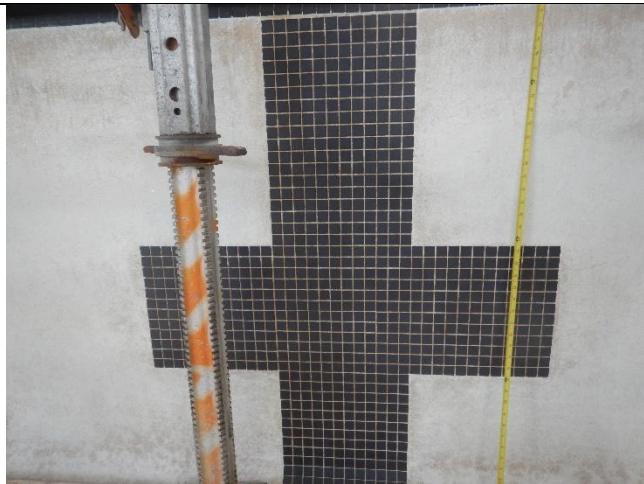
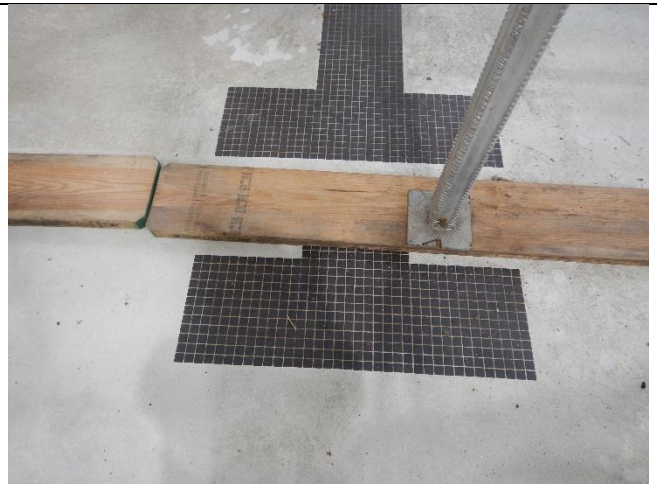
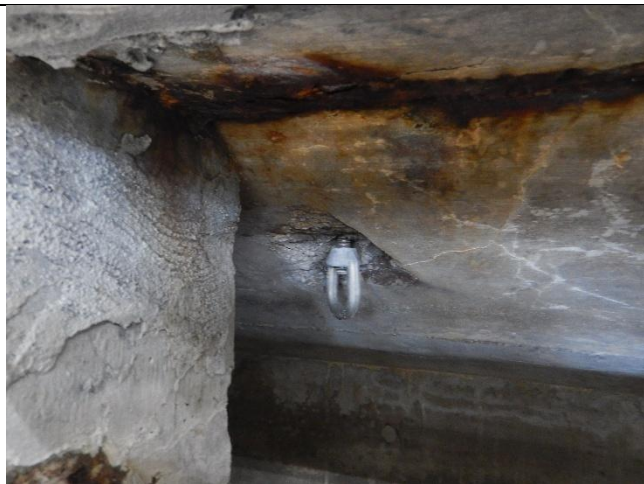
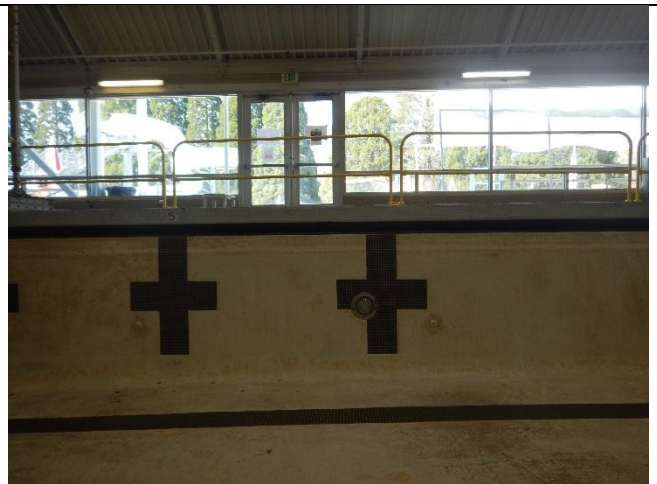
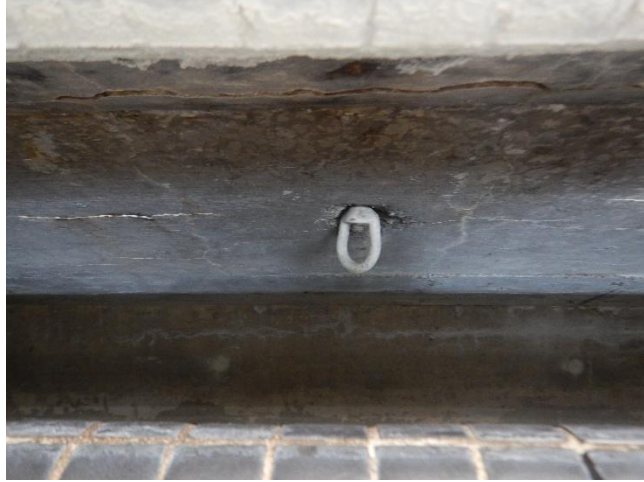
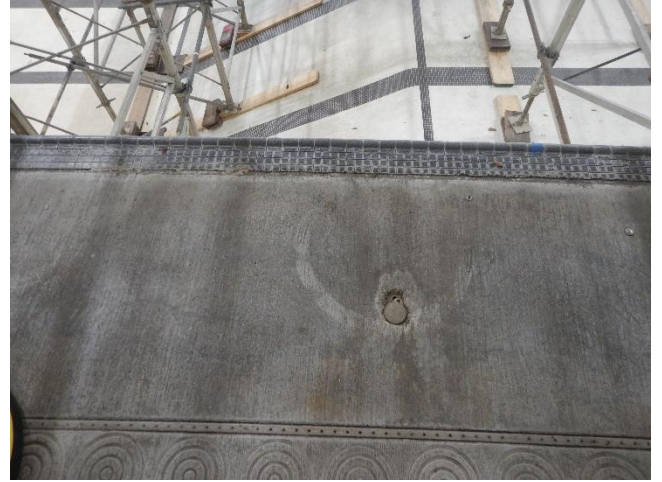
27. Markings and Anchors (50-Meter Pool)

- i. Depth markers must be clearly marked. Some markers shown as white tile in black field inlay are not clearly legible due to worn and calcified tiles.

- c) Lane ropes and safety lines are anchored by eye hooks drilled directly into the back of the gutter trough or into the cantilevered deck above. Hooks are in varying conditions, and some concrete material had been chipped away surrounding some of the anchors.

- i. Tile inlays are in fair condition, with few observed areas of chipped or missing tile and worn or missing grout. With roof shoring on the pool floor at the time of visit, the lane markings could not be assessed comprehensively, and it may be possible that the inlays are damaged by the shoring itself.

- e) Wall targets are available for eight (8) competition lanes on each end wall and both sides of the bulkhead as well as eight (8) cross-course lap swim lanes. Tile inlays are in fair condition. Current wall target dimensions are outdated but typical. This is less critical than floor markers due to the use of touchpads for competition.

- f) Stanchion anchors for backstroke flags are present for multiple swimming courses. Anchors are corroding but functional.

- a) Due to the mismatched nature and varying condition of signage around the pool, it is recommended to replace all depth signage and NO DIVING signs in a uniform, cohesive layout that meets code-required depth indication, spacing, and symbology.

- b) Extend the contrasting line at the 7 feet slope break up the walls of the pool in conjunction with pool refinishing.
- c) Reassess the condition of the lane marker inlays after shoring is removed. Clean all tile and grouting and replace any broken or missing tiles. Consider replacing tile inlays if damage is considerable and/or the following recommendation is taken.

- d) Because Osborn Aquatic Center is such an important swimming facility for the region and state, it is recommended to update the floor lane markings to terminate 6'-7" from the wall for all swimming courses, bringing it to the current standard of World Aquatics and USA Swimming.

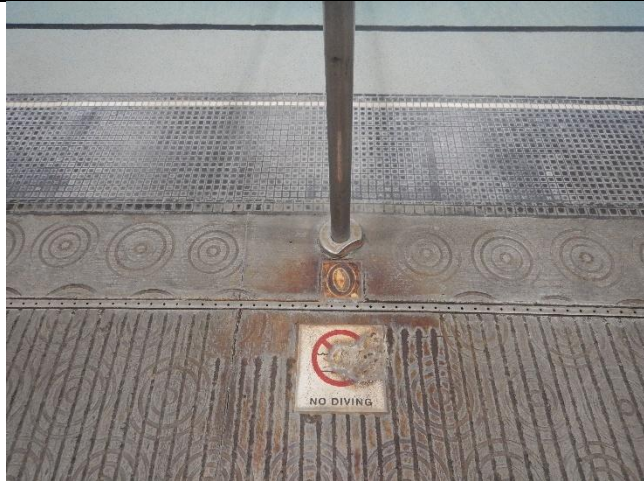
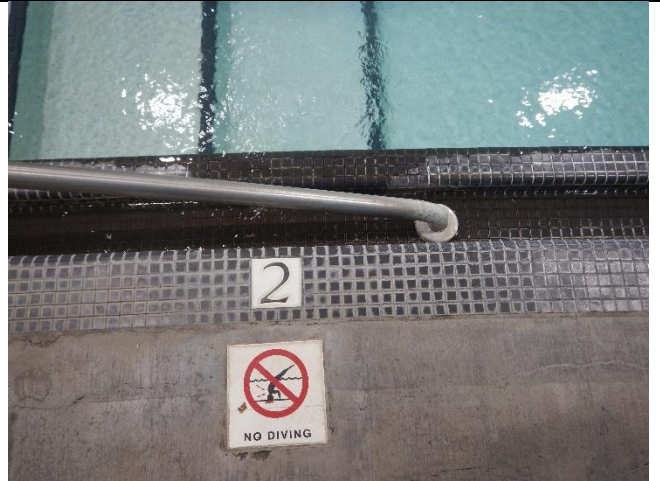
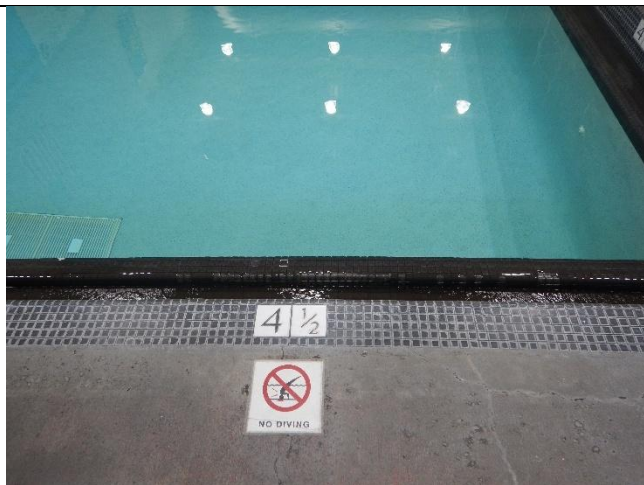
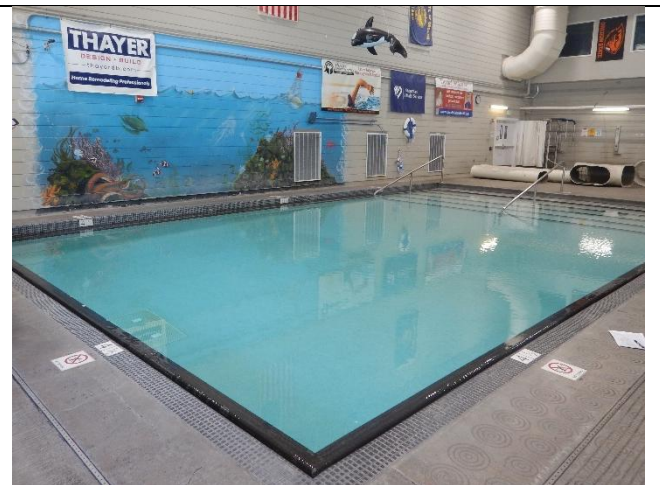
28. Markings and Anchors (Therapy Pool)

- a) The Therapy Pool has depth markers and NO DIVING warning signs at nine (9) locations around the pool perimeter. Depth is indicated with 4"x4" slip-resistant tiles in the vertical and horizontal perimeter tileband. Each location has a 7"x7" slip-resistant tile warning sign in the concrete deck behind the tileband displaying NO DIVING and the international no diving symbol. Signs are in readable condition except for the 0" depth indicator and associated NO DIVING sign at the stair wall.

- a) Replace all depth markers in conjunction with perimeter tileband work. Ensure new vertical and horizontal depth markers comply with state code requirements for size, spacing, and abbreviations.
- b) Include NO DIVING signs in the perimeter tileband for a cohesive appearance. Ensure new signage meets code requirements.
- c) Replace cup anchors and relocate if necessary to maximize programming benefits.

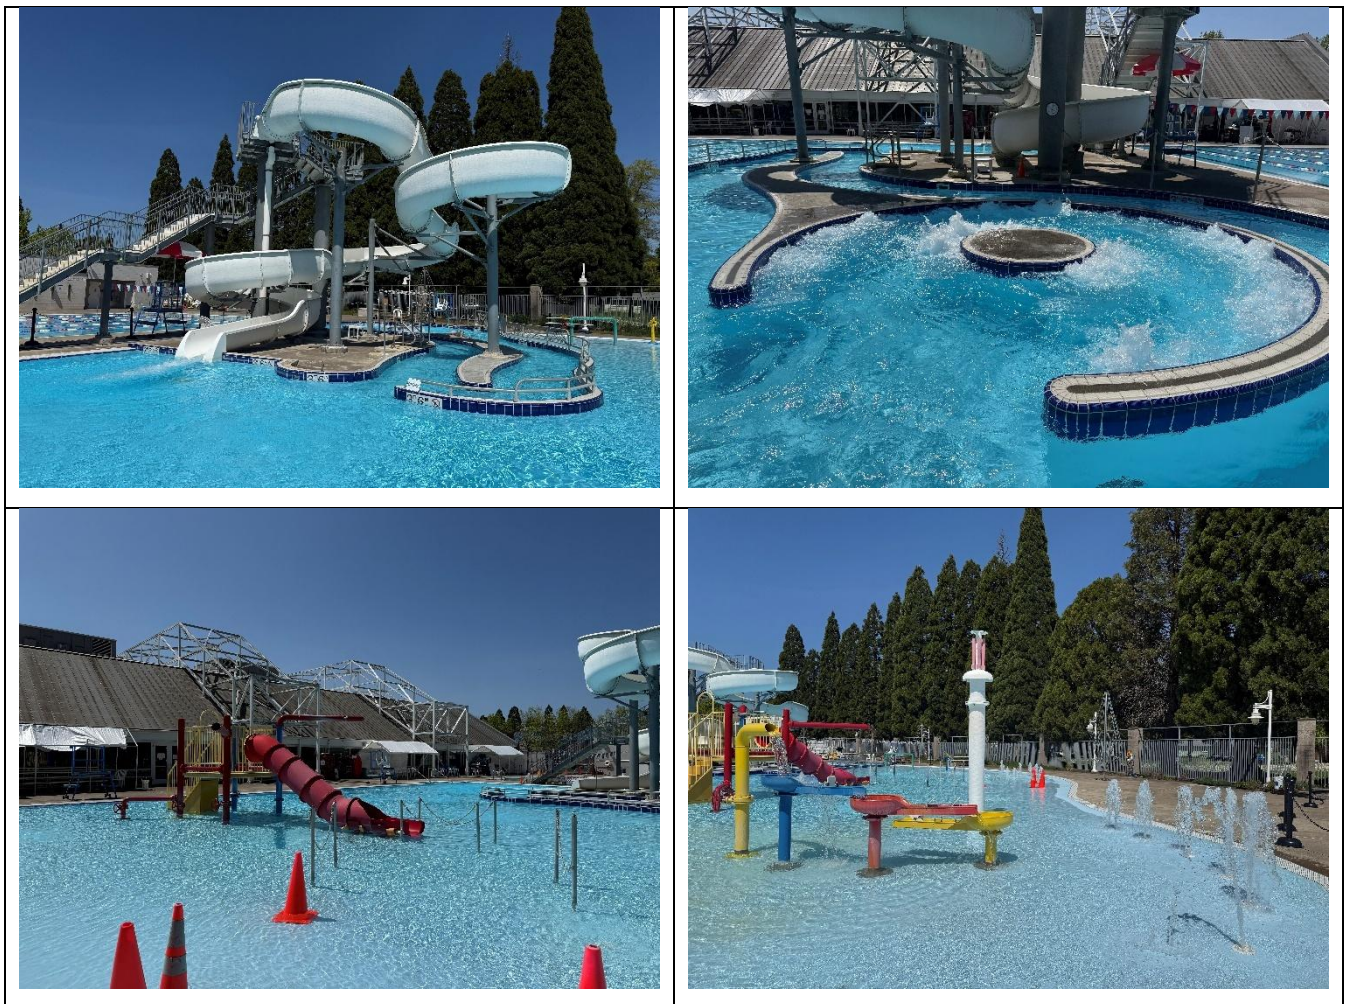
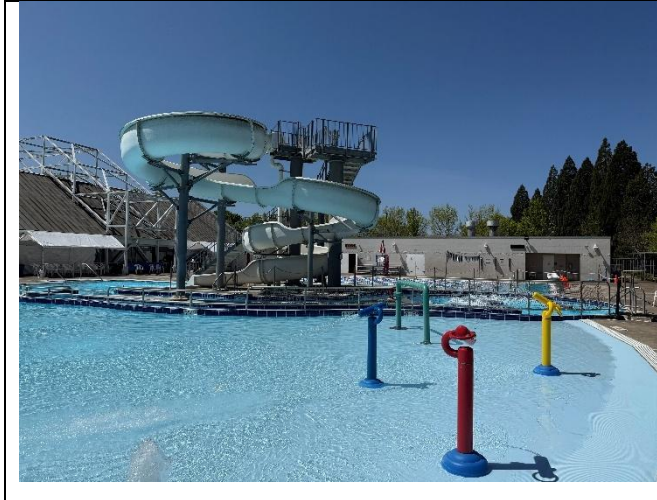
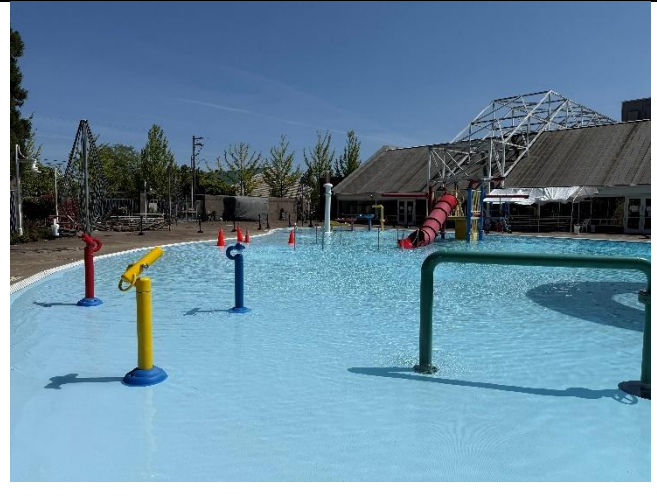
- b) The Waterslide is an open-flume slide on a 20-foot tower. Operators reported replacing a small section of the flume around ten years ago, but the rest is original to the pool. Sections of the fiberglass stairs are replaced every few years due to consistent wear and tear. It is also reported that hornets nest under the stairs.

- f) The Play Structure has multiple spray features and a slide and is in generally poor condition. The interactivity of spray elements are non-functioning and spray out continuously. The attached slide flume has been replaced once; the top and bottom flume sections were replaced again more recently as a result of improper supporting to the pool floor.

- g) The Leisure Pool has multiple additional spray features in varying conditions.
 - i. A cascade feature is in fair condition, but the tow guards are no longer in place. The valving interaction is no longer operable, but the dam features are still mostly in place.

- ii. The tumble bucket feature column is in fair condition and has its toe guard in place. However, the buckets have been removed and are no longer replaceable, so the feature now sprays upward continuously when in operation.

- a) Replace Waterslide flume at the end of its useful life. Manufacturers now offer restoration services that may also be an option.
- b) Reinstall Kid Slide and continue periodic maintenance.
- c) Replace Play Structure for cosmetic improvement and to restore the interactivity of spray features for young children.
- d) Replace tumble buckets and cascade features with equivalent new features.

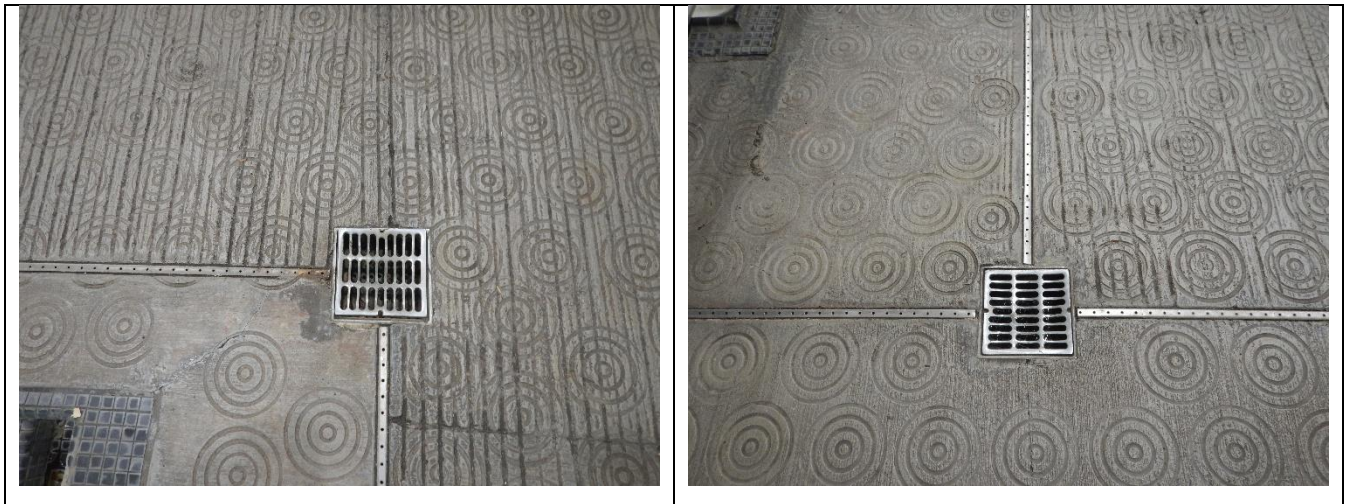
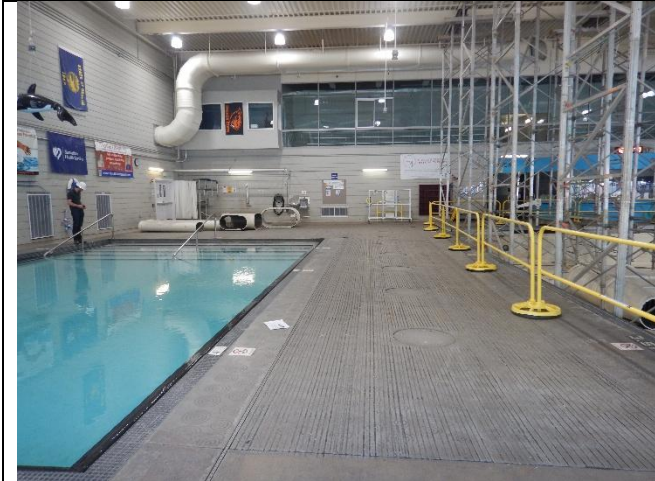
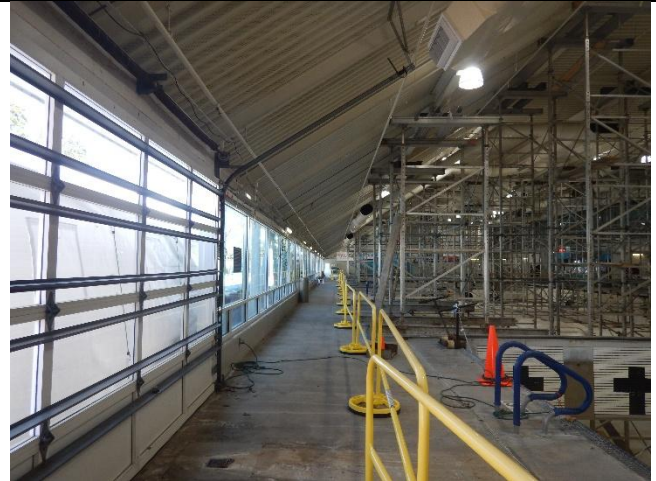
- a) The deck in the natatorium is a brushed non-slip concrete finish with areas of stamped nonslip finish between the pools and around the Therapy Pool. The deck finish is showing significant wear and has minor cracking in multiple areas.
- b) Deck drainage consists of slot drains around each pool with area drains in each corner and along the long side of the 50-Meter Pool. Operators reported that deck drainage is mostly sufficient but requires significant preventive maintenance. If drains are not blown out periodically, stagnant water causes drain flies.

- a) If Osborn Aquatic Center pursues a significant renovation of the 50-Meter Pool, it is recommended to redo the decks and deck drainage in conjunction with the pool renovation.
- b) Refer to architectural and structural assessments for additional recommendations regarding the pool deck.

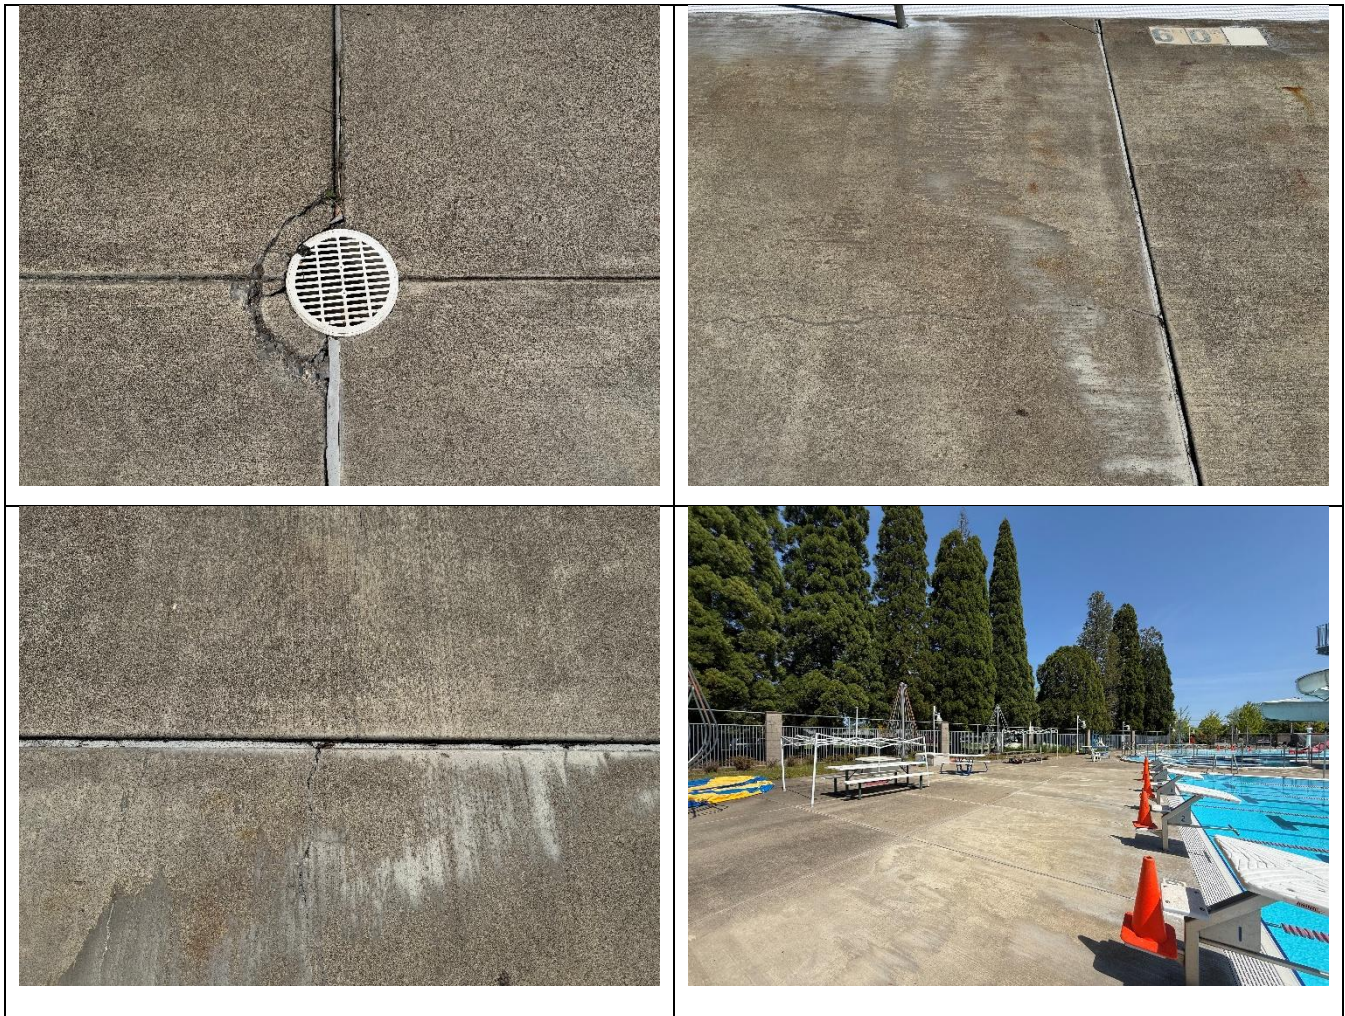
- a) The pool deck surrounding the 25-Meter Pool and the Leisure Pool is a brushed non-slip concrete and is in fair condition with only minor cracking observed. The elastomeric sealant in the deck's expansion joints was observed to be cracking.
- b) There are area drains surrounding both pools and a slot drain in the deck between the two pools. Operators did not report any significant issues with drainage of the outdoor pool decks.

- c) Remove and reapply elastomeric sealant to the deck expansion joints in areas where cracking or excessively worn.
- d) Refer to architectural and structural assessments for recommendations regarding the pool deck.

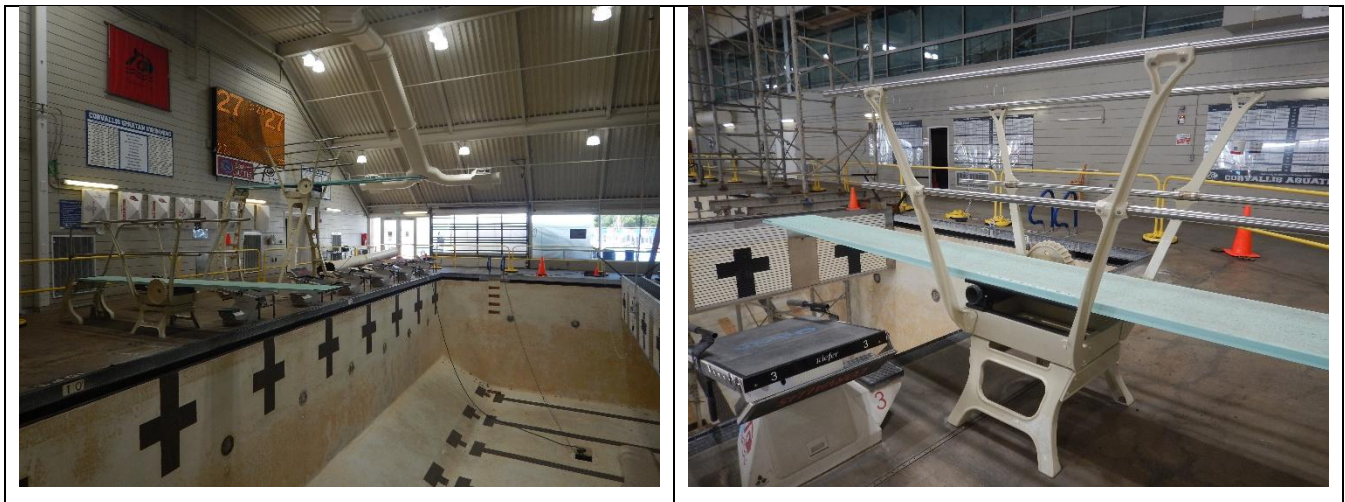
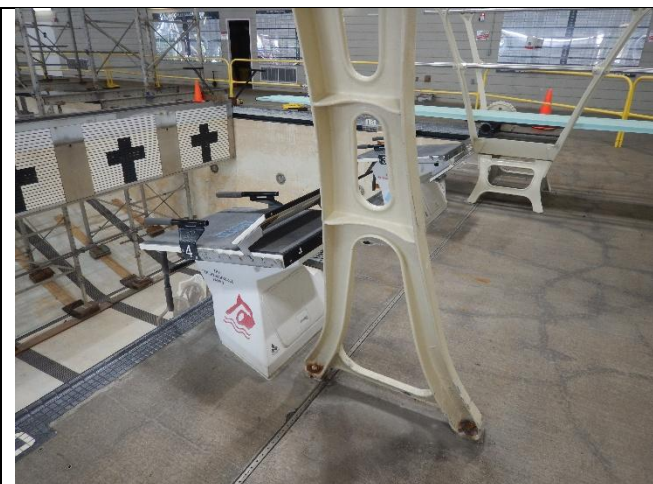
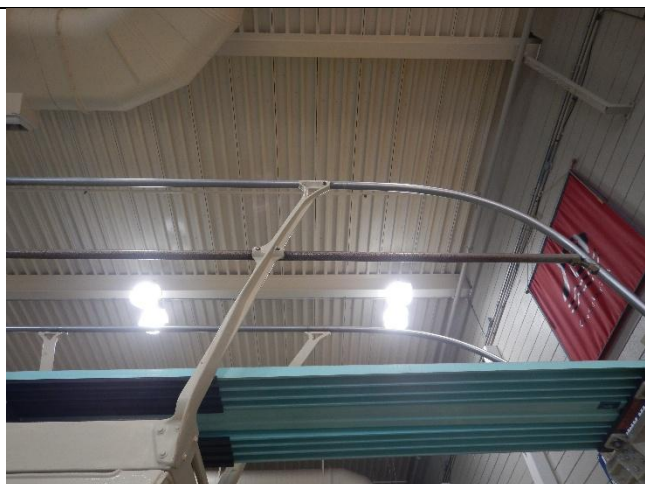
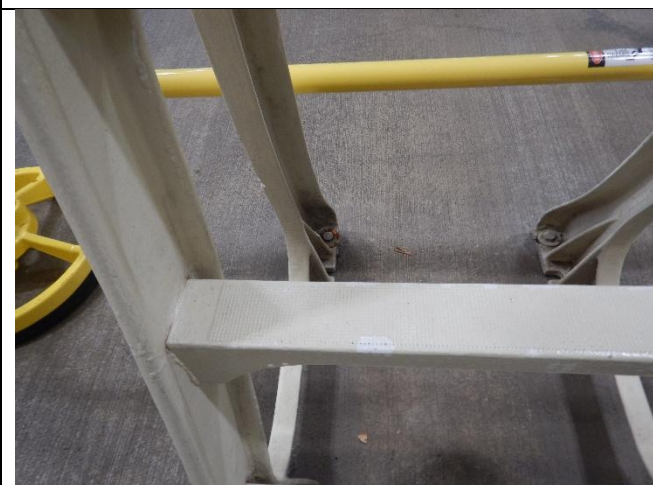
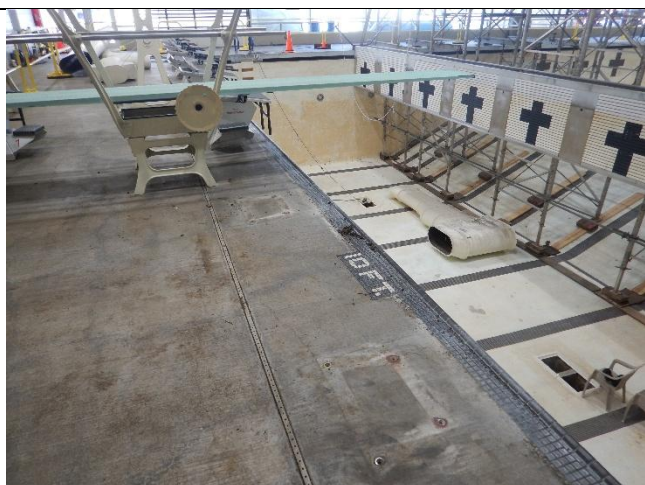
- a) The 50-Meter Pool is equipped with one (1) 1-meter springboard and one (1) 3-meter springboard.
- b) The powder coat was recently redone and is in good condition for both stands. The springboards are in good condition, with only minor visible surface wear. The handrails on both stands are showing some surface corrosion. Bonding of the dive stands could not be verified.
- c) The fulcrum was operable on the 1-meter dive stand but was difficult to move on the 3-meter dive stand.

- a) Replace springboards when surface begins flaking or losing its non-slip texture. Maintain fulcrum assemblies per manufacturer instructions.
- b) Verify bonding of dive stands in the case of natatorium deck renovation.
