City of Corvallis
Corvallis School District

Osborn Aquatic Center Facilities Assessment

Scott
Edwards
Architecture

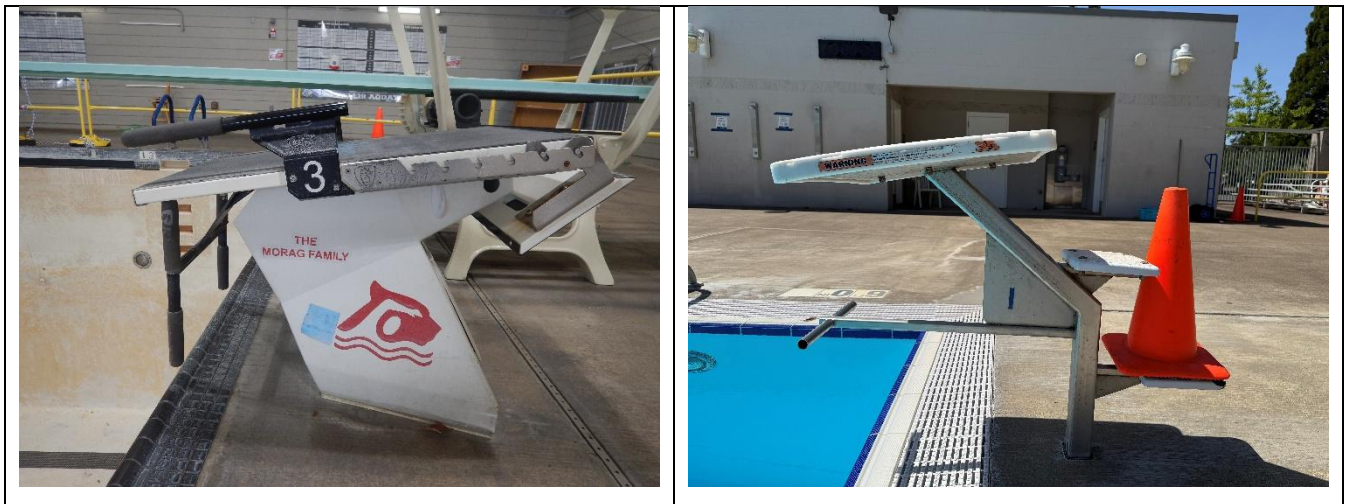
- a) The 50-Meter Pool is equipped with competition starting blocks with non-slip grit surface, hand rails, and adjustable rear foot wedge. These blocks are anchored well and in good condition, showing only minor cosmetic wear and staining.
- b) The 25-Meter Pool is equipped with Paragon single-post blocks with molded plastic top surface and step. These blocks are anchored well and are in good condition. Backstroke handle grips were observed to be missing. One block was measured to be 2'-7 1/2" above the water surface, which is two inches too high.

- a) Continue to maintain starting blocks per manufacturer recommendations and replace at the end of their useful life. Replace 25-Meter Pool blocks if a competitive upgrade is desired.
- b) When replacing 25-Meter Pool starting blocks, ensure the Myrtha gutter's freeboard is compensated for to achieve a leading edge dimension of 2'-5 1/2" above the water surface.

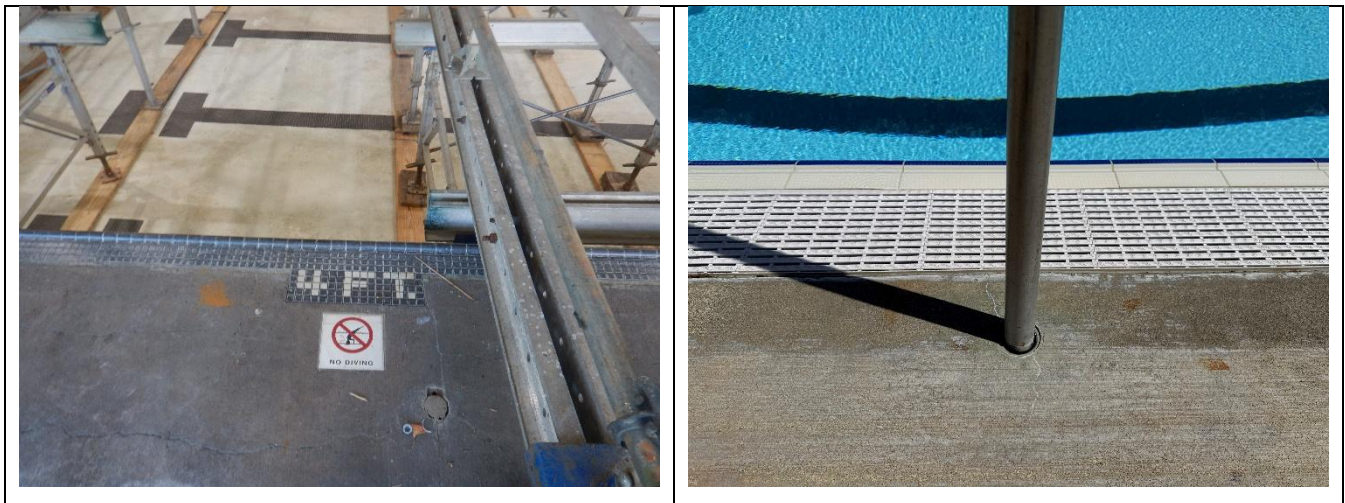
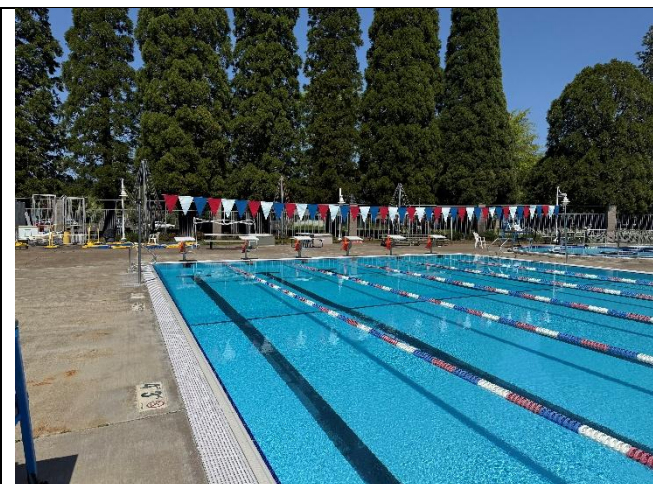
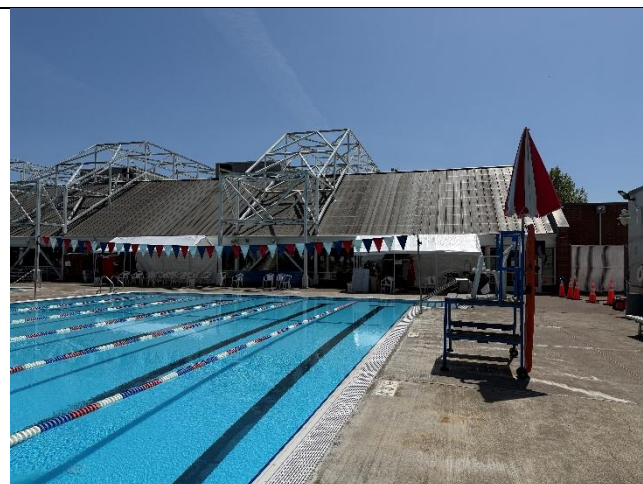
- a) False start and backstroke stanchions are provided for the 50-meter pool and are anchored in the concrete deck outside the perimeter tileband. The stanchions and pennants were stored away at the time of the visit and were not observed. Anchors for backstroke flag stanchions were covered but observed to be in fair condition. The anchors and covers suffered from cosmetic surface corrosion and staining.
- b) Backstroke stanchions for the 25-Meter Pool are anchored in the concrete deck outside of the Myrtha gutter. The stanchions were observed to be in fair condition with some minor surface corrosion. At least one stanchion was observed to be slightly bent. Anchors and pennants were observed to be in good condition.

- a) Replace all false start and backstroke stanchion anchors for the 50-meter pool in the case of improvements to the pool deck. Replace stanchions and pennants for both pools at the end of their useful life.

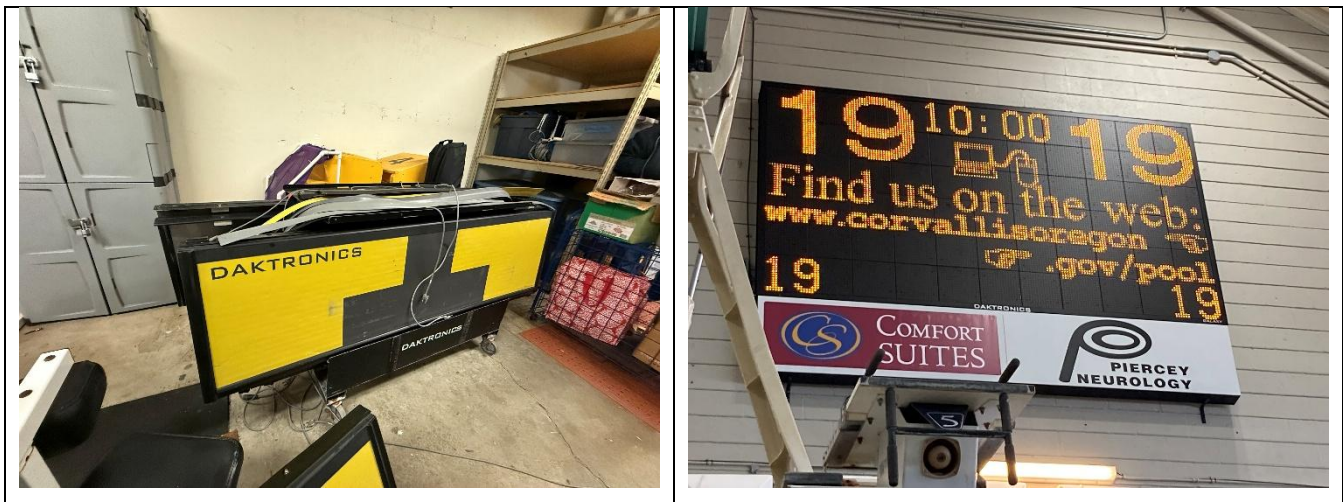
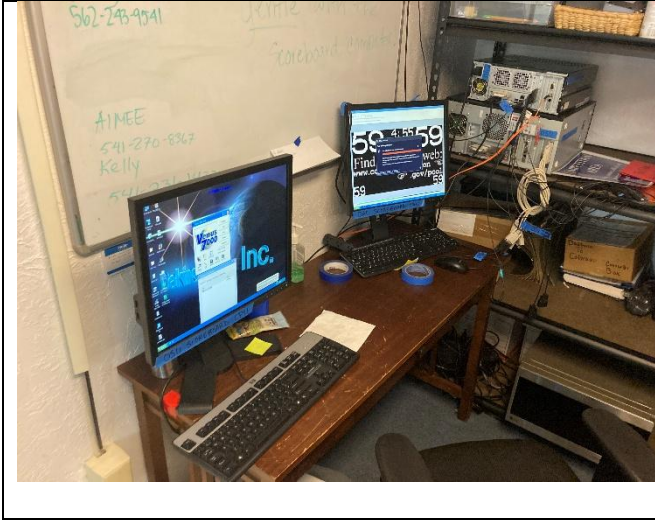
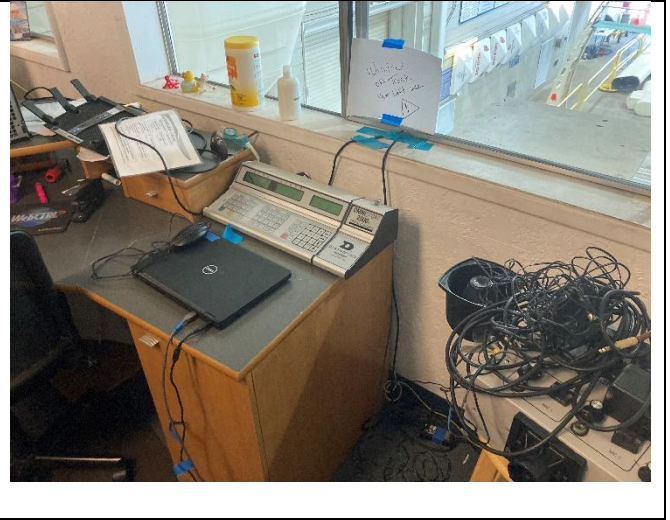
- a) The 50-Meter Pool uses an above deck cable harness and Daktronics touchpads for competition swimming. The harness, touchpads, and starting device were observed in the storage room to be in fair condition.
- b) The natatorium is equipped with a Daktronics Galaxy LED display scoreboard
- c) The timing console, scoreboard control, and two meet manager computers were in a control room on the natatorium mezzanine level. The equipment is reportedly still functioning but is dated and does not inspire confidence.

- a) Due to the importance of Osborn Aquatic Center as a regional and state facility for competition, it is recommended to replace all timing system components including touchpads, scoreboard, and consoles with a new industry standard system.
- b) If a renovation of the pool deck is to take place, it is recommended to install an in-deck timing conduit with deck plates for simpler, and more polished operation.

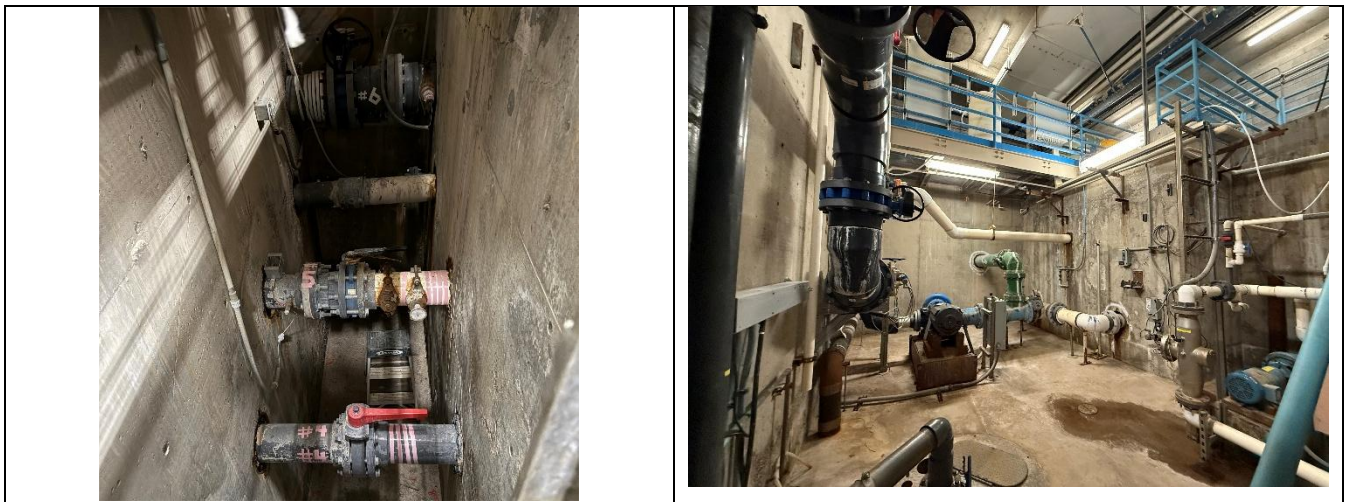
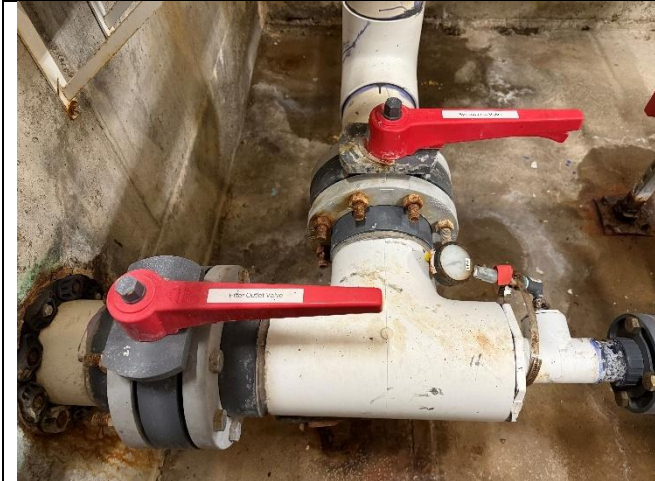
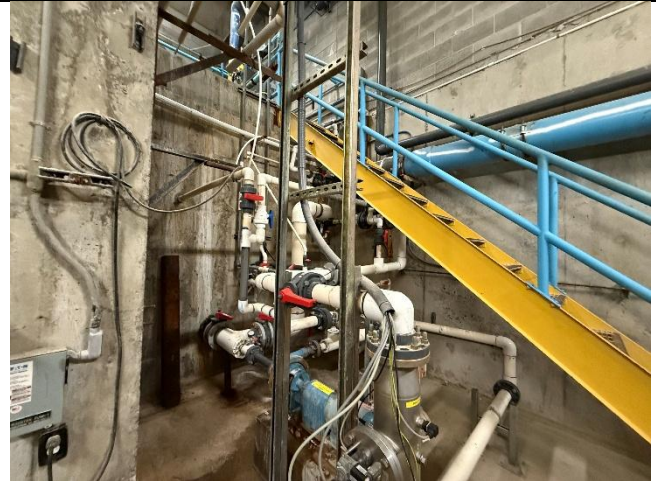
- a) Piping in the mechanical room serving the indoor pools is a mix of steel, schedule 40 PVC, and schedule 80 PVC in varying but generally poor condition. No leaking was observed due to the 50-Meter Pool being drained; operators reported known minor leaks in the recirculation piping. The Therapy Pool recirculation system was running, and similarly minor leaks were observed. Several piping sections were marked for replacement many years ago, but the project never took place.

- b) Valves in the indoor pool mechanical room were of similarly mixed material and condition. Most valves are reportedly operable but some need replacement.

- d) Piping was not observed to have content labels or flow direction, leading to uncertainty particularly in the valve pit.

- a) It is recommended that all piping and valving serving the indoor pools be replaced as part of a greater mechanical system renovation. Aquatic designer will specify new piping and labeling requirements.

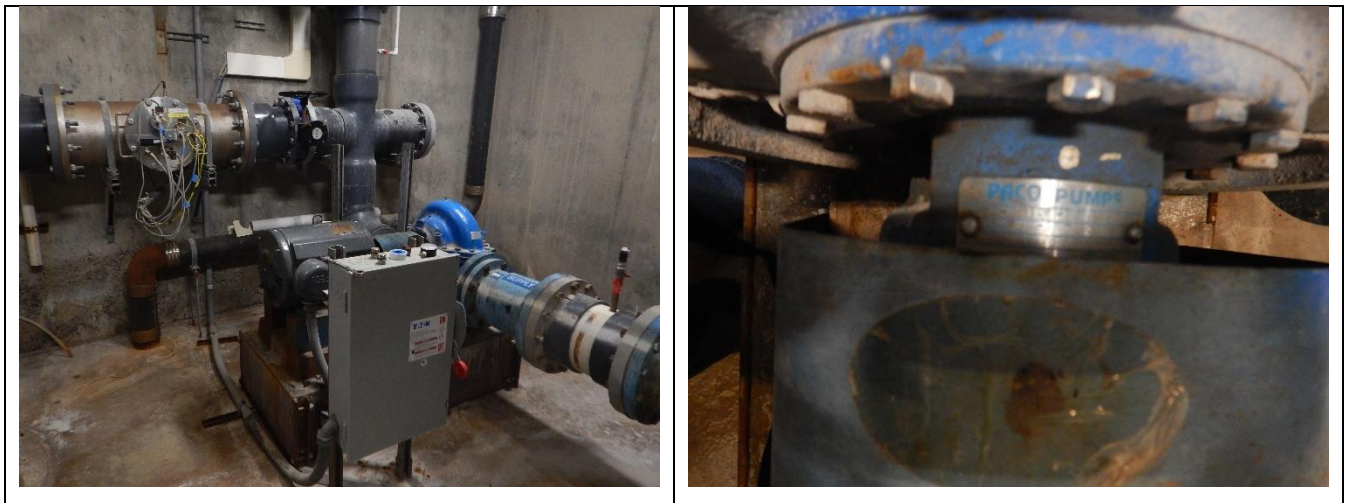
- a) The 50-Meter Pool is recirculated by a Paco 30-horsepower, flooded-suction pump. Both the impeller housing and motor housing are showing significant corrosion.
- b) The pump's housekeeping pad is cracking. Operators recalled an instance in the past where the housekeeping pad needed to be reworked because of excessively destructive pump vibration.
- c) The pump operates on a VFD that is reportedly approaching 20 years old.

- a) Replace recirculation pump, motor, and VFD as part of a greater mechanical system renovation. VFDs continue to be recommended for recirculation pumps for energy savings and motor longevity.

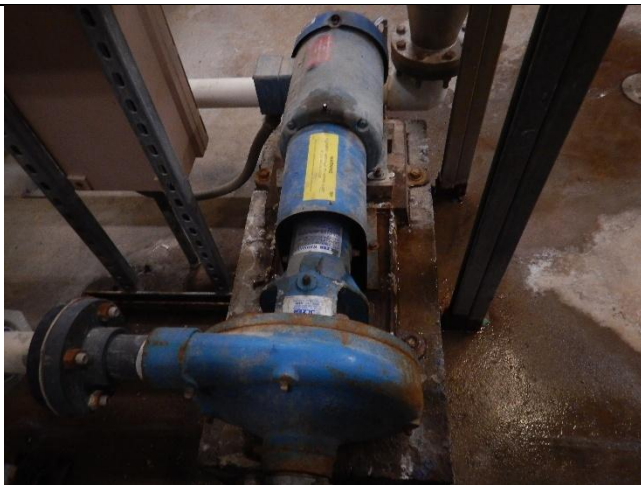
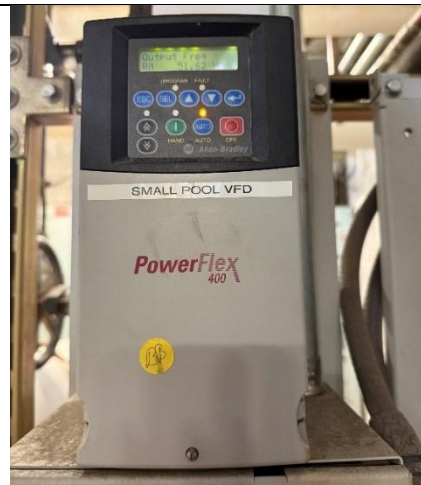
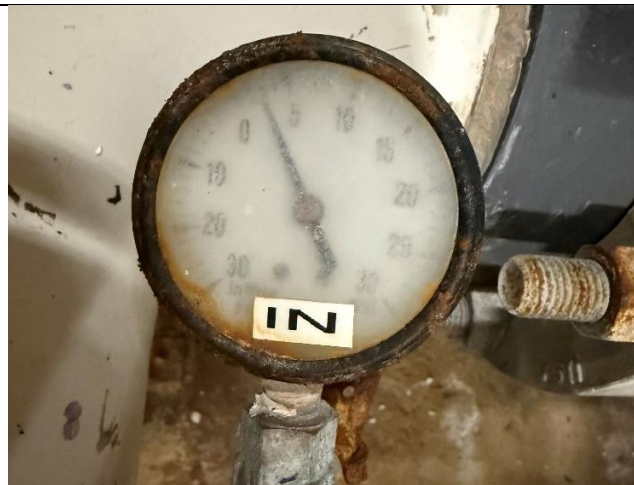
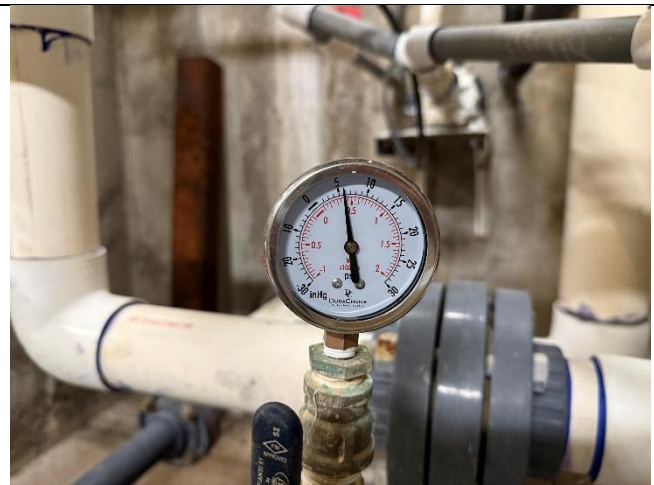
- a) The Therapy Pool is recirculated by a Paco 5-horsepower, flooded-suction pump. Both the motor and impeller housing show significant corrosion, as well as the anchors to the pump's housekeeping pad.
- b) Vacuum and pressure gauges were available at the pump suction and discharge.
- c) The pump operates on a VFD that is reportedly approaching 20 years old.

- a) Replace recirculation pump, motor, and VFD as part of a greater mechanical system renovation. VFDs continue to be recommended for new recirculation pumps for energy savings and motor longevity.

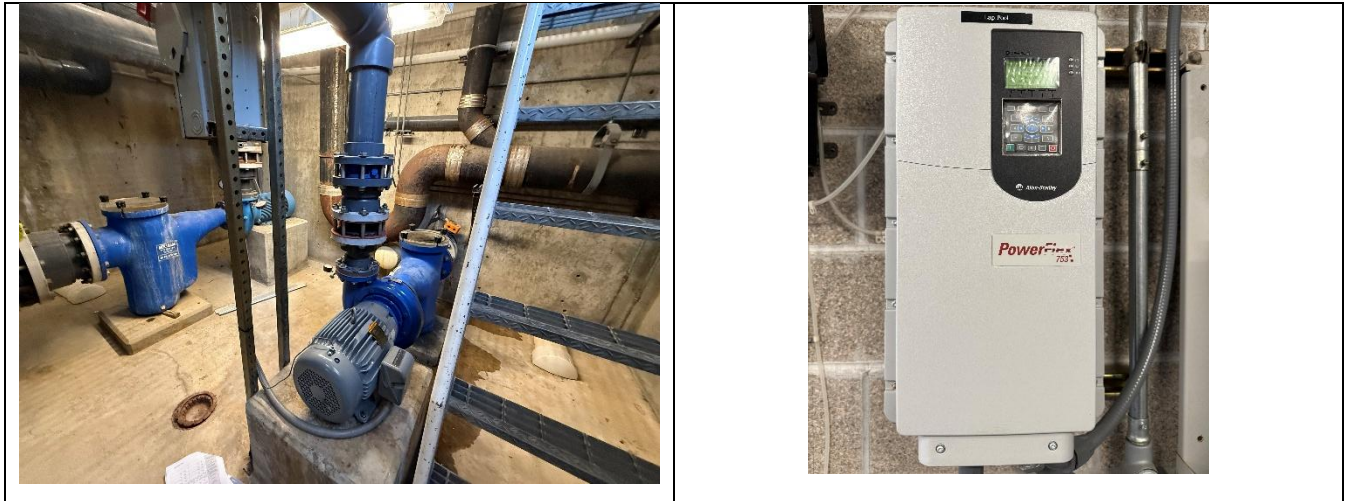
- a) The 25-Meter Pool is recirculated by a 15-horsepower flooded-suction Paco pump. Both the motor housing and impeller housing is in good condition.
- b) The pump has a basket strainer, isolation valves, as well as suction and pressure gauges. The suction gauge is corroded and at risk of failure.
- c) The 25-Meter Pool recirculation pump is equipped with a VFD that was replaced recently and is in excellent condition.

- a) Replace compound gauge at pump suction.

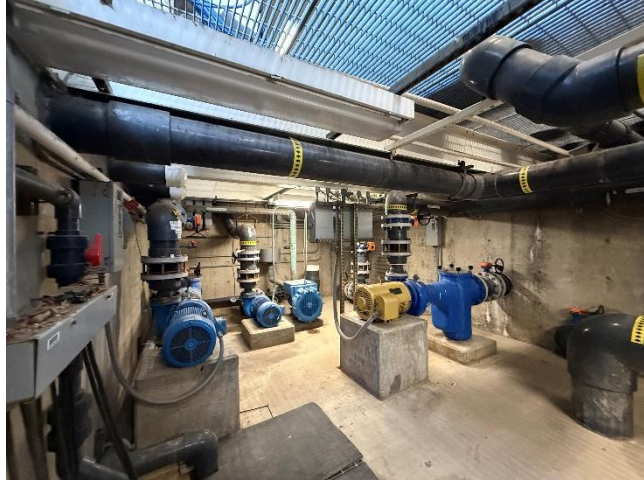
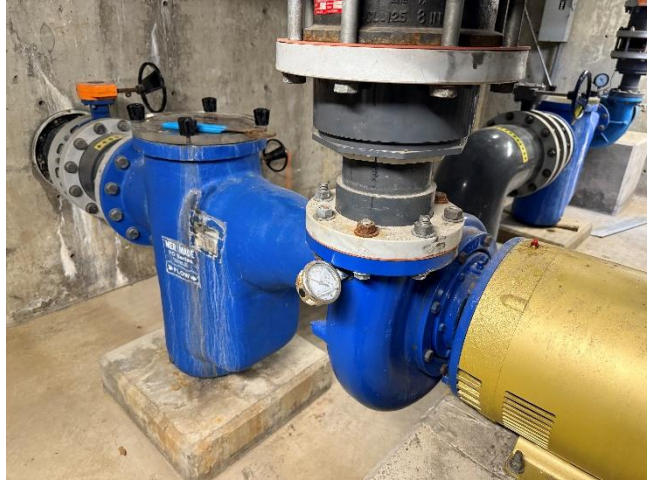
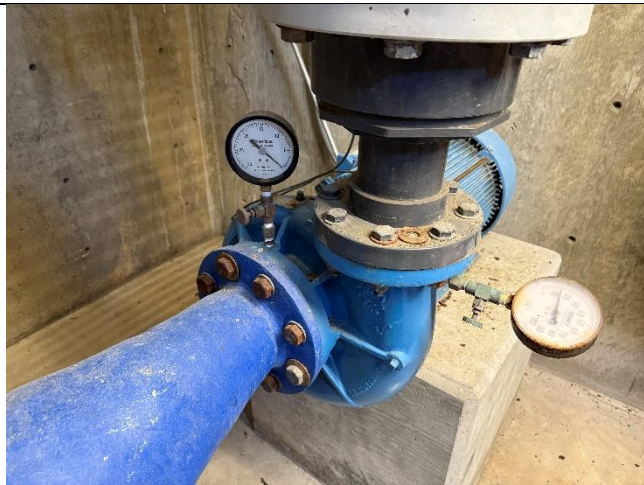
- a) The Leisure Pool is served by five (5) flooded-suction metallic Paco pumps. The recirculation pump is 25-horsepower. The pump driving the current channel and the pump that serves the kid slide and several other spray features are both 20-horsepower. The pump that serves the waterslide and the pump that serves the play structure and remaining spray features are both 15-horsepower. The impeller housing and motor housing for all pumps are in fair condition.
- b) All pumps have strainer baskets, suction and pressure gauges, and housekeeping pads. Some gauges are corroding but the rest are in fair working order.
- c) The recirculation pump has a VFD on the main pool mechanical level that is at the end of its useful life.
- d) Pumps are started by a large panel on the main mechanical room level. Contact selectors need to be frequently replaced according to operators.

- a) It is recommended to immediately install safety vacuum release systems (SVRS) on each of the four feature pumps due to their direct-suction connection to Leisure Pool SOFAs—refer to section “Main Drains (Leisure Pool).”
- b) Replace corroding pressure gauges when they fail.
- c) Replace recirculation pump VFD.
- d) It is recommended to consider adding VFDs for all feature pumps. The ability to adjust pump speed can provide energy savings and help with the longevity of motors and electrical infrastructure.

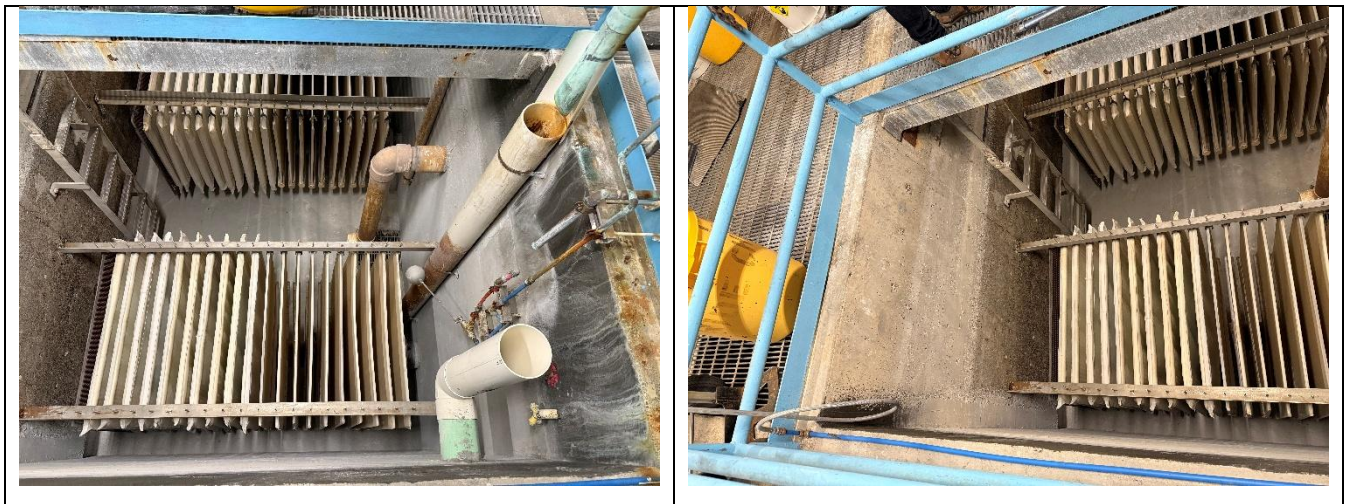
- a) The 50-Meter pool is filtered by a diatomaceous earth (DE) vacuum system that consists of media-coated filter laterals in a concrete tank upstream of the recirculation pump suction. The system is original to the pool and is dated but well-maintained. Operators reported consistently excellent water clarity in the pool prior to being drained.
- b) The concrete tank, filter frame, and laterals are in fair condition. Waterproofing in the tank interior was redone in recent years.
- c) Several bags of filter media was observed in the mechanical room. Operators described a method of applying new media to minimize DE release into atmosphere using modified barrels.

- a) It is recommended to consider replacing the 50-Meter Pool's DE filter system with a more modern system with equivalent performance for ease of operation. A properly designed regenerative media system could serve a pool this size with a single unit, with automatic bump cycles and media changes that are far less labor intensive. Replacing the DE system with a high-rate sand system would likely not be possible due to space constraints in the pool mechanical room.

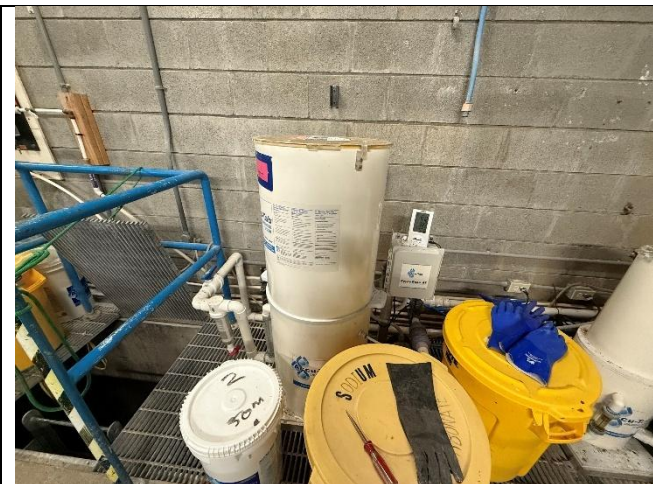
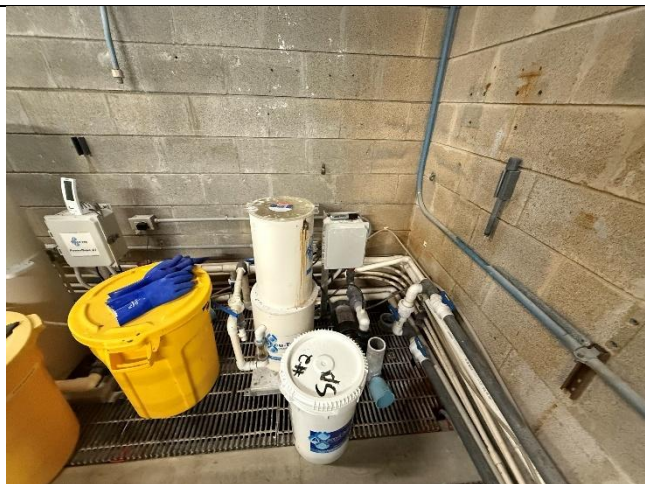
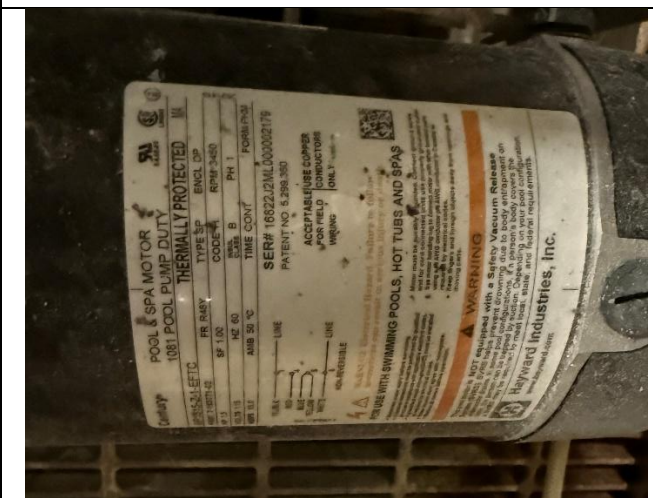
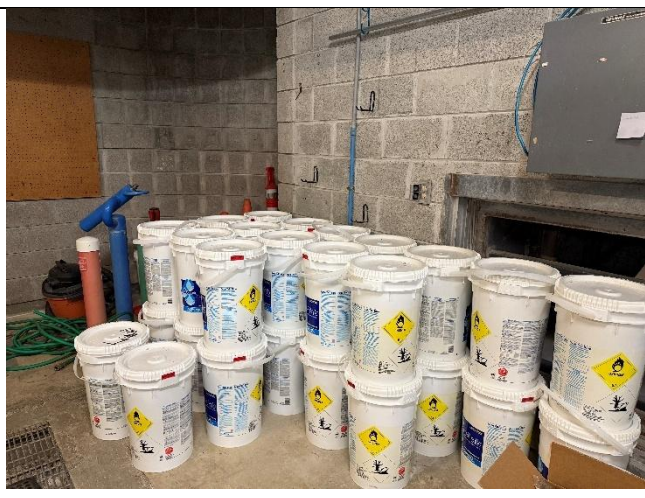
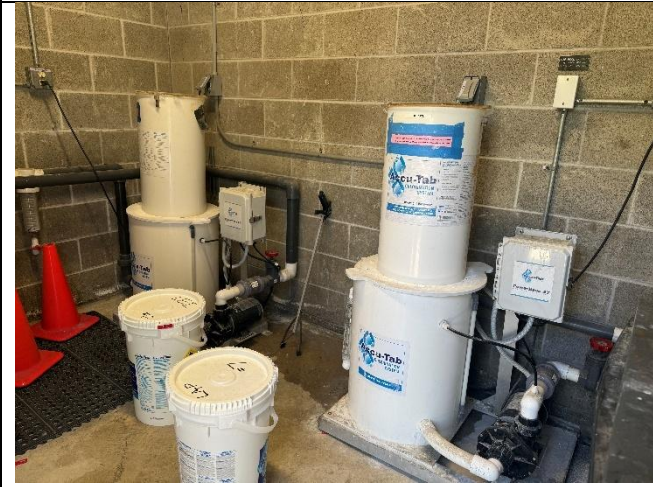
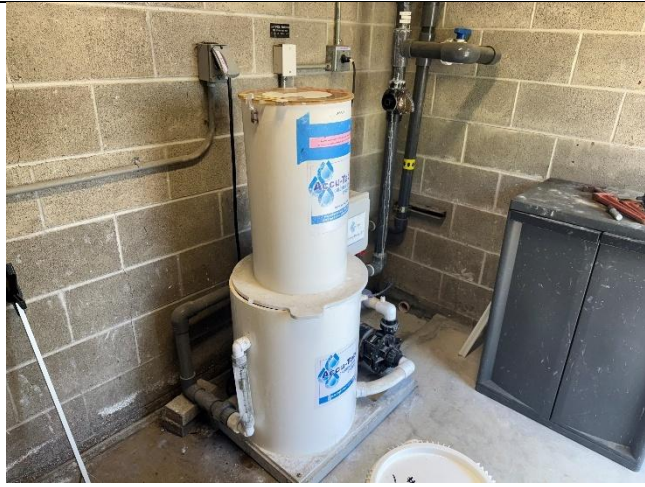
13. Chemical Controllers (All Pools)

- a) Chemical or Water Chemistry controllers are a requirement of current Oregon code for new construction or substantial alteration of aquatic facilities. Water chemistry for each pool is currently controlled by a Prominent DCM5 chemical controller. The four controllers vary greatly in age and condition.
- b) The 50-Meter Pool chemical controller is tied to the pool's calcium hypochlorite feed, CO₂ feed, and UV system. It is functional but aging and due for replacement.
- c) The Therapy Pool chemical controller is similarly in command of the pool's calcium hypochlorite feed, CO₂ feed, and UV system. Like the 50-Meter Pool's controller, it is functional but aging and due for replacement.
- d) The 25-Meter Pool and Leisure Pool chemical controllers are tied to each pool's calcium hypochlorite and CO₂ systems. They were replaced very recently and are in new condition.

- a) It is recommended to replace the chemical controllers for the 50-Meter Pool and Therapy Pool as both are at their end of life.

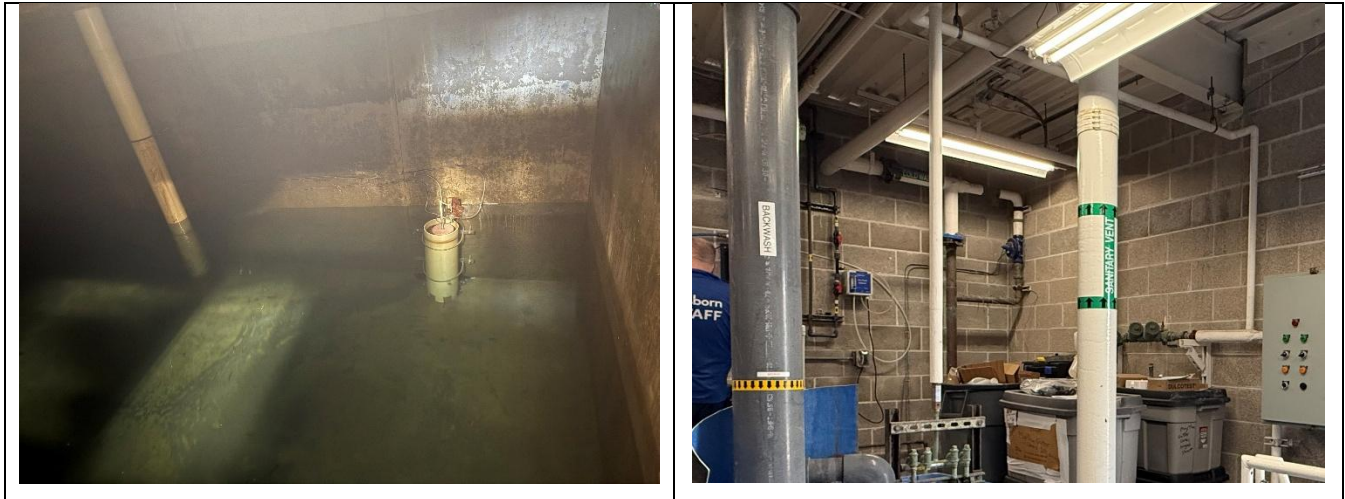
19. Indoor Pool Mechanical Room (Overall Conditions)

- a) The mechanical space serving the indoor pools is in good condition considering its age. The general condition of the space and equipment is greatly benefitted by the absence of muriatic acid in the pool systems.
- b) The mechanical space contains some electrical infrastructure from abandoned systems that no longer serve any function and would cause confusion to an operator who is not already familiar with the facility.

- a) Remove abandoned systems and organize conduit runs along the mechanical room walls and ceiling.
- b) Refer to architectural and structural assessments for additional recommendations.

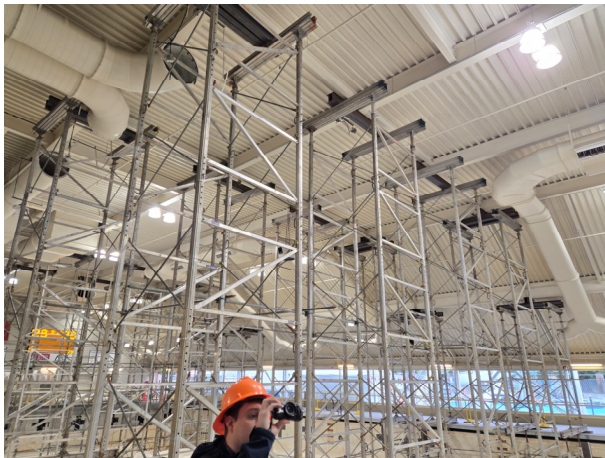
Existing natatorium roof shoring.

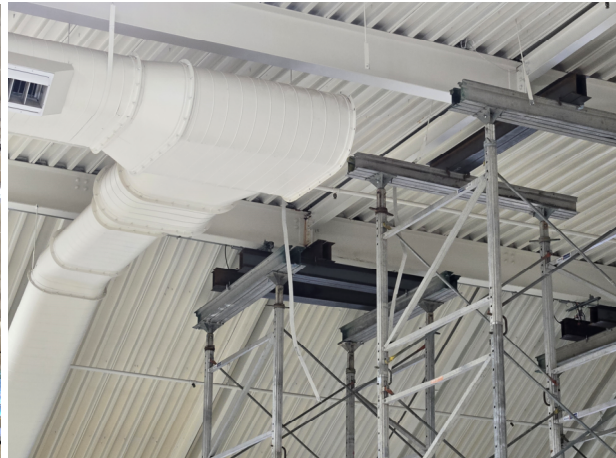
Deteriorated natatorium space truss joint.

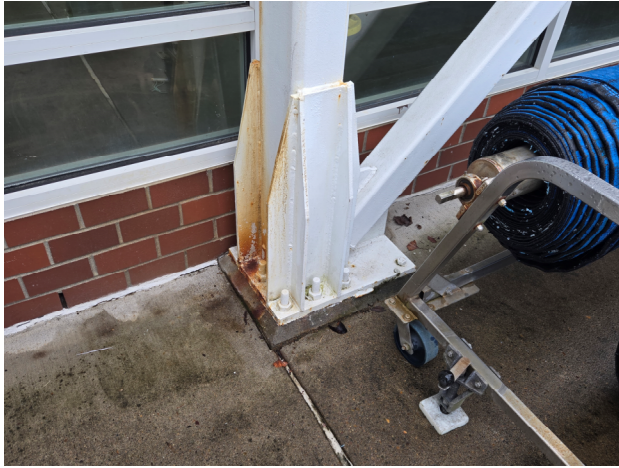
Surface rust at natatorium north wall braced frame column base.

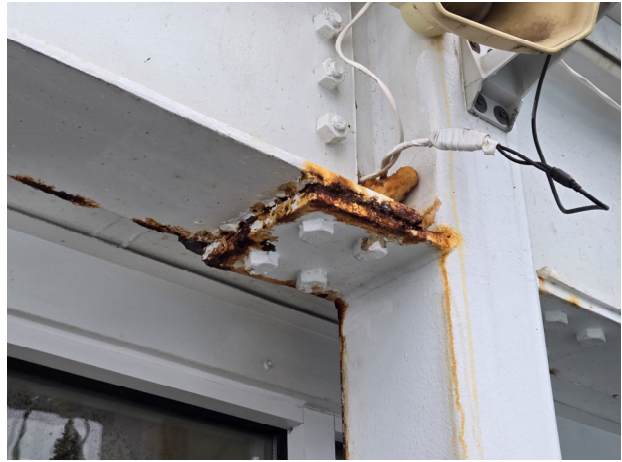
Natatorium north wall connection deterioration.

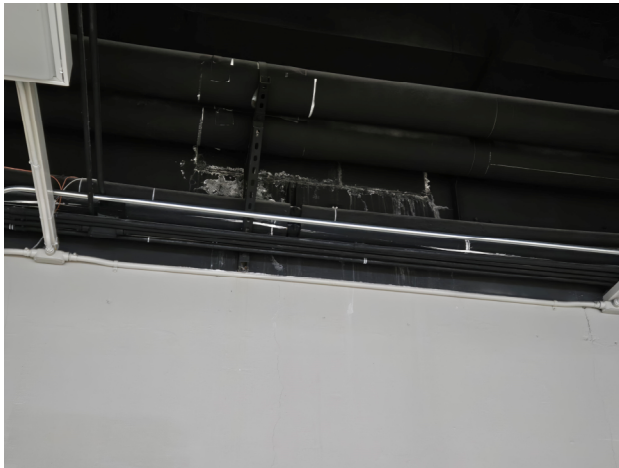
Evidence of interior moisture at natatorium south wall.

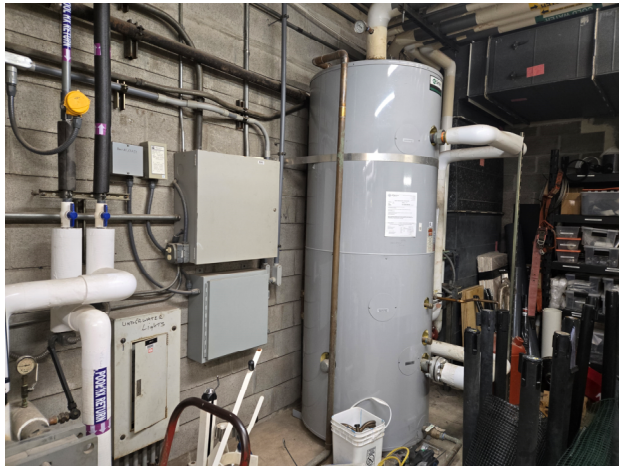
Partially braced tank.

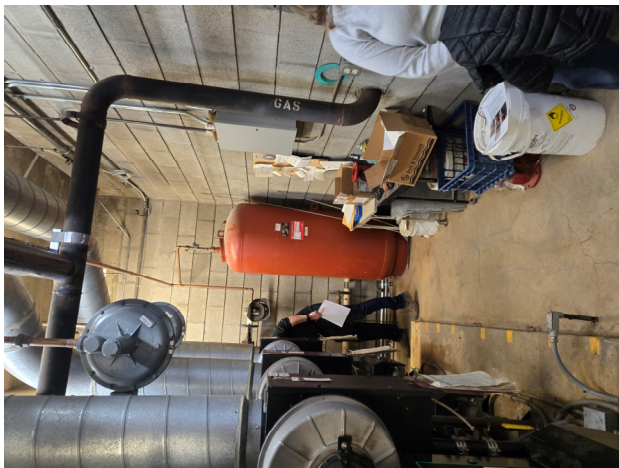
Unbraced tank in natatorium mechanical room (photo rotated).

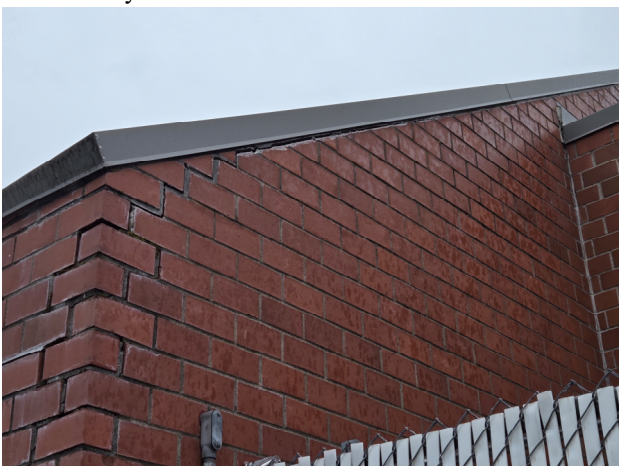
Northwest parapet veneer damage.

- Sealing the base of each HSS penetration through all roof assemblies is key.
3. Repair damage brick cladding, in particular along the North Elevation

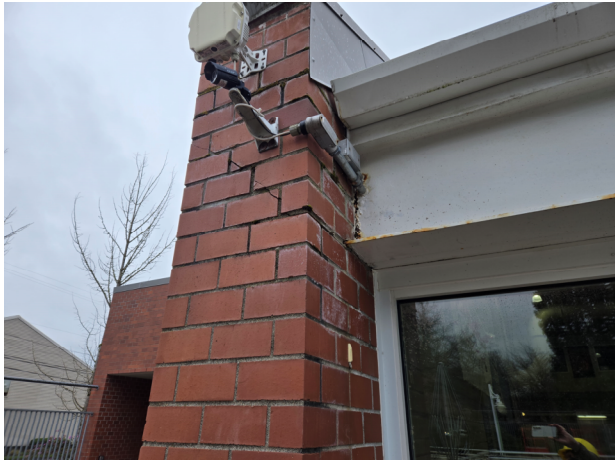
Northeast parapet veneer damage.

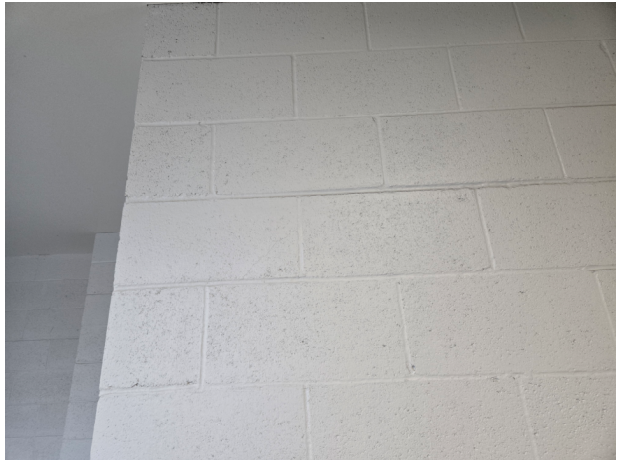
Horizontal crack in non-structural CMU wall.

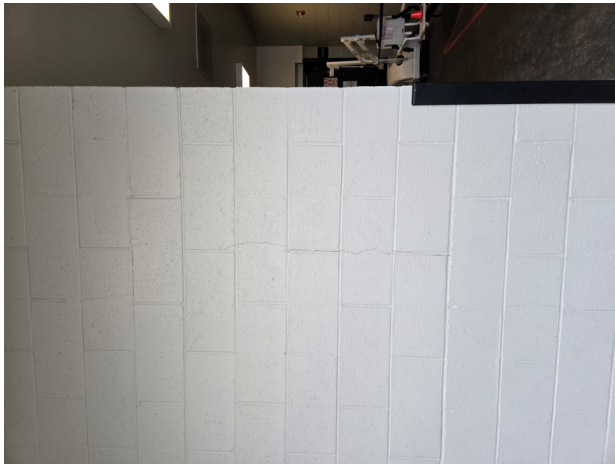
Vertical CMU crack (photo rotated).

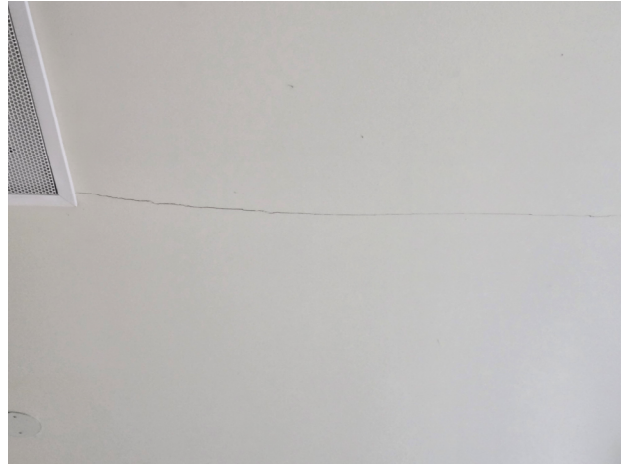
Ceiling Wallboard crack.

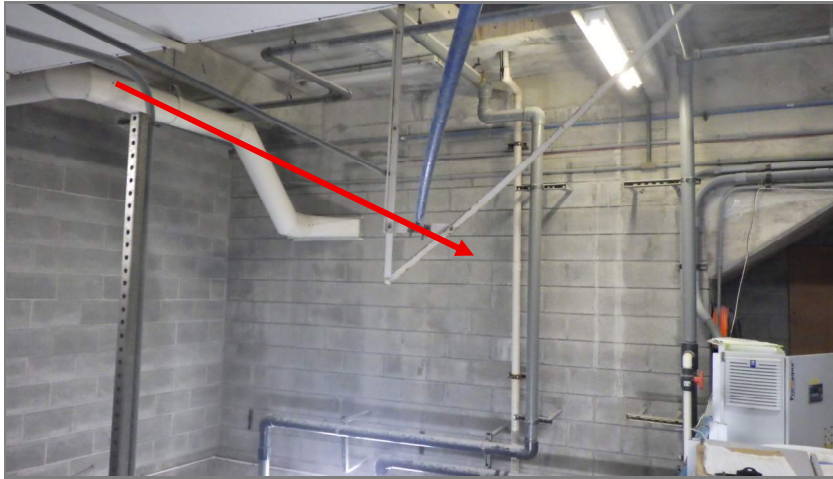
Figure 4.2

Interior pump roof with streaks showing on exposed CMU walls.

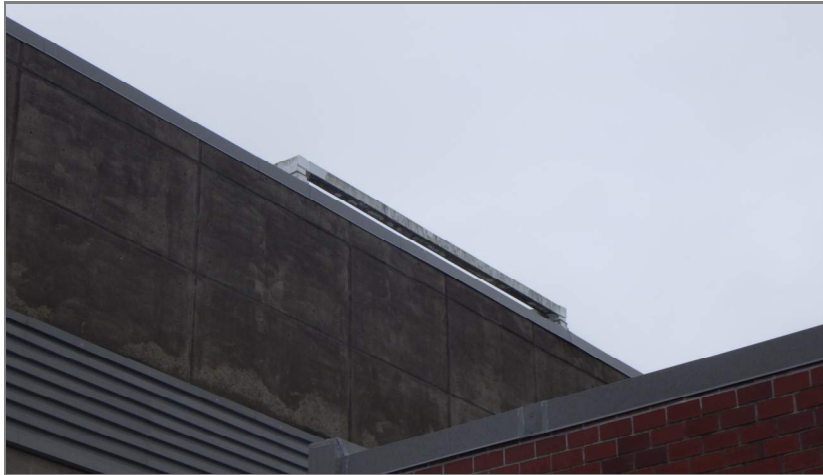
Figure 4.15

Water stains and inconsistent texture on the exterior wall.

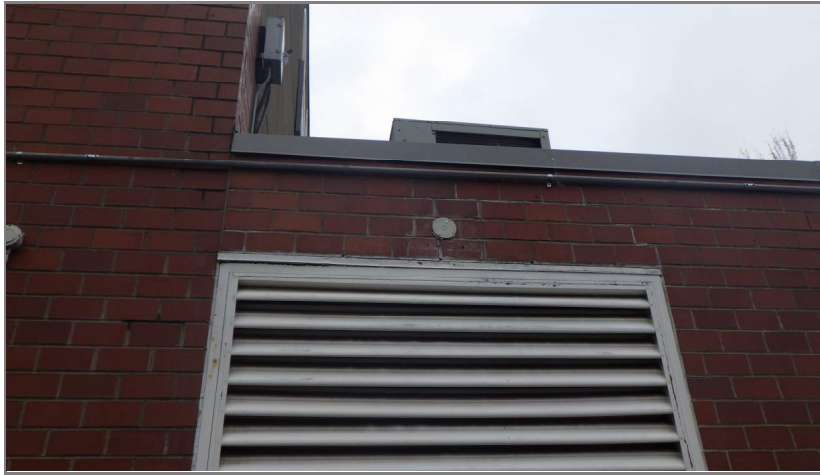
Figure 4.17

Typically, most penetrations had a sheet metal flashing at the head, but the perimeter sealant was noted to be hardened and weathered.

5. Full sealant replacement around all window, doors and penetrations at all exterior walls.

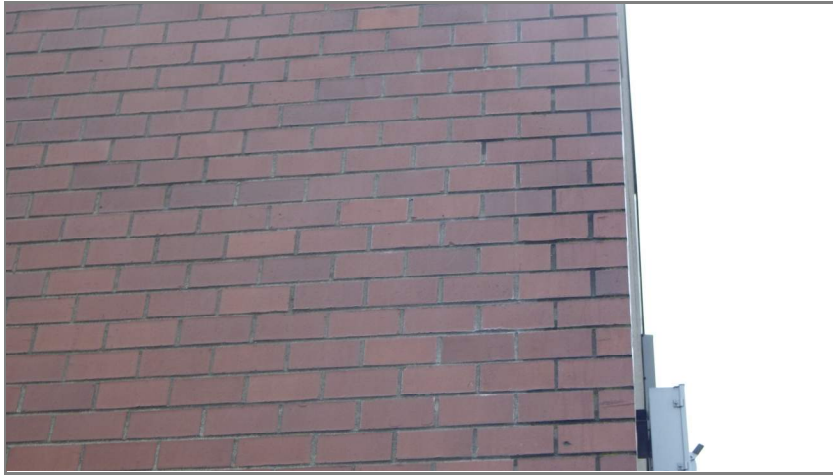
Figure 4.20

Outside corners were noticeably darkened with moss build up within mortar joints.

1. Replace all windows with new storefront style aluminum frame similar to existing
2. Tuck and repointing of all brick cladding walls including brick sealer
3. Exterior insulate and over-clad all exterior concrete pre-cast concrete walls

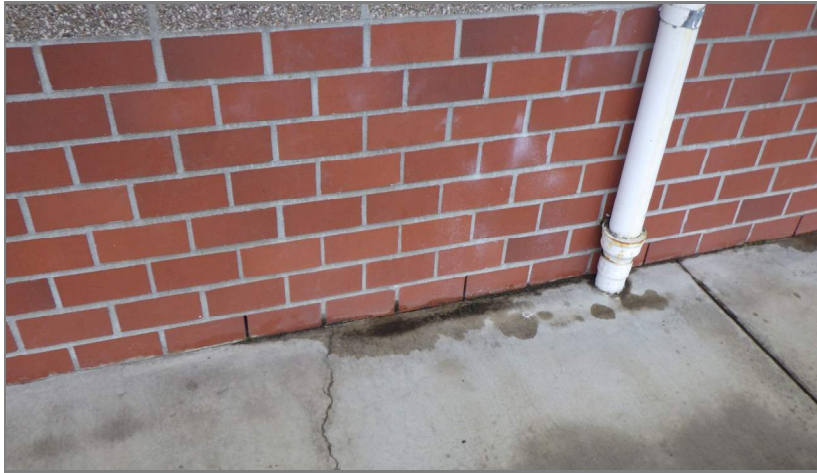
Figure 4.23

At certain areas, water was pooling along the base of brick clad walls on top of the hardscape. It was unclear if the water is from the adjacent downspout or from another source.

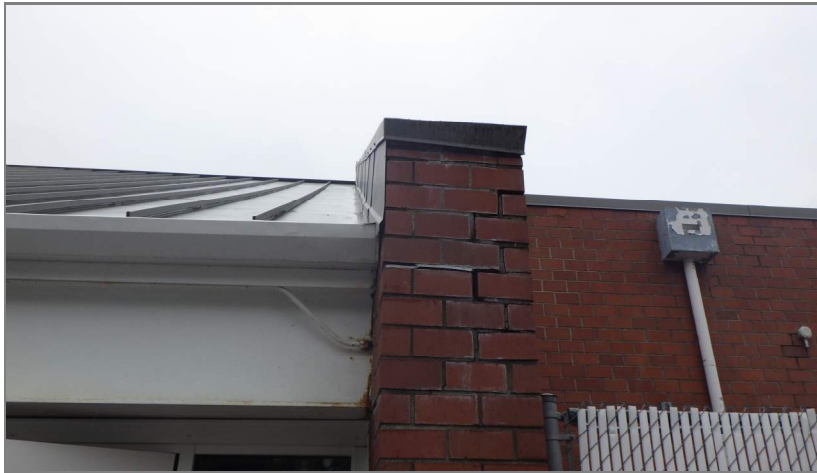
Figure 4.24

Area of significant damage to the brick cladding and in need of repair.

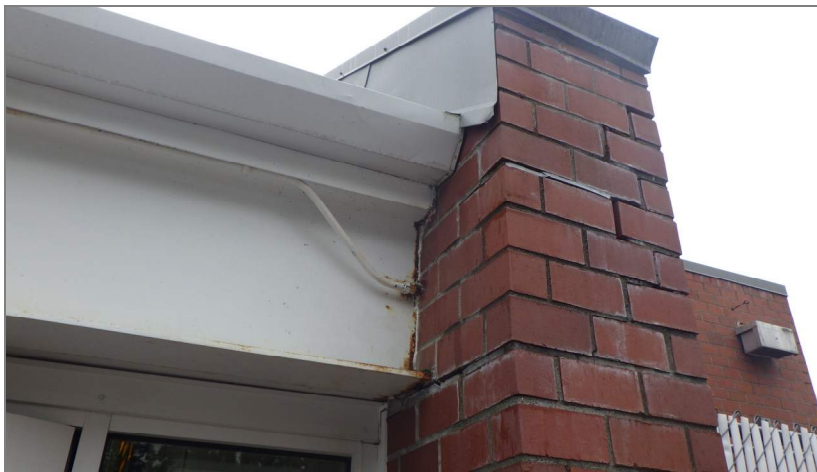
Figure 4.25

Alternate angle of the damaged mortar and brick.

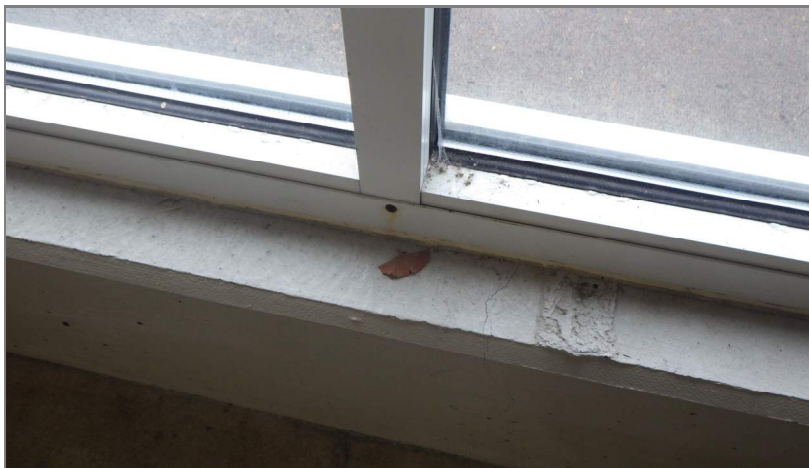
Figure 4.29

Staining at windowsill and rusted fastener at back angle.

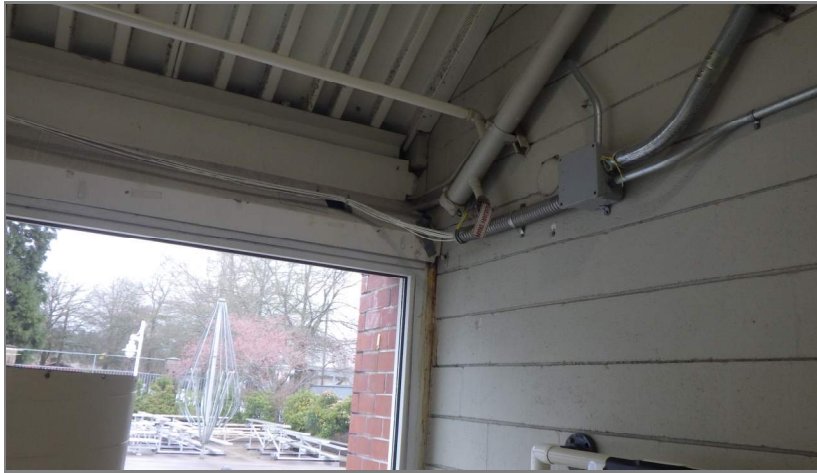
Figure 4.30

Observed leak around the window to CMU transition at the northeast corner.

4. Repair known leaking windows (south office, north pool ribbon window). Perform a full maintenance scope for all windows, including replace all broken, damaged or missing gaskets, seals and window components.

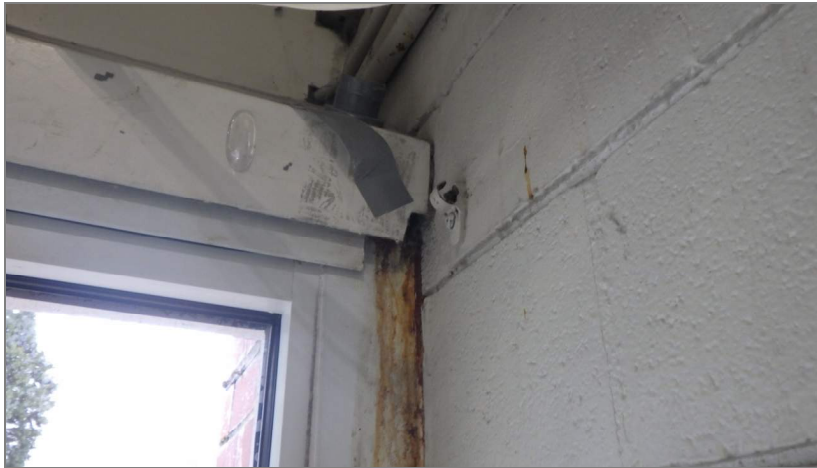
Figure 4.31

Close up of water stains and leak around the window head.

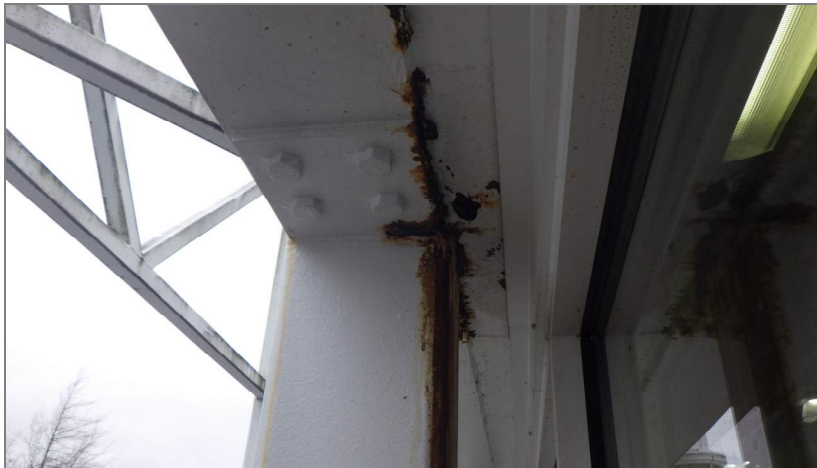
Figure 4.32

Heavy rust stains at steel head above storefront window.

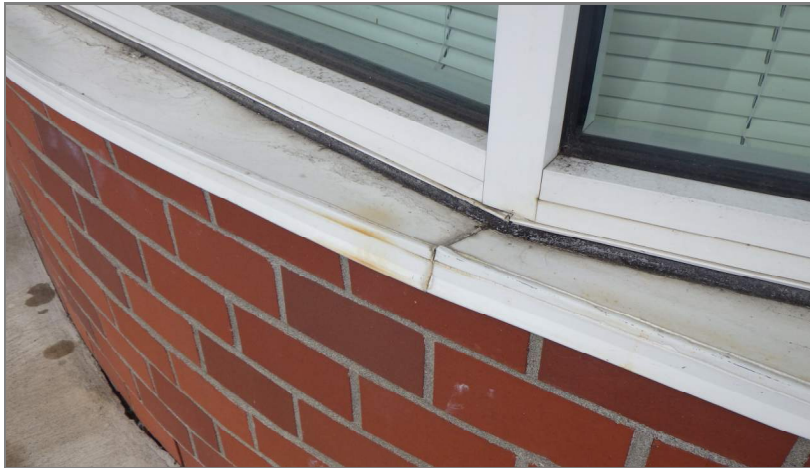
Figure 4.34

Windowsill metal flashing bent and backsloped.
