City of Corvallis
Corvallis School District

Osborn Aquatic Center Facilities Assessment

Scott
Edwards
Architecture

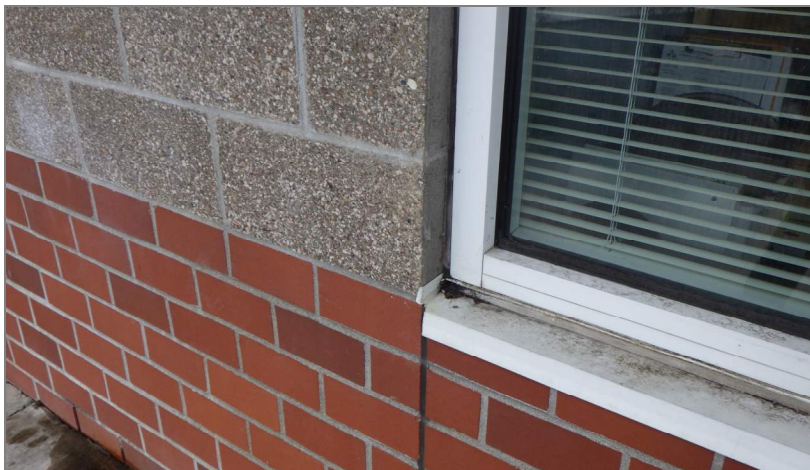
Figure 4.35

Most build up at inside corner of metal sill flashing and failed sealant between window frame and CMU wall.

5. Full sealant replacement around all window, doors and penetrations at all exterior walls.

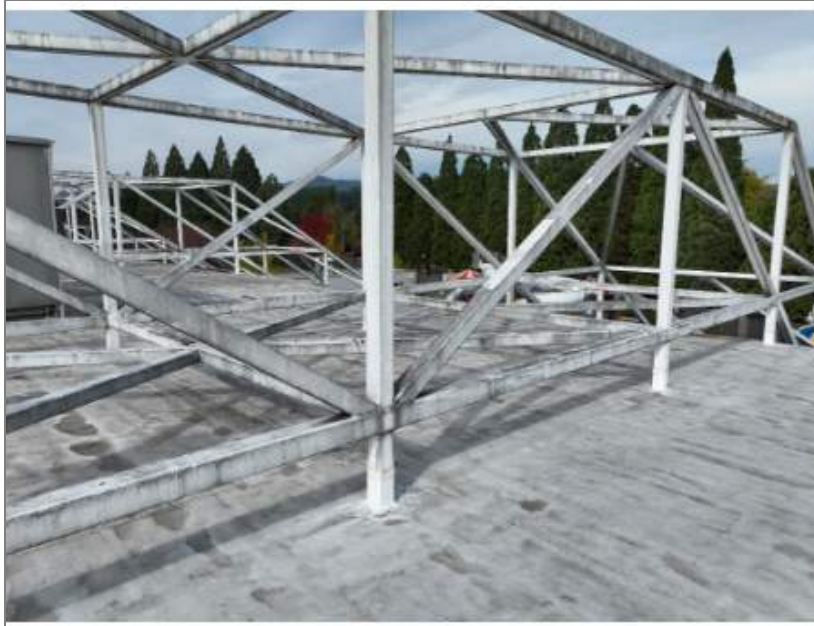
Figure 4.38

Based on a review of the documents provided, it is unclear to what extent the noted structural deterioration extends to all locations, and how much of the deterioration is a result of poor detailing and vapor control around the base of each HSS penetration further exasperating the thermal bridge impact leading to higher levels of condensation or a result of active leaks. RDH recommends additional investigation should occur to confirm if the similar HSS penetrations in the standing seam steep sloped roofs are faring in a similar manner.

Example of the HSS structure over and penetrating the low slope roof assembly.

- Sealing the base of each HSS penetration through all roof assemblies is key.
3. Repair damage brick cladding, in particular along the North Elevation

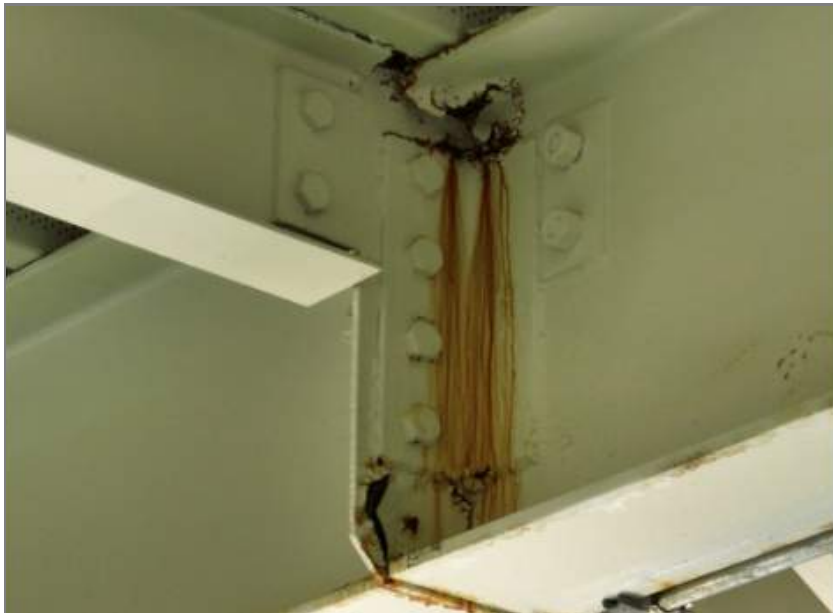
Figure 4.39

Interior view of rust stains directly below a HSS post penetration.

1. Repair all noted deficiencies in the steel roof structure per Miller Engineering's drawings:
 - Thermal Isolation Bearing Pad is key to reducing condensation risk which is primary the cause of the current deterioration

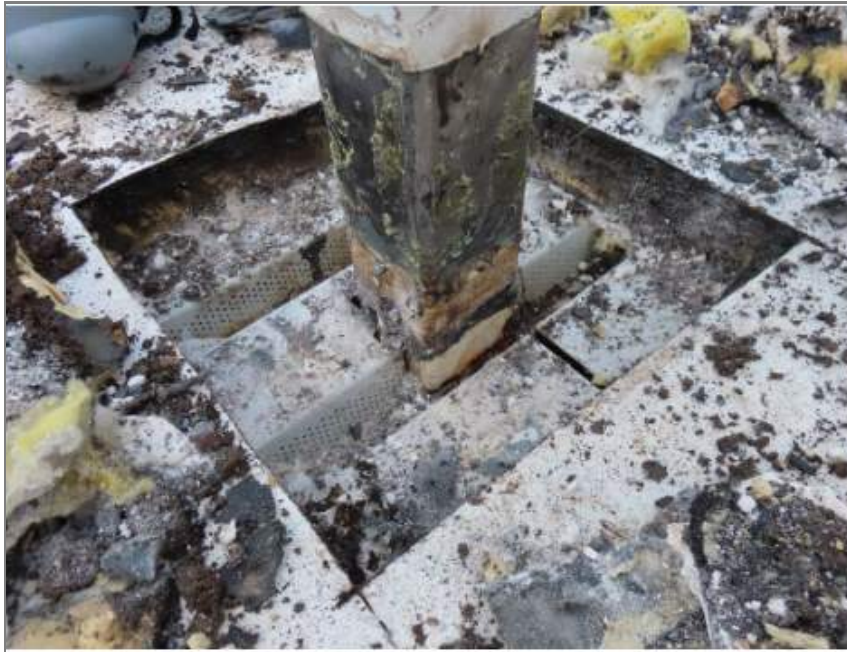
Figure 4.40

Second roof cut within the low sloped roof area which shows the single ply PVC overlayed over the existing BUR roofing system. It is not clear how the vapor retarder in the roof assembly was tied into the HSS.

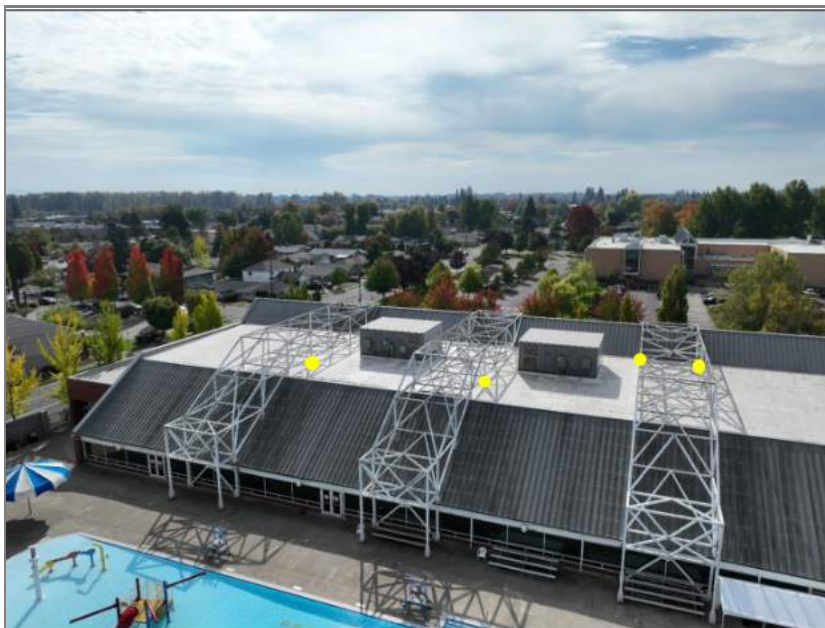
Figure 4.41

In addition to the low sloped roof areas, there are two steep sloped roof sections that are covered with a standing seam metal panel. It is unknown if there are any issues of leaks with this roof assembly or if there have been any records of repairs or maintenance.

Based on a review of CSF's report there were no openings or investigations or comments about how the existing or roof overlay systems integrated with the metal steep sloped roofs but are included to be replaced in their scope of work dated February 17, 2025. RDH does note that the same HSS penetrations as noted to be deficient in the low sloped roofs are present within the steep sloped roofs, however, there does not appear to be any investigation or confirmation on their current condition. Additional investigation should be undertaken to verify their current condition and need to be replaced.

Steep sloped metal roofs are covered with standing seam metal panel.

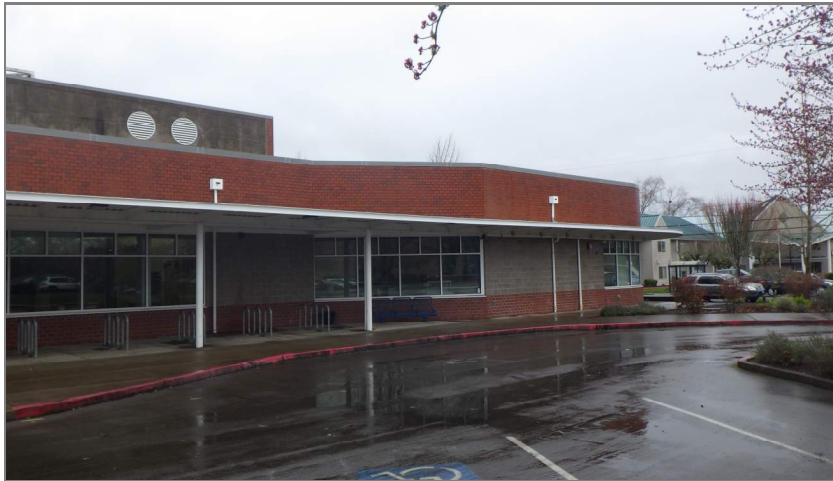
Figure 4.42

The third roof assembly is a metal steel canopy that wraps around the south elevation over the front entrance and offices. The metal roof is entirely exterior, sloped away from the building and drains into a gutter and downspout system. It is unknown if there is a membrane on top of the roof, but noted on the 1999 plans, sheet A4.1, there is a “special coating” which was intended to be applied over this entire roof section. While on site, RDH notes that there were multiple areas where the canopy roof was draining water back to the building, along the brick façade and potentially compromising the window system below, notably the one window leak as described in the window section above. The field of the canopy appears to be shedding water away from the building as intended.

Metal canopy roof on south elevation.

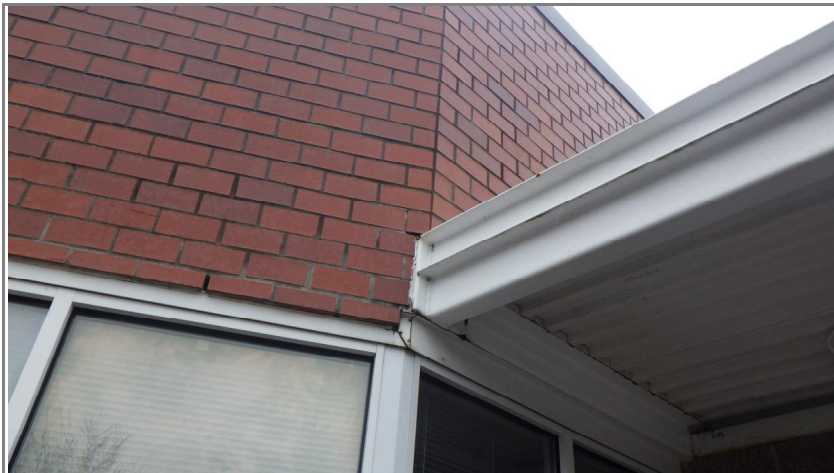
Figure 4.44

Termination saddle transition of metal roof to brick veneer cladding,

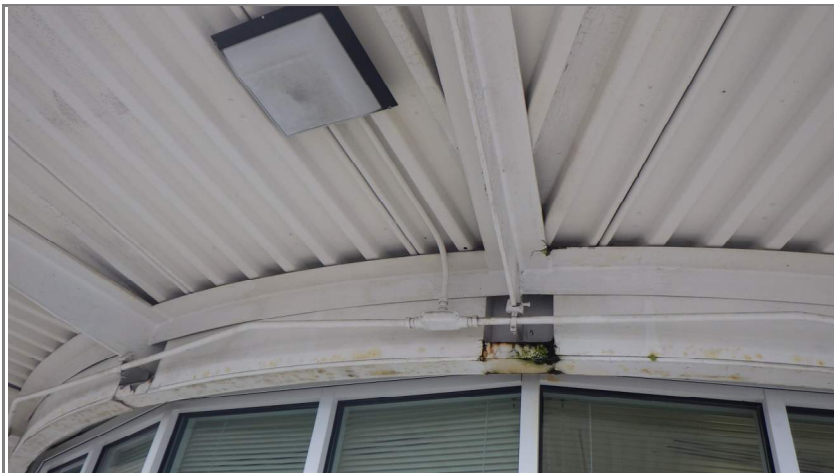
Figure 4.45

Signs of roof leaks in canopy directly over window assembly.

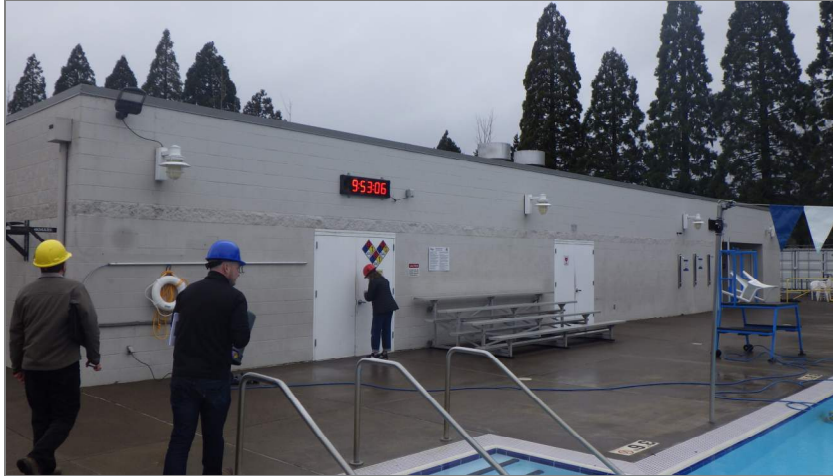
Figure 4.46

A second auxiliary building was added as part of the 1999 renovation. This is an unconditioned pump and maintenance building. The exterior walls are painted CMU block with single and double metal swing doors with metal head flashing similar to the primary building. The roof is a low sloped single ply membrane overlay over the original BUR roof similar to the main building. Minor staining and cracking was observed at select areas on the exterior walls.

Overall view of the auxiliary maintenance building.

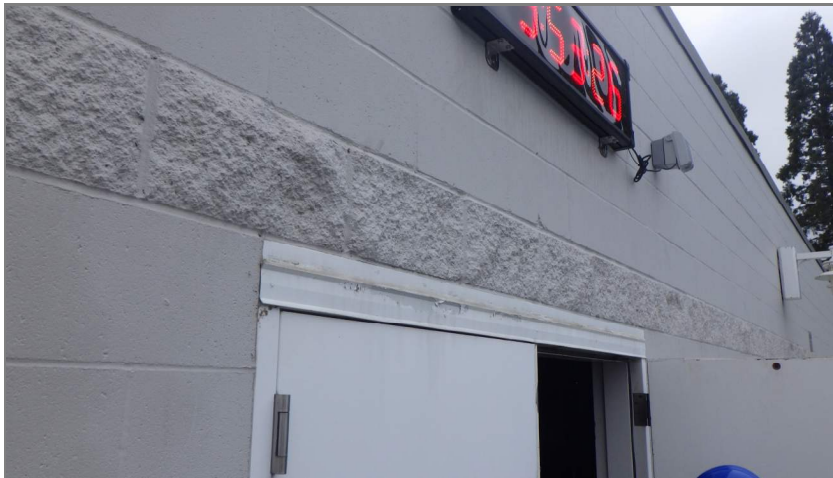
Figure 4.47

Typical head detailing above metal doors.

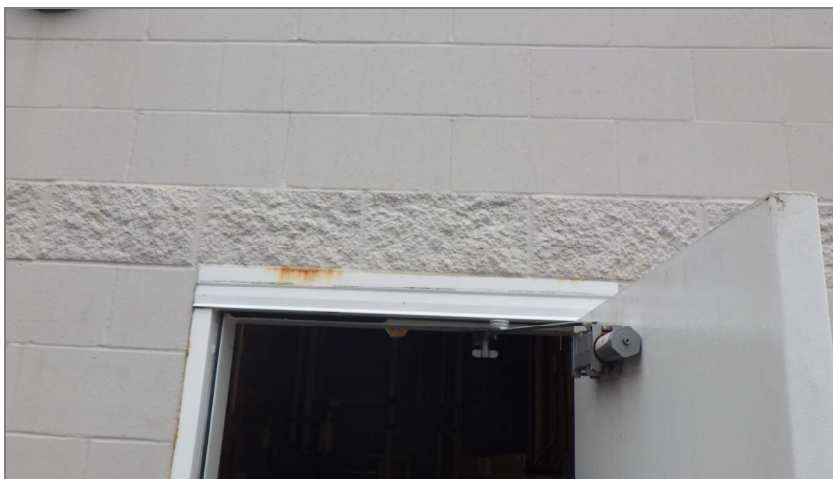
Figure 4.48

Staining above metal head flashing over swing door.

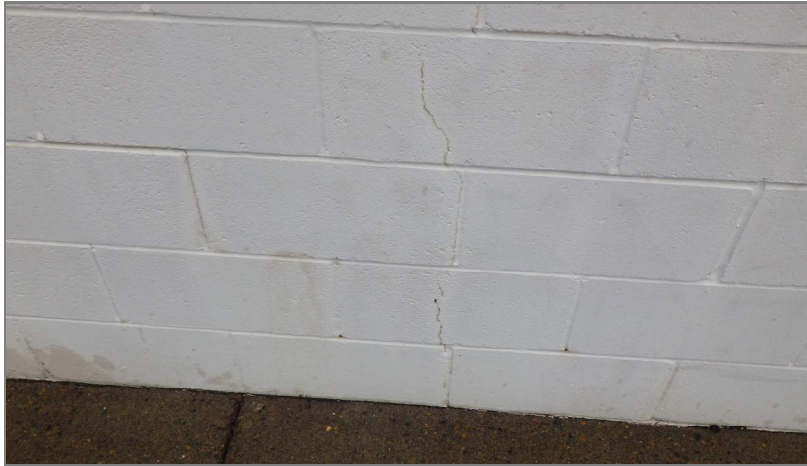
Figure 4.50

Minor cracks in the exterior walls.

Following the repairs to the roofing systems, the next highest priority would be to perform repairs to the brick veneer walls that were noted to be damaged. Additionally, RDH recommends a full-sealant replacement maintenance project at all control joints, penetrations, windows and doors and transitions.

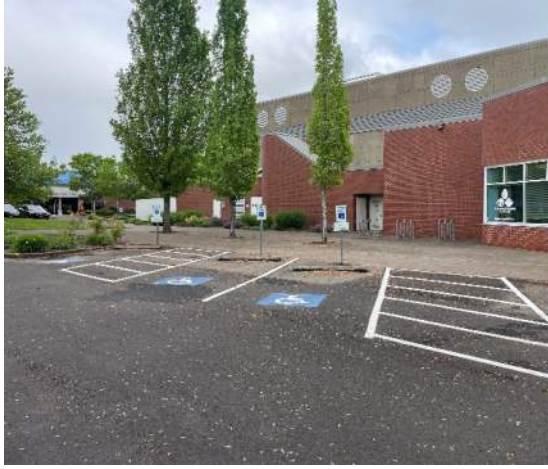
Accessible Aisle Slopes	No	Portions of the aisle exceed 2.0% slope. 2.3% running slope was observed adjacent to the face of curb.
Accessible Aisle Striping	Not current	Existing aisle striping is not current with the 2023 OTC standards and is missing the "NO PARKING" lettering in the aisle.
Accessible Signage	No	Signs are mounted at incorrect height and signage location is outdated. See Exhibit C, Figure 5 for current standards.

Photo 1: Existing accessible stalls, aisles, and signage (See Routes 4 & 5 for more detail)

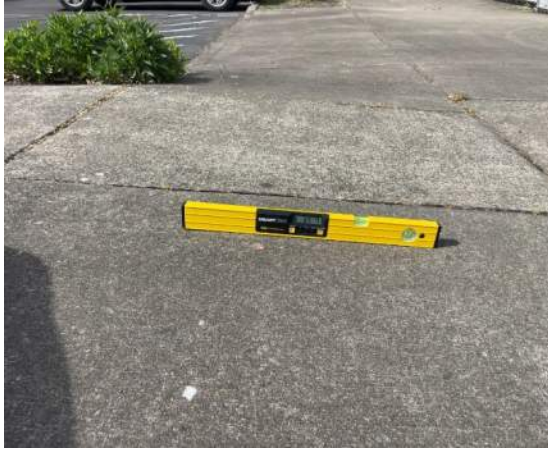
Item	Compliant	Notes
Accessible Route Width	Yes	Minimum width provided is adequate. Provided with varies from 11' to 16'
Accessible Route Cross Slope	Yes	No portions of the route exceed 2.0% cross slope.
Accessible Route Longitudinal Slope	No	Two ramped longitudinal slopes exceeded 5.0% and do not provide handrails. 8.1% and 8.4% running slopes were observed on approach from the landing. Running slopes do not meet ADA standards. See photo 3.
Holes > 0.25"	No	Gaps = 1" noted between panels in the accessible route. See photo 4.
Lips > 0.25"	Yes	None observed.
Protrusions into accessible route	Yes	None observed.
Slip surfaces	Yes	Water Valve lid in route. Minimum route width is met to maintain clear width minimums

Photo 3: Route 1 East Ramp longitudinal approach not compliant with ADA Standards

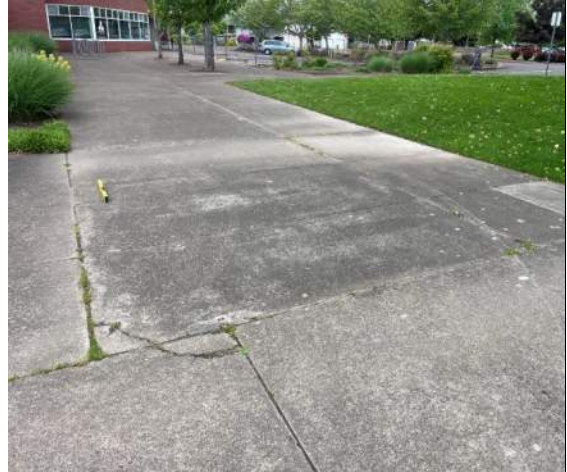
Photo 4: Longitudinal cracks and gaps present in Route 1

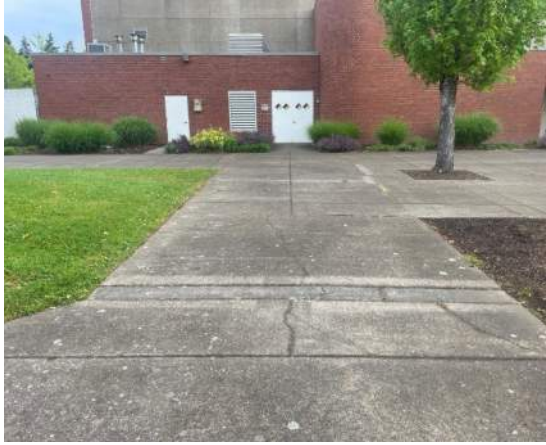
Photo 5: Longitudinal cracks and gaps present in Route 2

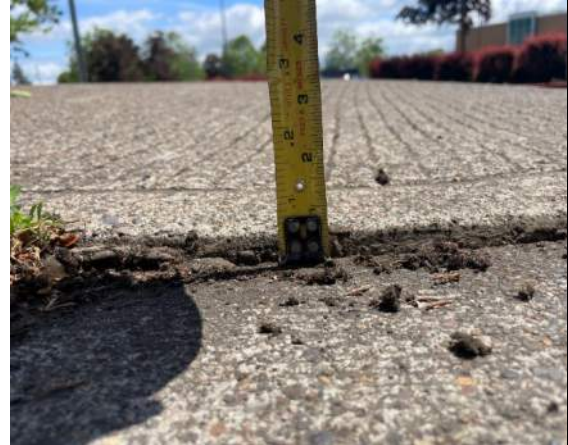
Photo 6: Route 2 East Ramp Run not compliant with ADA Standards (Lip > 0.25")

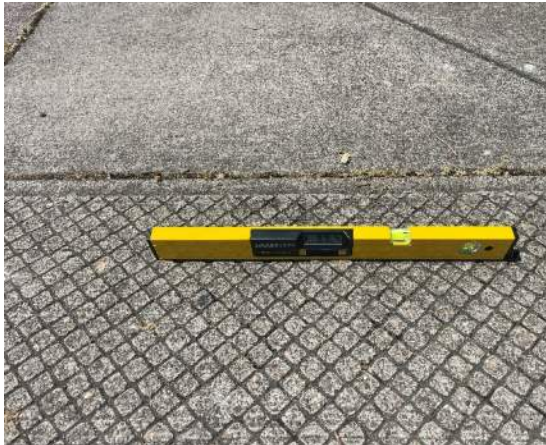
Item	Compliant	Notes
Accessible Route Width	Yes	Minimum width provided is adequate. The provided width is approximately 9'.
Accessible Route Cross Slope	No	Portions of the route exceed 2.0% cross slope. Cross slopes ranging from 2.4% to 6.1% were observed east of the ramp along the sidewalk to the main entry of the building.
Accessible Route Longitudinal Slope	Yes	No ramped longitudinal slopes exceeding 5.0% were observed. See 'Ramps' below. See photo 8 for route.
Holes > 0.25"	Yes	Gaps = 1" noted between panels in the accessible route. See photo 5.
Lips > 0.25"	No	Lip > 0.25" observed on the East Ramp. See photo 6.
Protrusions into accessible route	Yes	Signs installed on the sidewalk maintained clear width minimums.
Slip surfaces	Yes	Storm Sewer cleanout lid located in route between ramps. However, the minimum route width required is available adjacent to manhole lid.
Ramps	No	West Ramp cross slope at the landing is 3.5%. East Ramp cross slope at the landing is 5.1%. Cross slopes cannot exceed 2.0% at landing locations. West and East Ramp Running slopes exceed 8.33%. 11.0% and 8.5% running slopes were observed respectively. No detectable warning surfaces are present on either ramp. See photo 7.

Photo 7: Route 2 East Ramp Run not compliant with ADA Standards (Ramp Run > 8.3%)

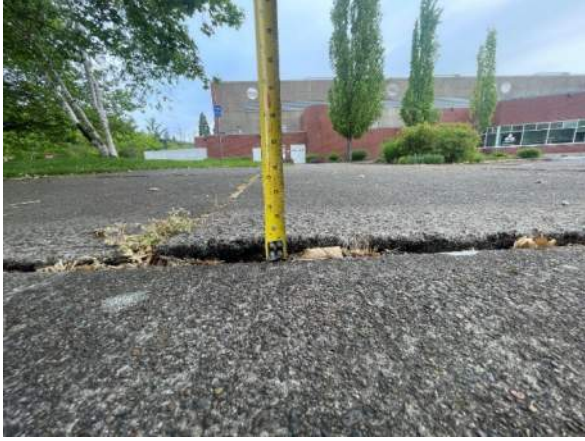
Lips > 0.25"	No	Lip = 0.5" in accessible route between panels. See photo 9.
Protrusions into accessible route	Yes	None observed.
Slip surfaces	Yes	None observed.
Ramps	No	South and North ramp widths are greater than 4.5'. Running slopes at ramps cannot exceed 8.33%. One running slope on the north ramp was observed as 8.7%. Cross slope cannot exceed 2.0%. Max cross slope observed was 2.1%. One landing slope on the north ramp was observed as 2.5%. No detectable warning surfaces are present on either ramp. See photo 10 for route.

Photo 9: Route 3 Access Route Lip = 0.5"

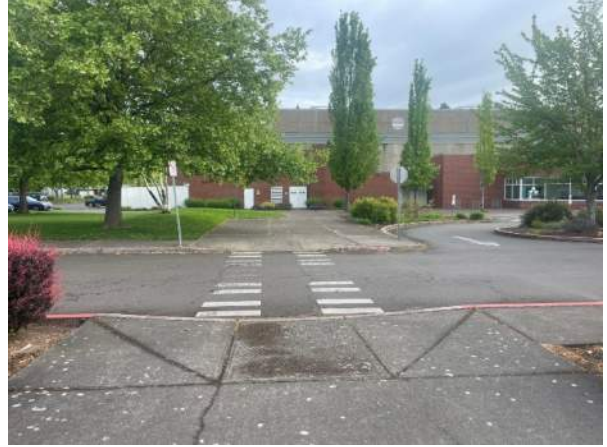
Photo 10: Route 3 South through North Ramp

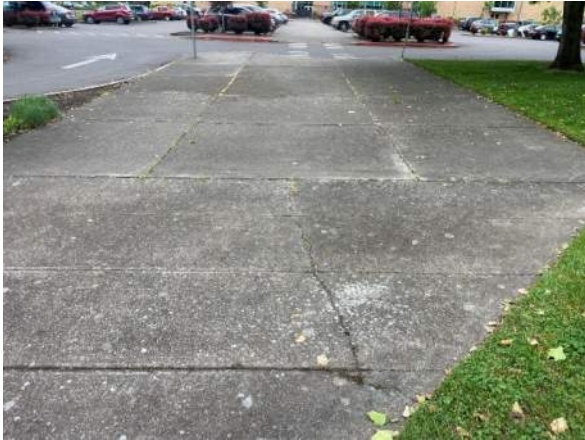
Item	Compliant	Notes
Accessible Route Width	Yes	Minimum width provided is adequate. Provided width is approximately 9'. Accessible route is the same as Route 2 to the main entry.
Accessible Route Cross Slope	No	Portions of the route exceed 2.0% cross slope. Cross slopes ranging from 2.4% to 3.3% were observed along the access route to the main entry of the building.
Accessible Route Longitudinal Slope	Yes	No ramped longitudinal slopes exceeding 5.0% were observed.
Holes > 0.25"	No	Gaps = 1" and Longitudinal cracks noted between panels in the accessible route. See photo 11.

Photo 11: Longitudinal Crack in Route 3

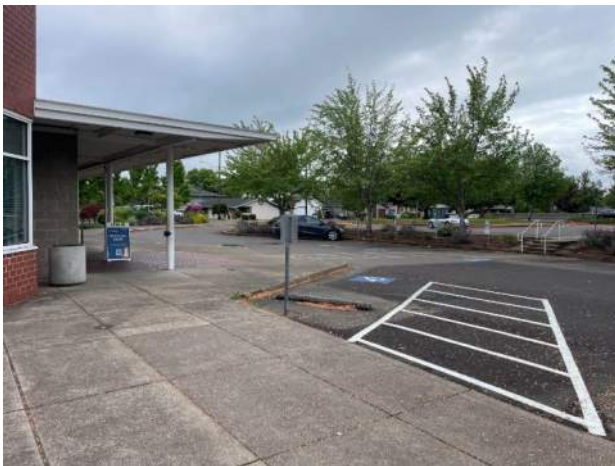
Item	Compliant	Notes
Accessible Route Width	No	Minimum width is a pathway from a stairwell. Provided width is approximately 6.2'. Aisles must be at least 6' wide, but since the aisle is adjacent to a 'Van-Accessible' space, the access aisle shall be at least 8' wide (OTC). See photo 14 for route.
Accessible Route Cross Slope	Yes	Cross slopes do not exceed 2.0% and are adequate.
Accessible Route Longitudinal Slope	Yes	No longitudinal slopes exceeding 5.0% were observed in the access route other than at the ramp. See 'Ramps' below.
Holes > 0.25"	Yes	None observed.
Lips > 0.25"	Yes	None observed.
Protrusions into accessible route	Yes	None observed.
Slip surfaces	Yes	Brick pavers approx. 20'W x 16'L are present at the main entrance to the building, but do not appear to present a slip hazard. See photo 15.
Ramps	No	Ramp run slopes are less than 8.3%. Max running slope of 6.3% was observed. Cross slopes are less than 2.0%. Max cross slope of 0.8% was observed. No detectable warning surface is present at the ramp. Access route is 8'W at ramp throat.

Photo 14: Route 6 Access Stall and Aisle to Main Entry

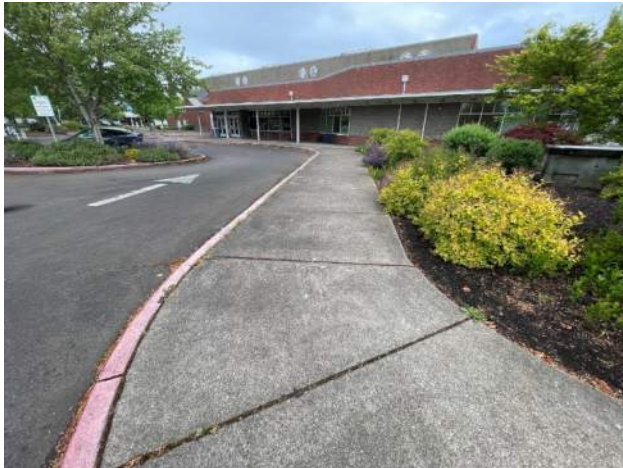
Item	Compliant	Notes
Accessible Route Width	Yes	Minimum width provided is adequate. Provided width is approximately 8'.
Accessible Route Cross Slope	No	Portions of the route exceed 2.0% cross slope. Cross slopes ranging from 2.5% to 4.2% were observed along southeast access to the main entry of the building.
Accessible Route Longitudinal Slope	Yes	No ramped longitudinal slopes exceeding 5.0% were observed.
Holes > 0.25"	No	Gaps = 1" present in the accessible route between panels.
Lips > 0.25"	Yes	None observed.
Protrusions into accessible route	Yes	Existing Fire Riser observed in access route, but a clear width minimum of 4' or greater is present. See photos 16 & 17 for route.
Slip surfaces	Yes	None observed.
Ramps	No	East Ramp at crosswalk exceeds 2.0% cross slope at face of curb. 2.6% cross slope was observed. No detectable warning surface is present. See photo 18 for reference.

Photo 18: Crosswalk connection to Route 7

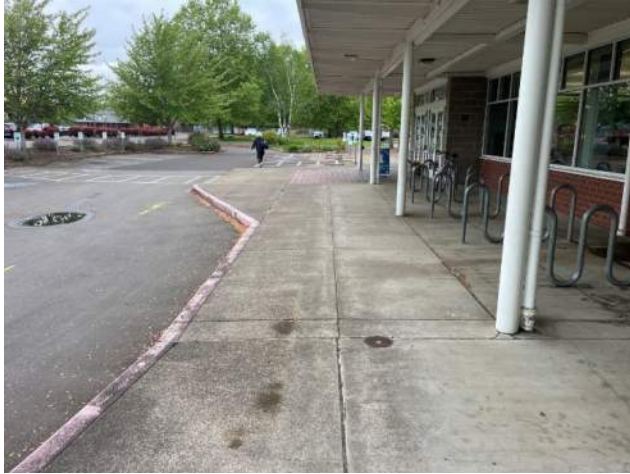
Photo 20: Route 8 Storm Sewer Lid and Cleanouts
