Facilities Assessment Report Corvallis School District

Submitted to Corvallis School District
by DOWA - IBI Group Architects, Inc.
February 2014

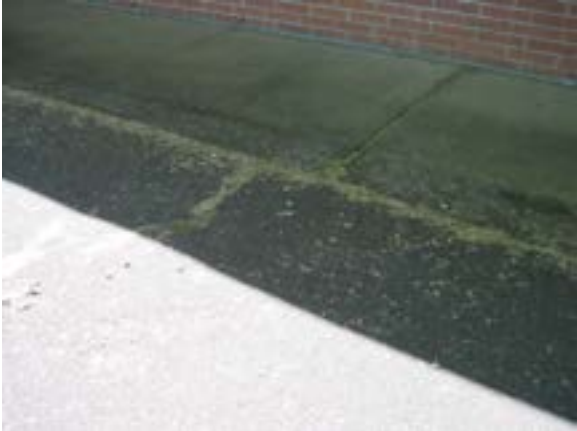
Figure A10.2.a - Ridge in slab/sidewalk

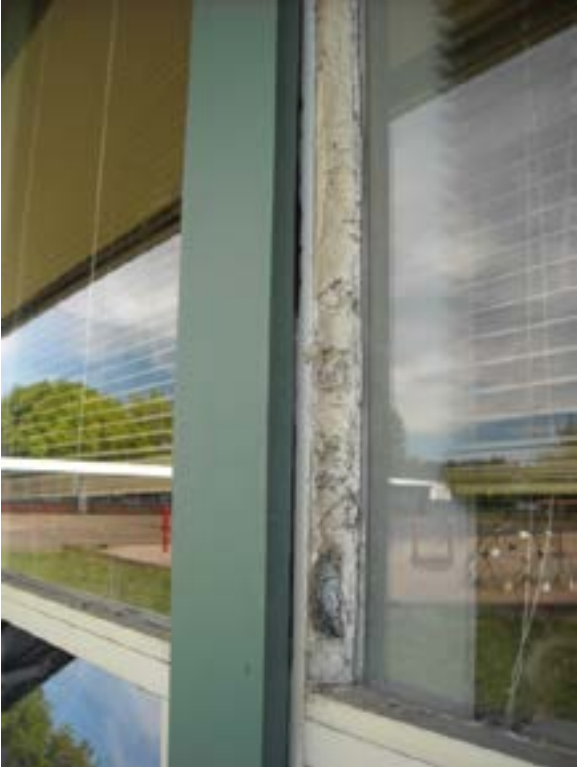
Figure A20.3 - Sealant Issues

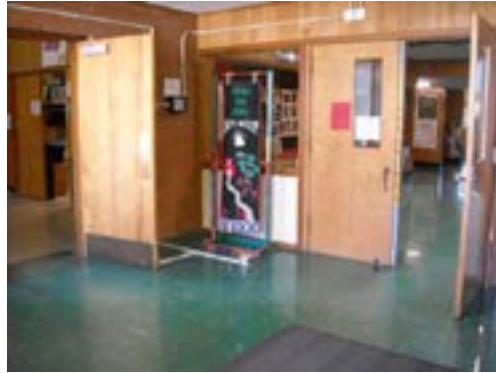
Figure B30.5 – Lack of visibility

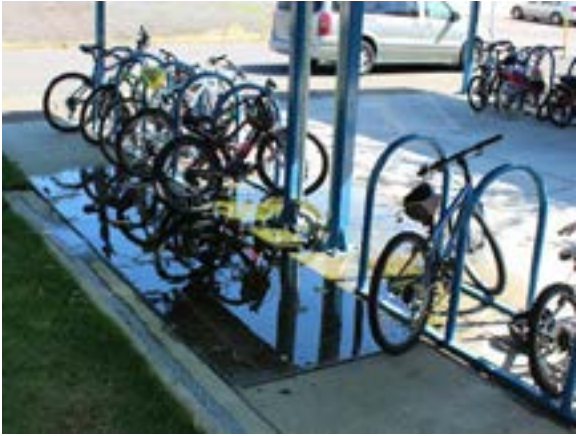
Figure C10.5 – Storm drain blockage

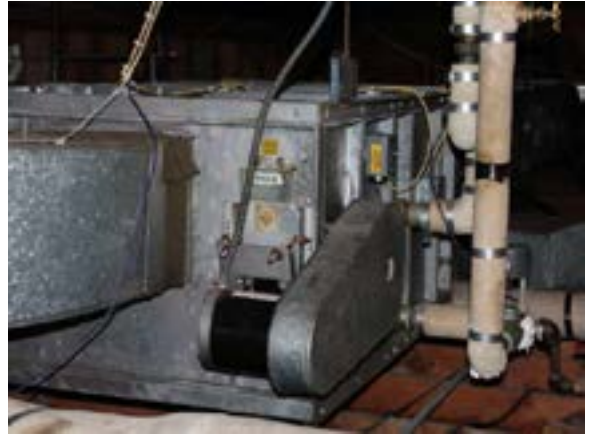
Figure C20.1.a – Forced air equipment

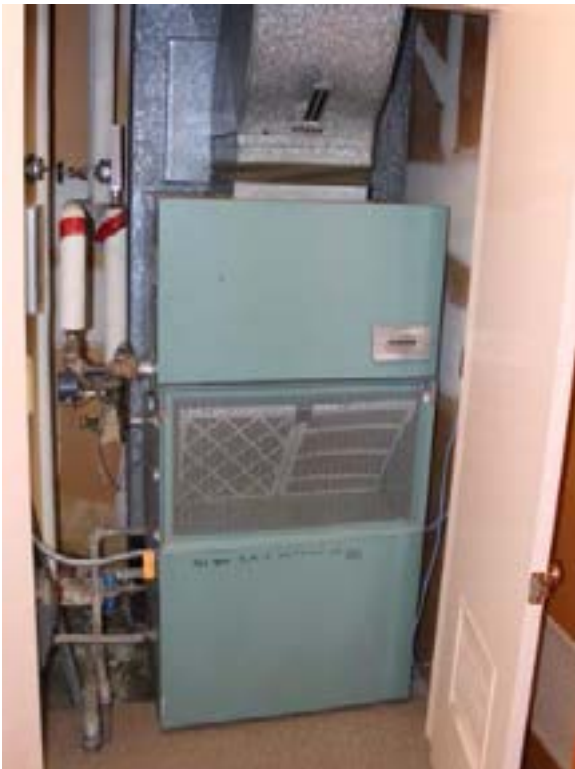
Figure C20.1.b – Library mechanical unit

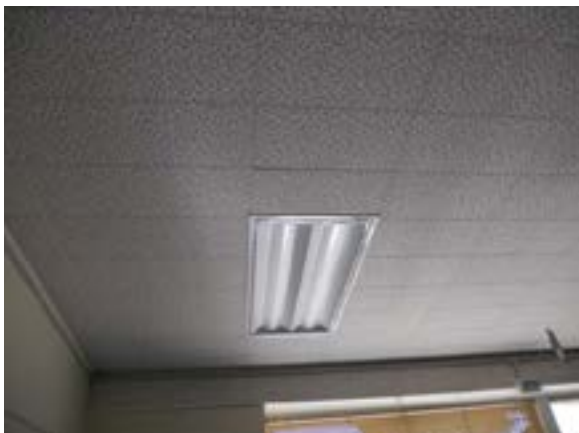
Figure D10.3.a – Classroom Light Retrofit

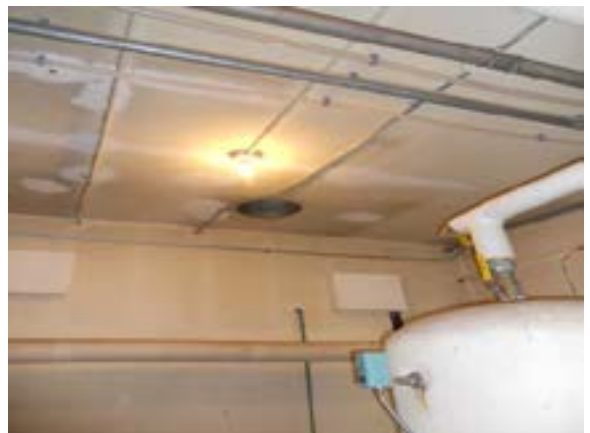
Figure D10.3.b – Mechanical room lighting

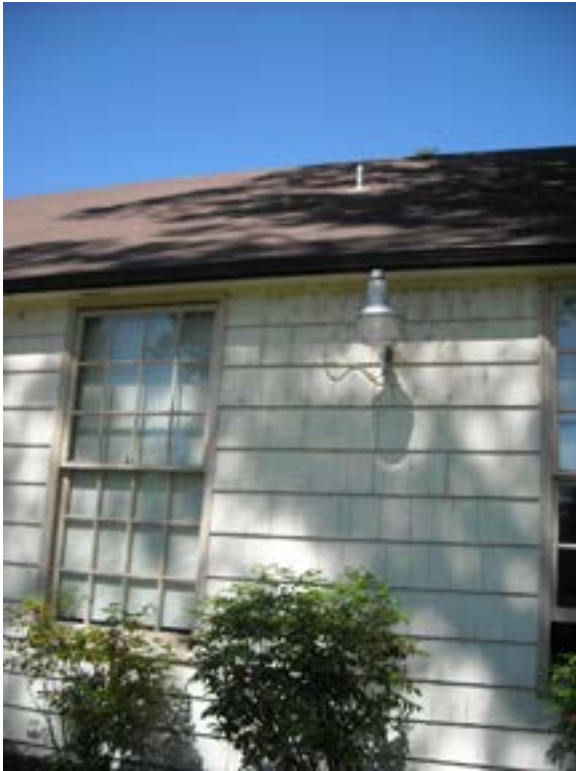
Figure A20.1 – Siding needs repainting

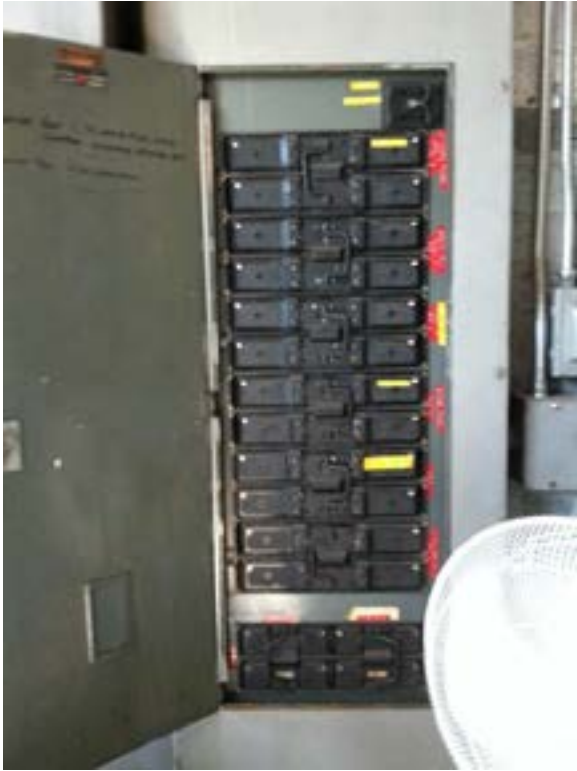
Figure D10.2.a – Main distribution panel

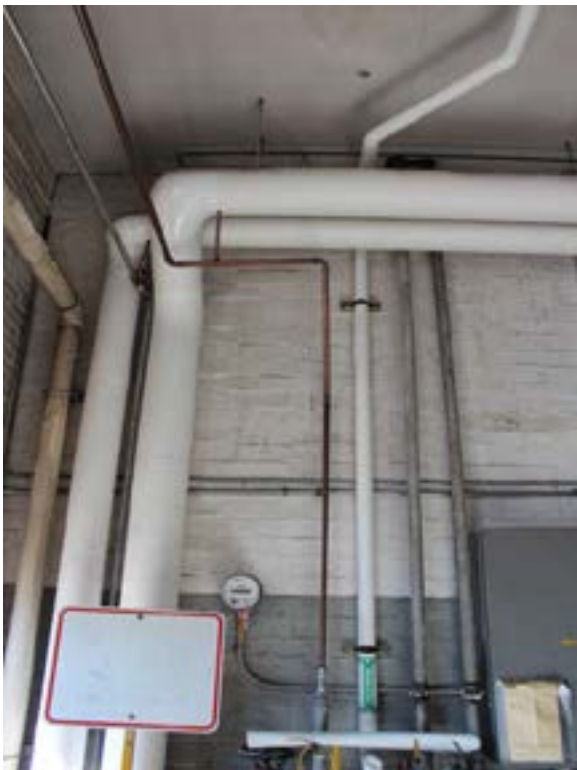
Figure D10.2.c – Piping installed above electrical

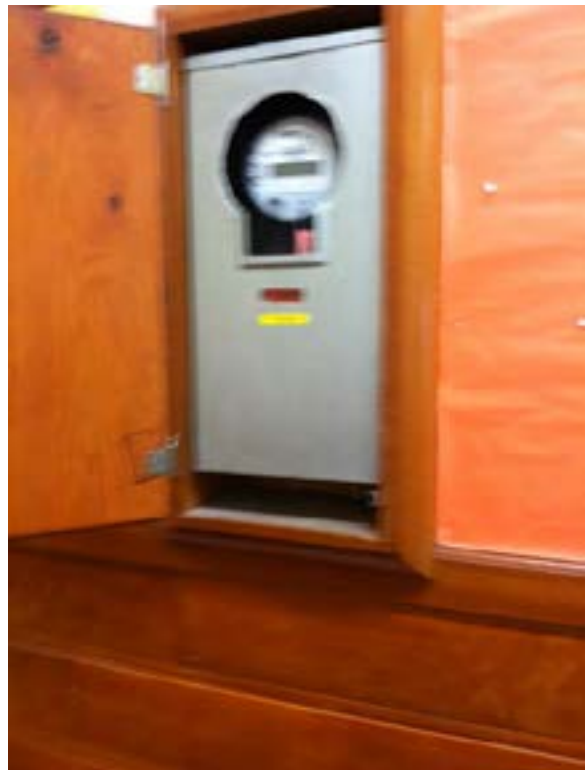
Figure D10.2.d – Noncompliant meter installation

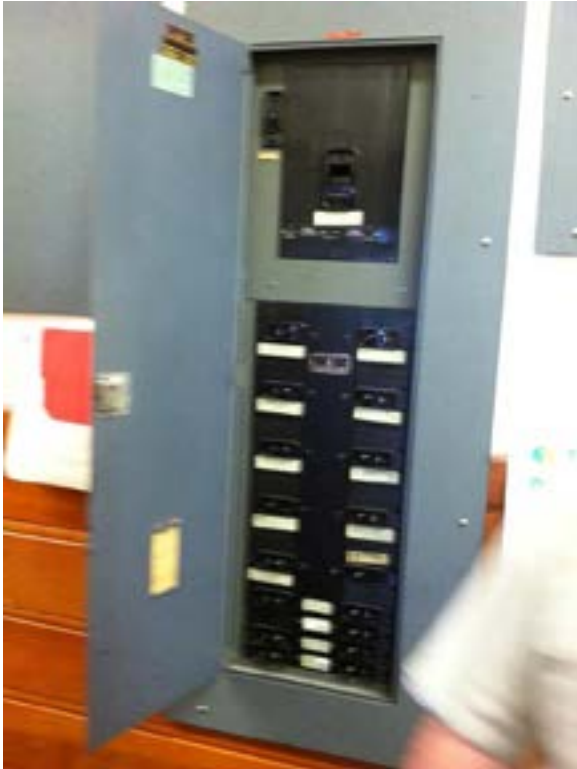
Figure D10.2.e – Panel lacks capacity

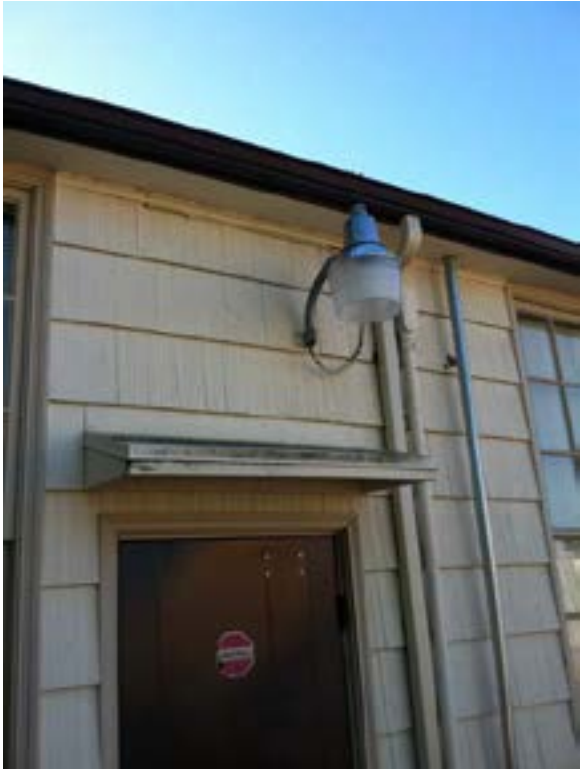
Figure D10.2.f – Armored cable used outdoors

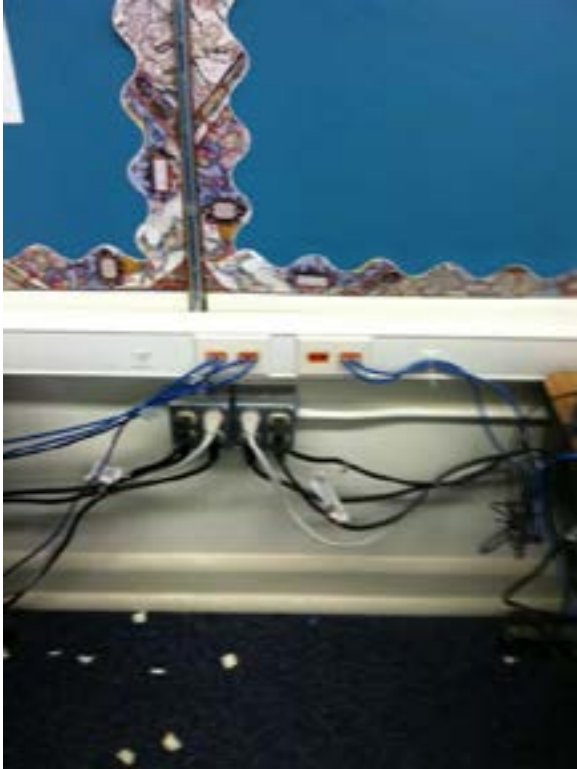
Figure D10.2.g – Insufficient classroom receptacles

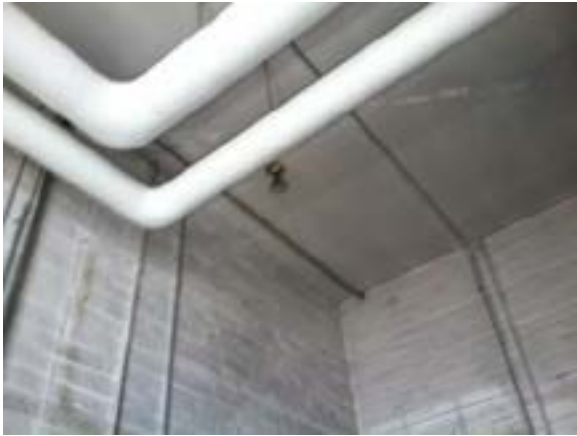
Figure D10.3.a – Mechanical room lighting

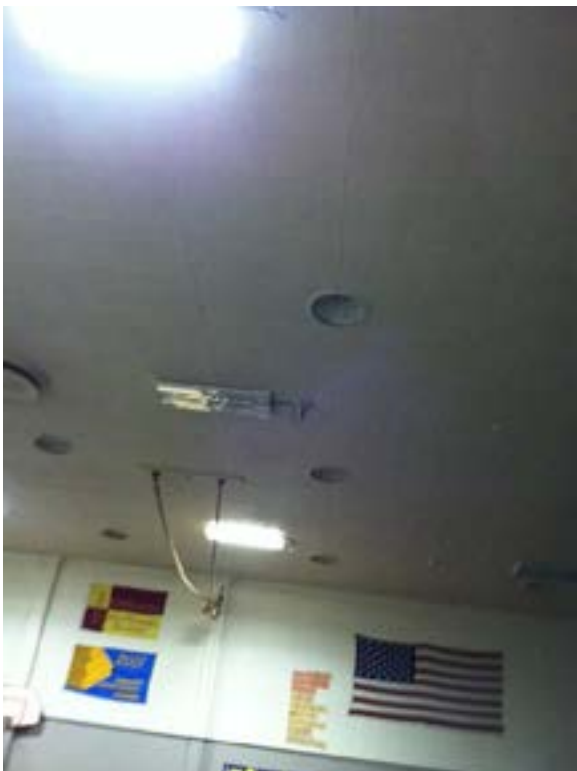
Figure D10.3.c – Hallways/Offices are overlit

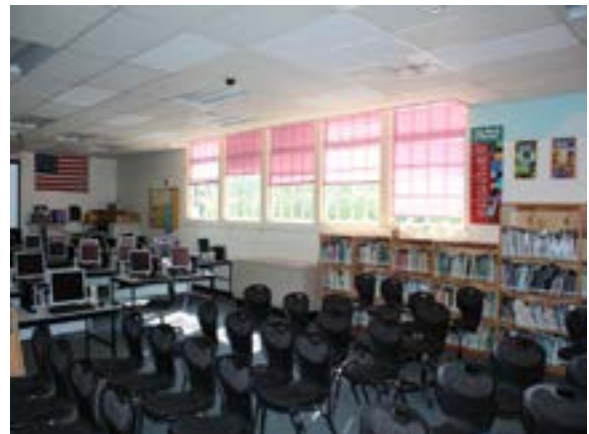
Figure D10.3.d – Retrofit lighting issues

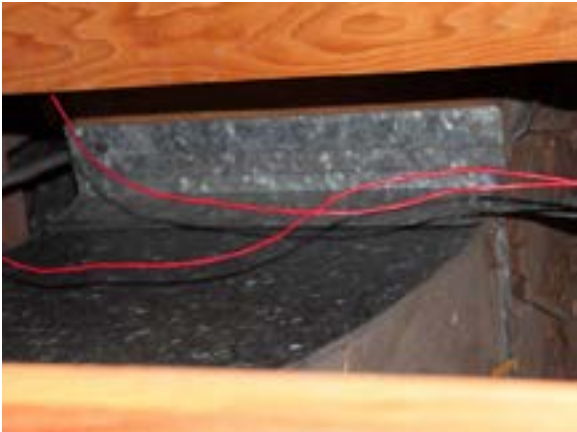
Figure D20.1 – Unsecured fire alarm wiring

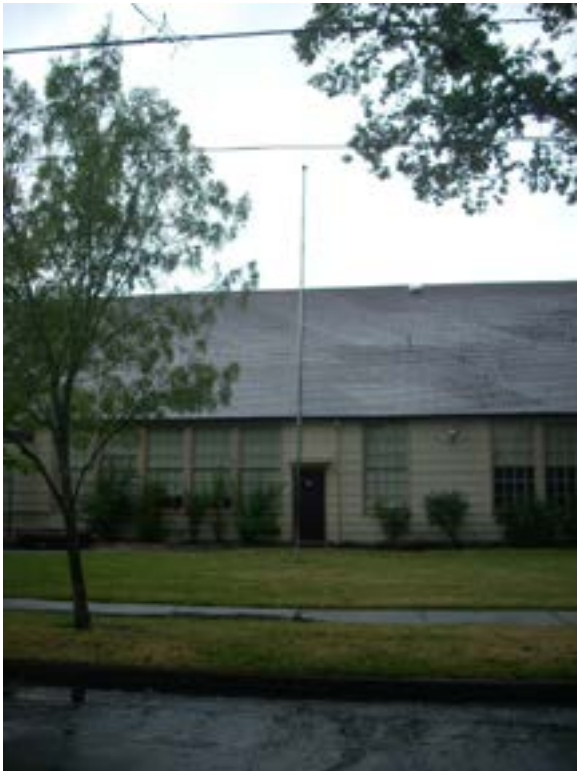
Figure E10.2 – Flagpole

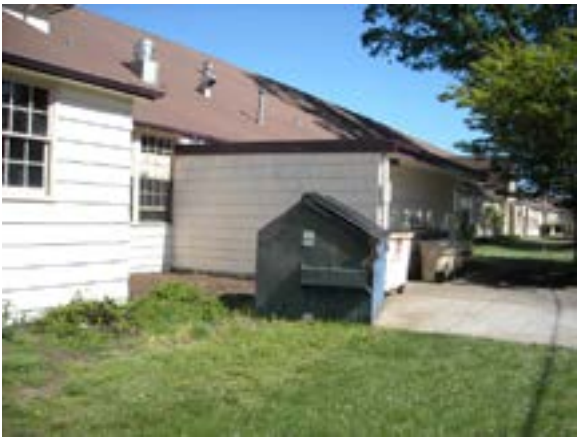
Figure E10.6 – Trash area

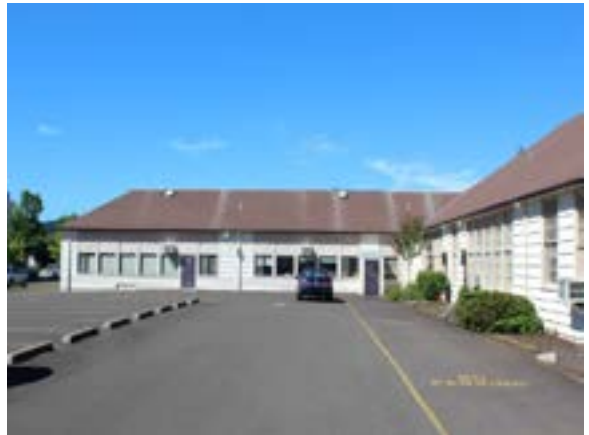
Figure E20.9 – Lack of parking lot lighting

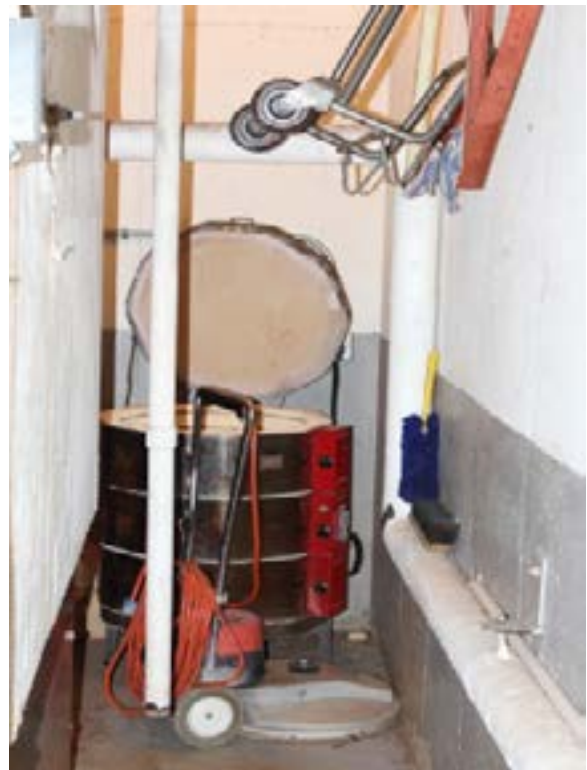
Figure C20.7.a – Kiln in boiler room

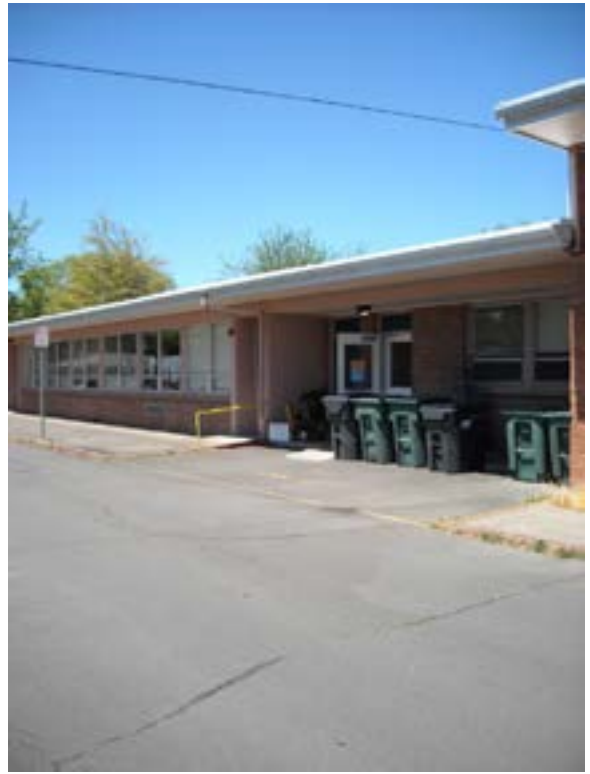
Figure E20.6 – Lack of trash enclosure

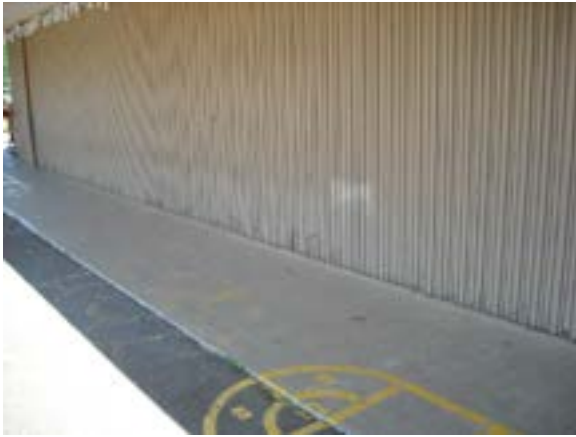
Figure A20.1 – Exterior wall damage

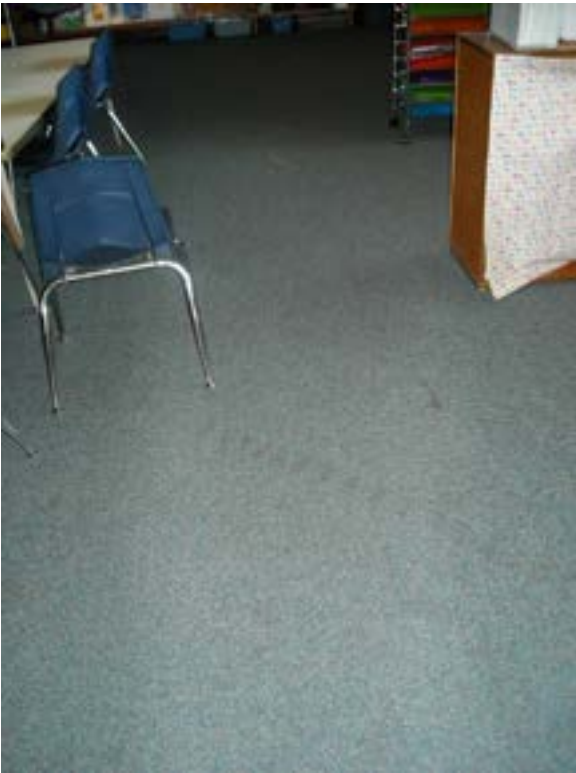
Figure B20.1.a – Carpeting in classroom

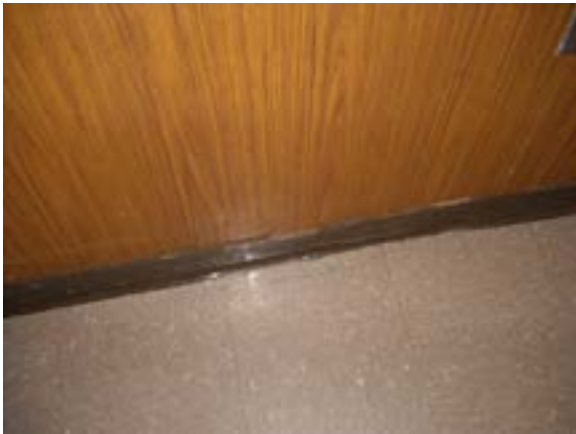
Figure B20.6 – Damaged base

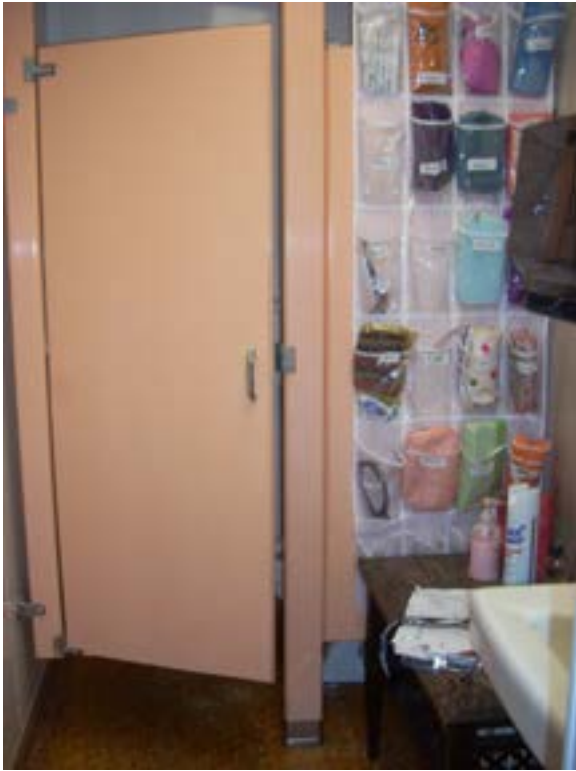
Figure C10.3 – Typical restroom fixture

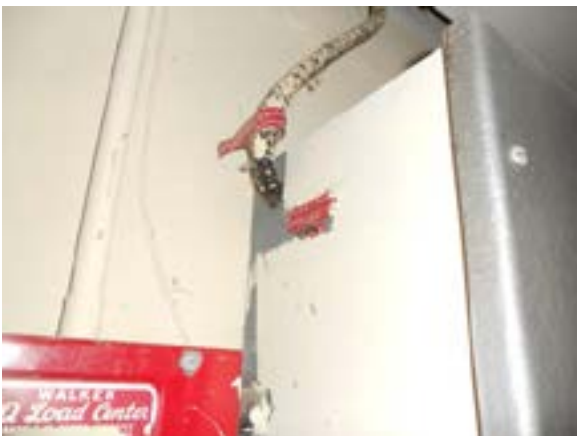
Figure D10.2.c – Wiring missing cable clamp

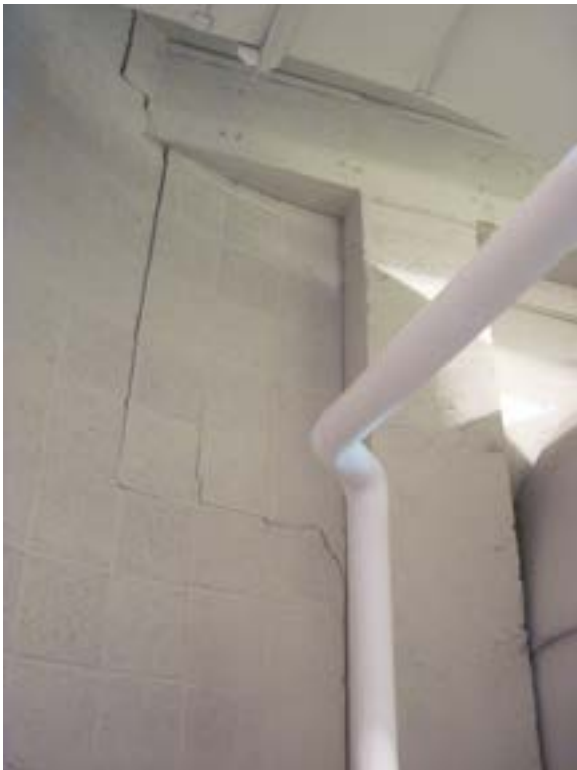
Figure A10.3.d – Boiler room wall

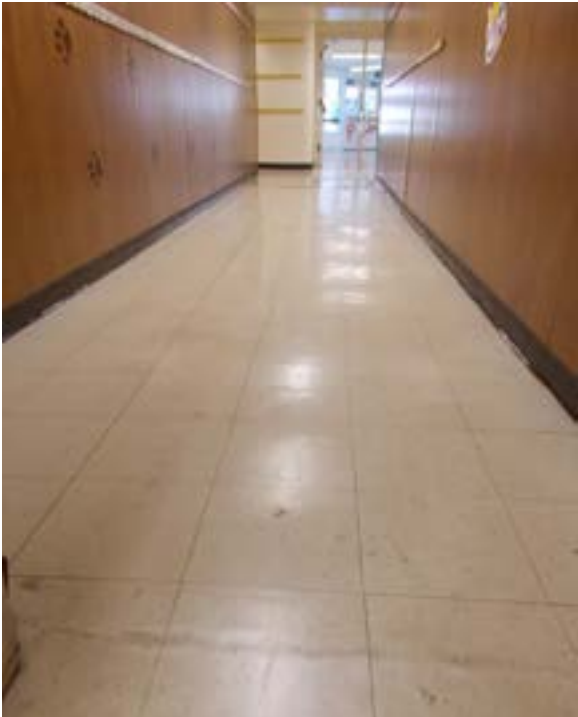
Figure B20.1.b – Flooring issues

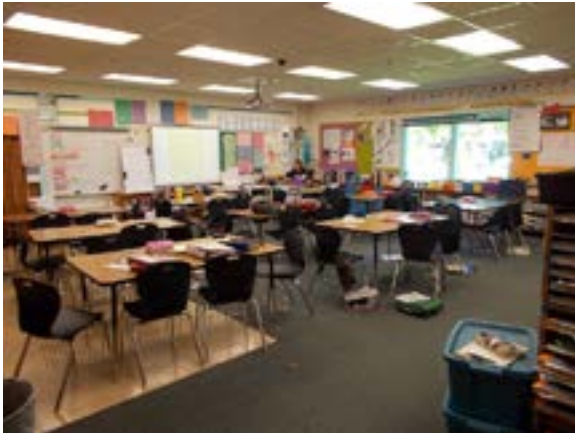
Figure B20.1.c – Flooring issues

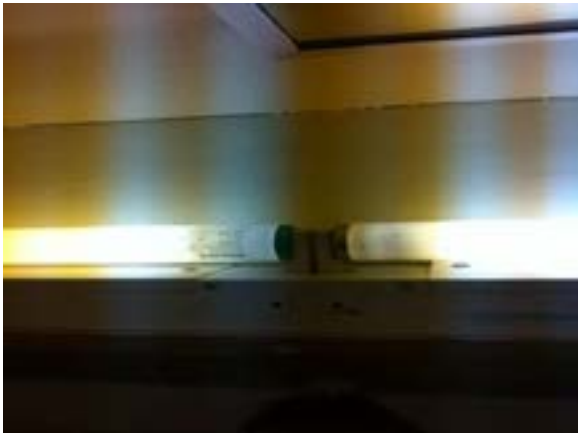
Figure D10.3.c – Mechanical room lighting

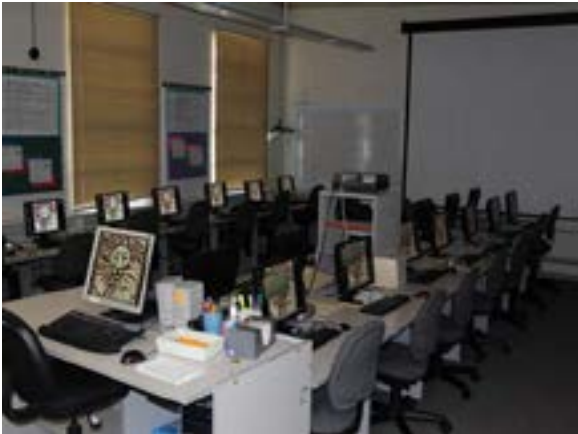
Figure D10.3.d – Typical computer lab lighting

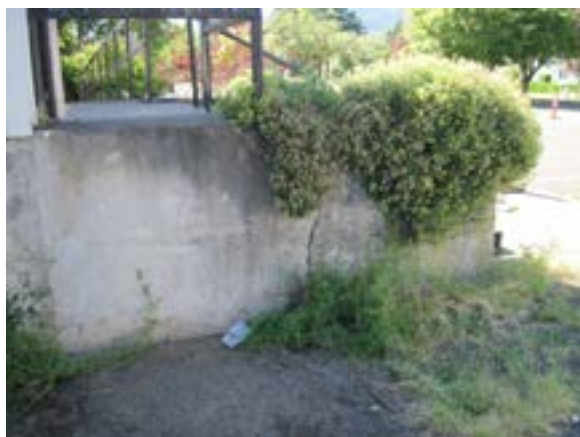
Figure A10.2 – Cracks in concrete wall

RECOMMENDATIONS			
A10.2	Seal crack in exterior walls supporting stair access to multi-purpose room to prevent further deterioration.		
A10.3	Prioritize and perform the remaining seismic improvements to structural systems as outlined in the Degenkolb report. Perform the remaining seismic improvements to non-structural components as outlined in the Degenkolb report.		
A20 - EXTERIOR COMPONENTS

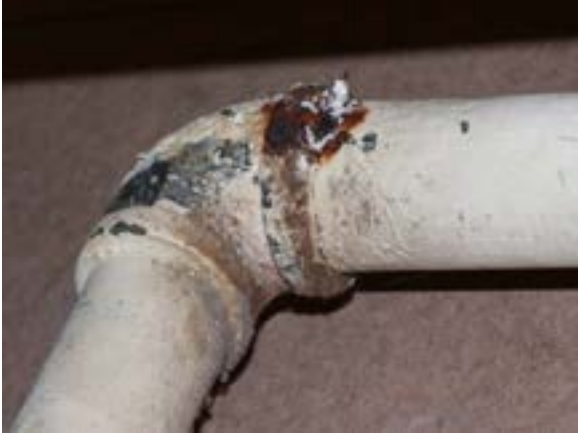
Figure C10.2.a – Sprinkler piping corrosion

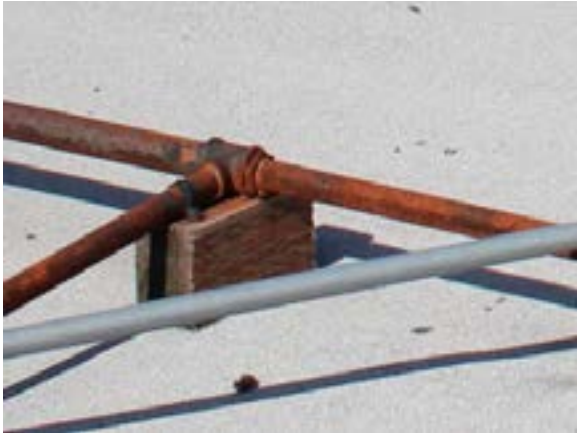
Figure C10.2.b – Gas piping corrosion

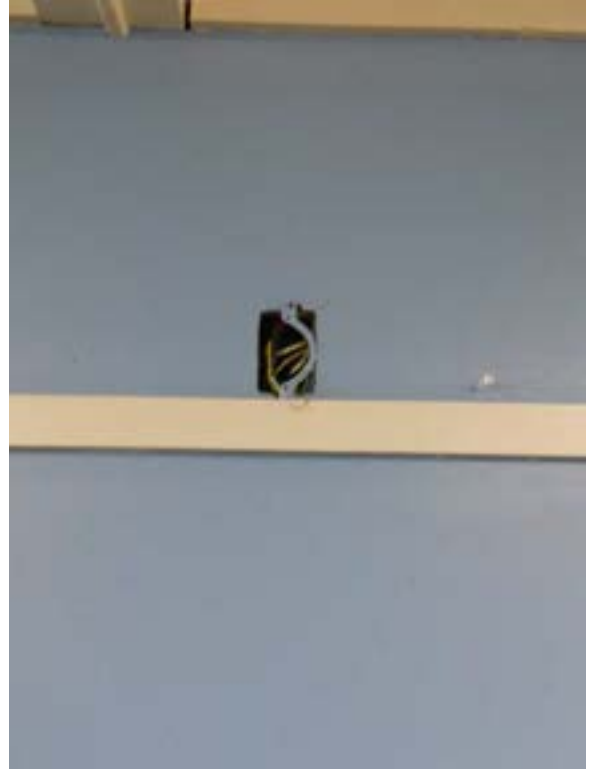
Figure D10.2.b – Junction box lacks cover

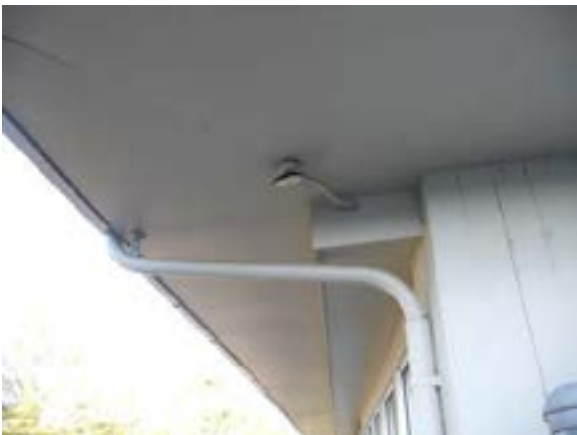
Figure D10.2.c – Junction box lacks cover

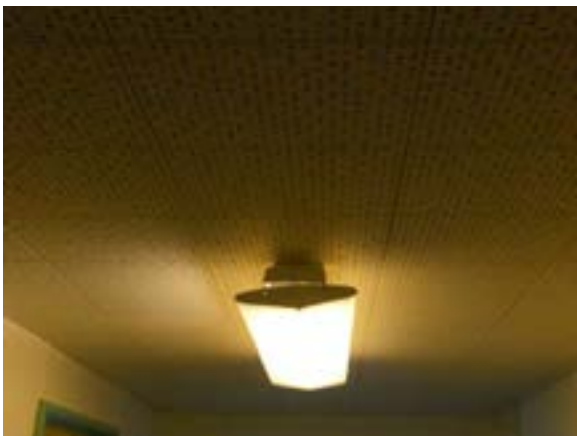
Figure D10.3.b – Dated hallway lighting

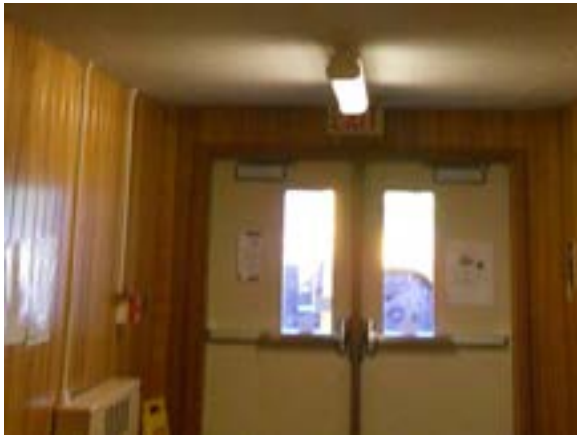
Figure D10.7 – Retrofitted exit sign

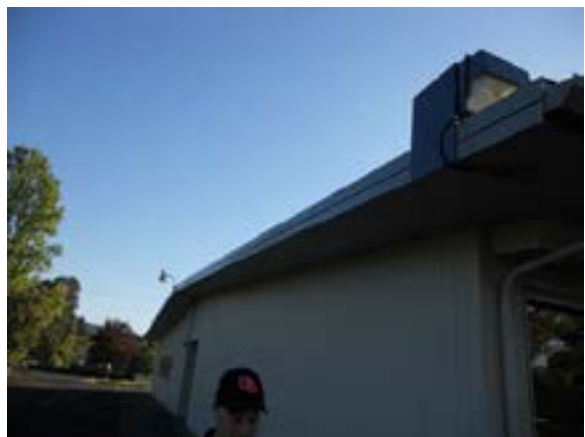
Figure E20.9.a – Insufficient parking area lighting

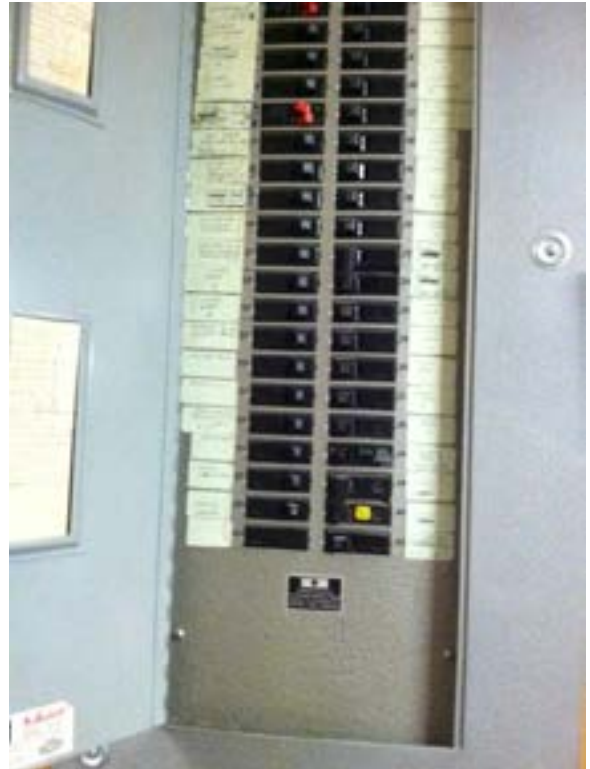
Figure D10.2.a – Lack of spare capacity

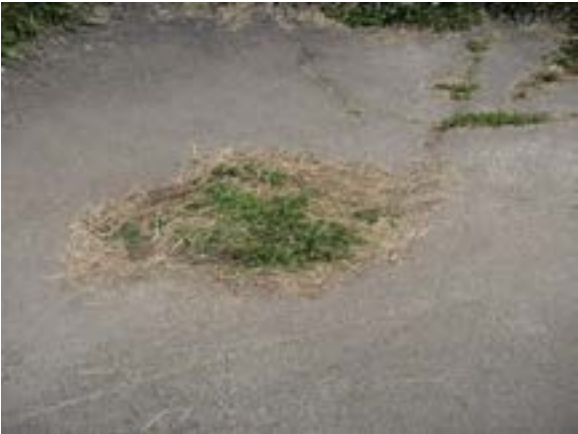
Figure E20.10 – Overgrown storm drains

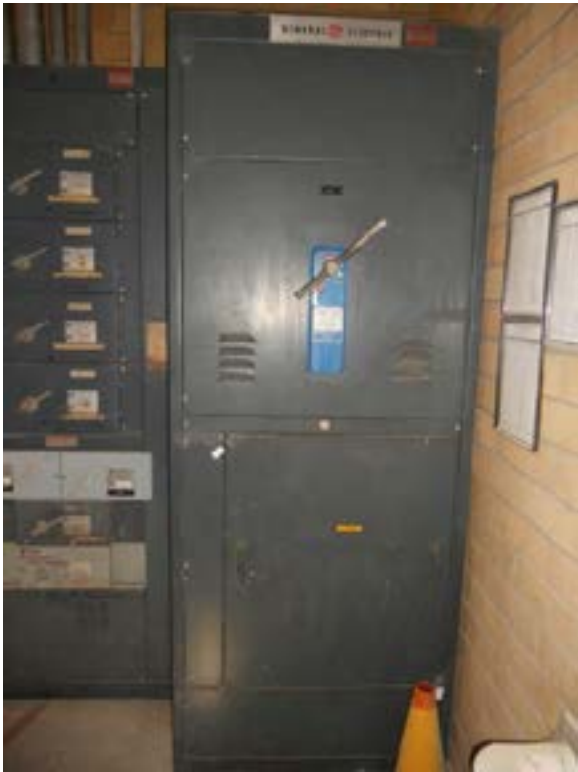
Figure D10.2.b – Lack of panel capacity

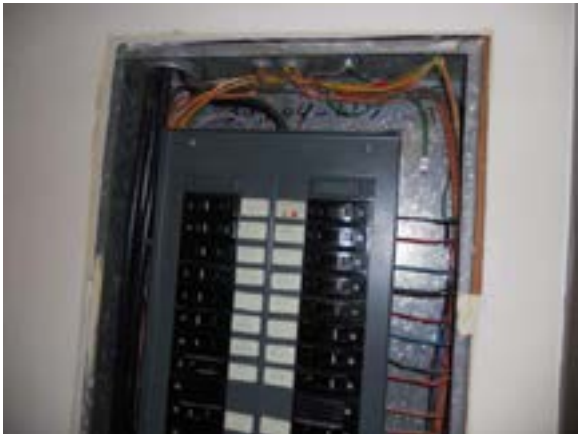
Figure D10.2.d – Inaccessible electrical panels

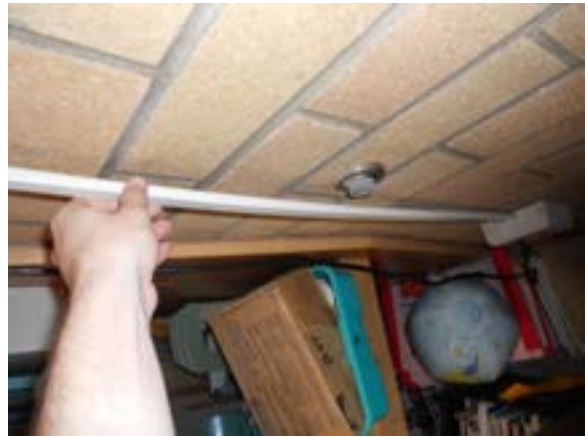
Figure D10.3 – Delamped classroom lighting

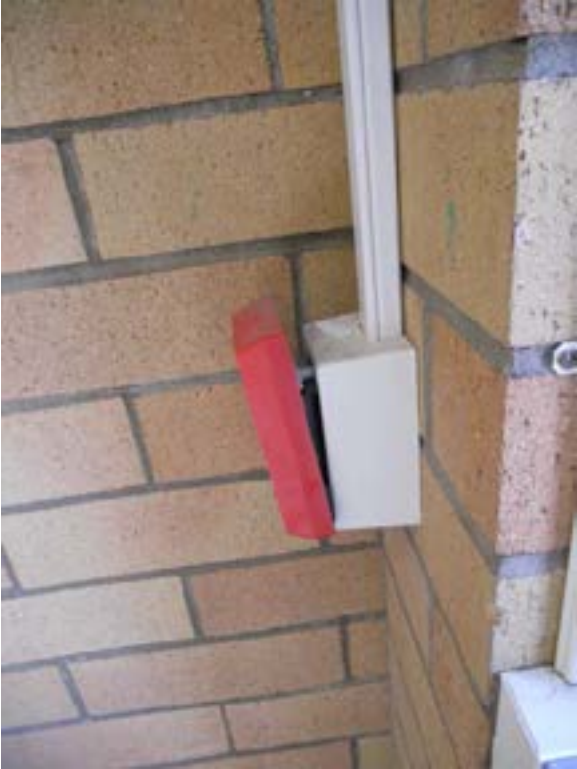
Figure D20.7 – Bypassed card access point

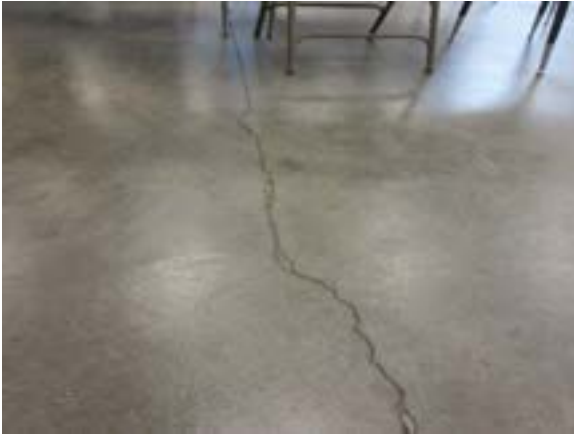
Figure A10.2a – Slab on grade cracking

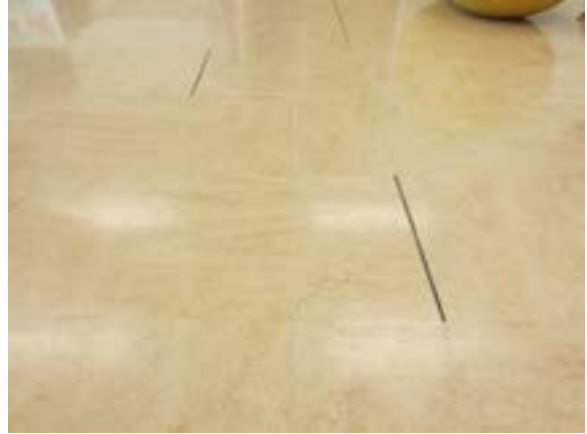
Figure A10.2.b – Slab on grade cracking

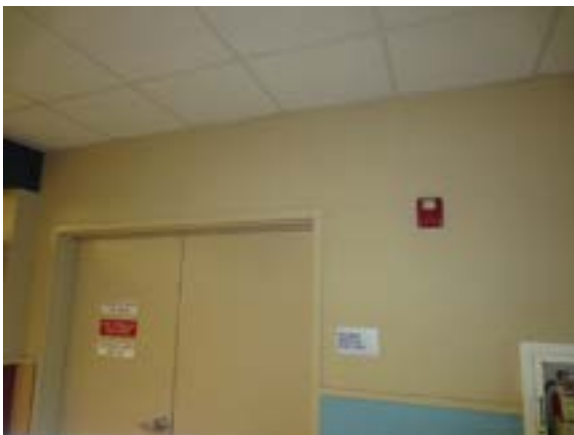
Figure A10.3.a – Crack in wall finishes

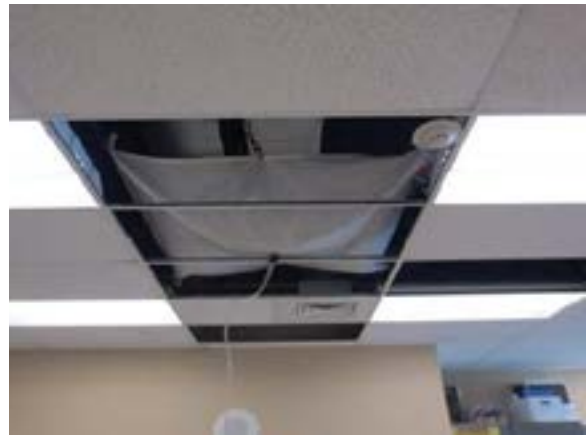
Figure A10.3.b – Ceiling leak

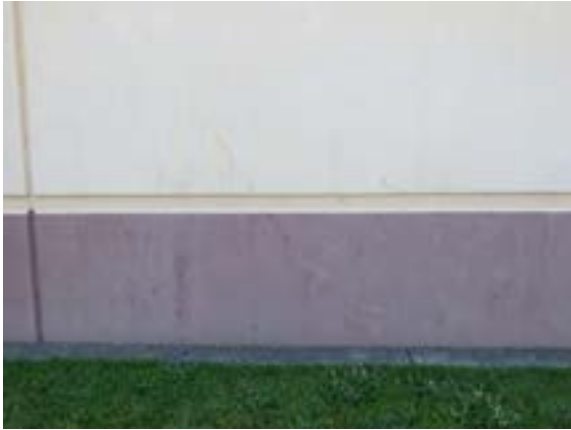
Figure A10.3.c – Cracks in concrete wall

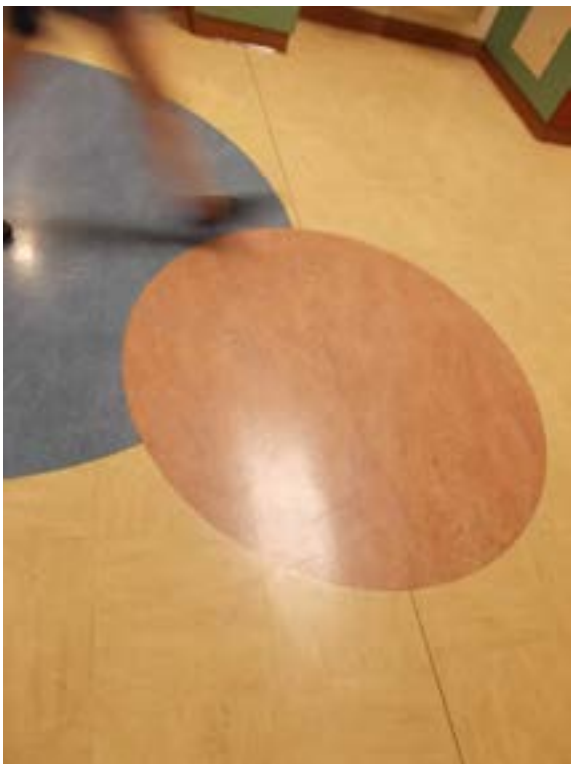
Figure B20.1.a – Flooring issues

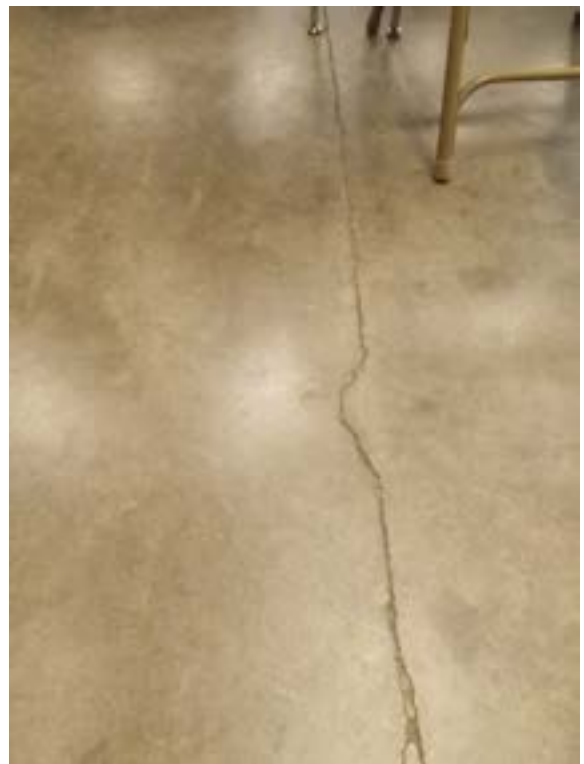
Figure B20.1.b – Flooring Issues

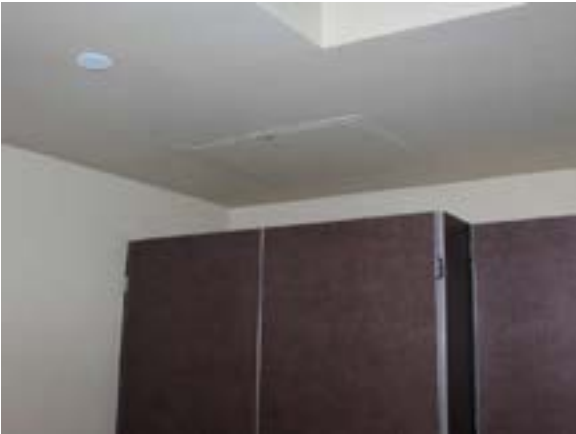
Figure C20.3 – Blocked fire/smoke damper

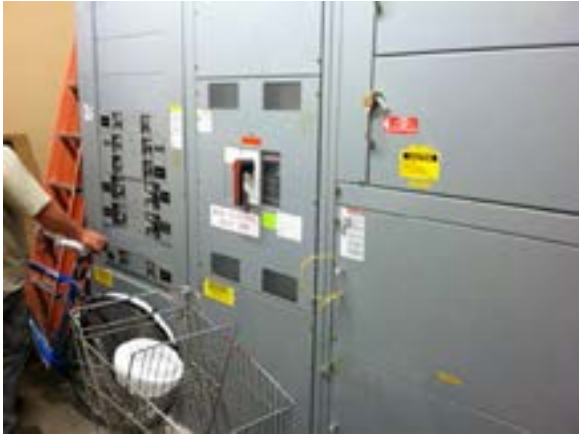
Figure D10.2 – Inaccessible switchboard

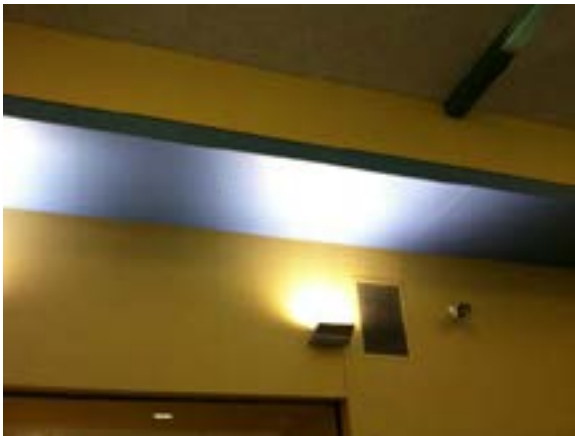
Figure D10.3 – Inadequate cafeteria lighting

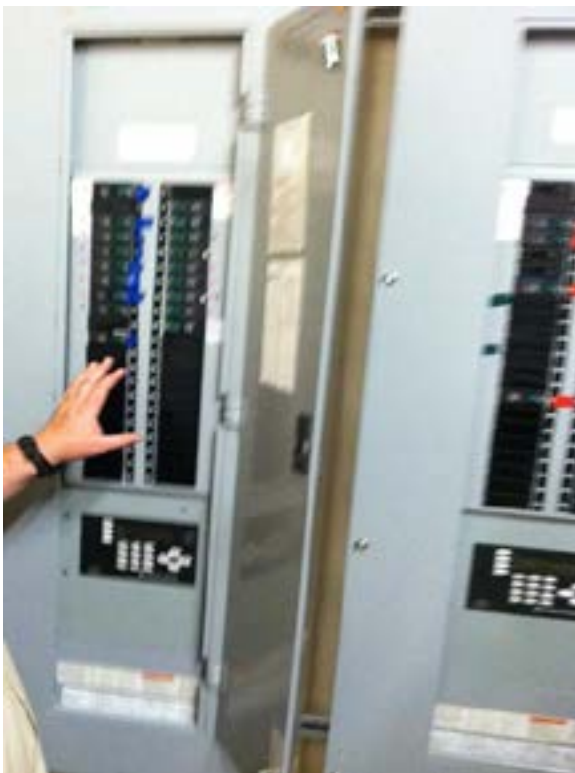
Figure D10.4 – Lighting control issues

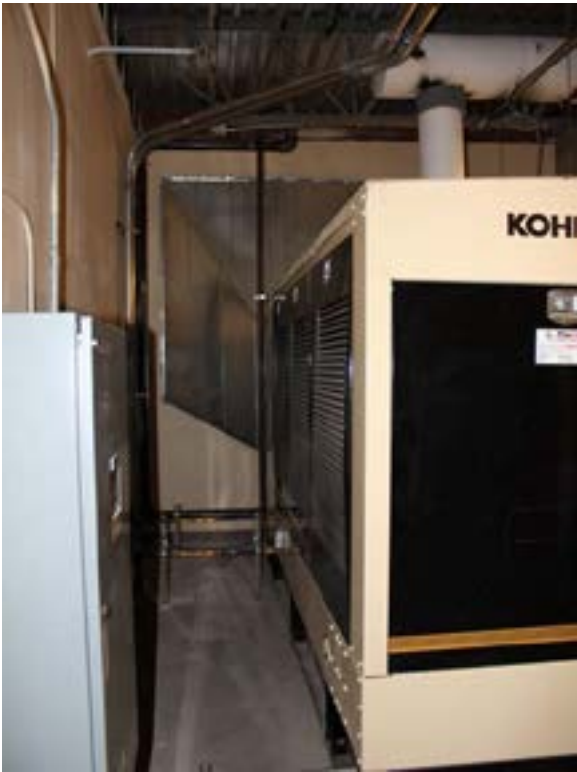
Figure D10.5.b – Insufficient space/access

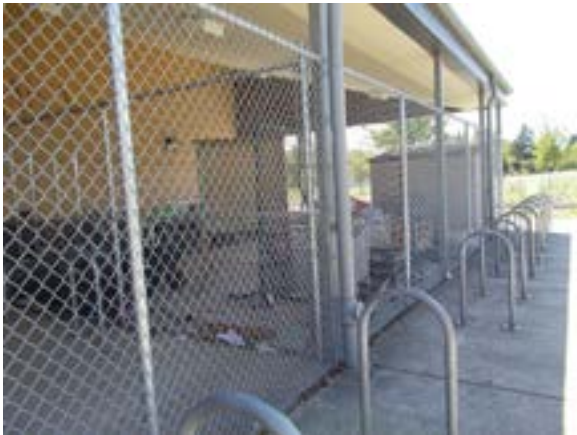
Figure E20.4 – Lack of site storage

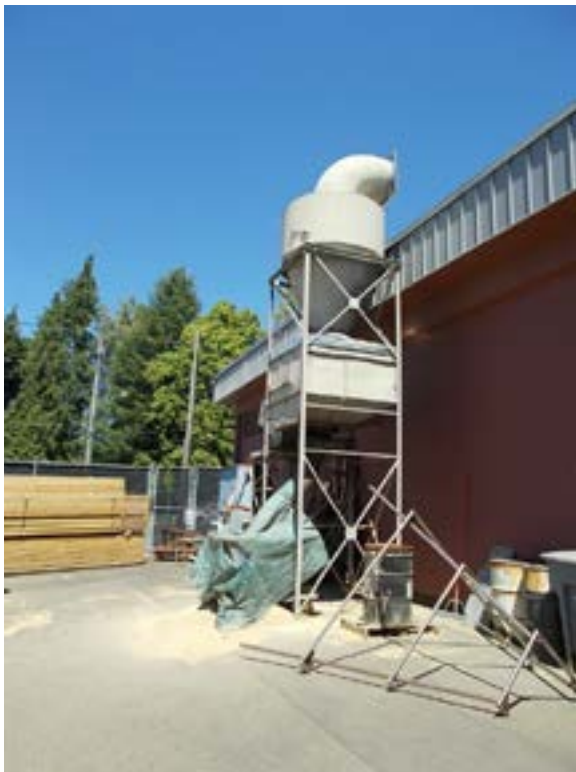
Figure B20.4 – Dust collector

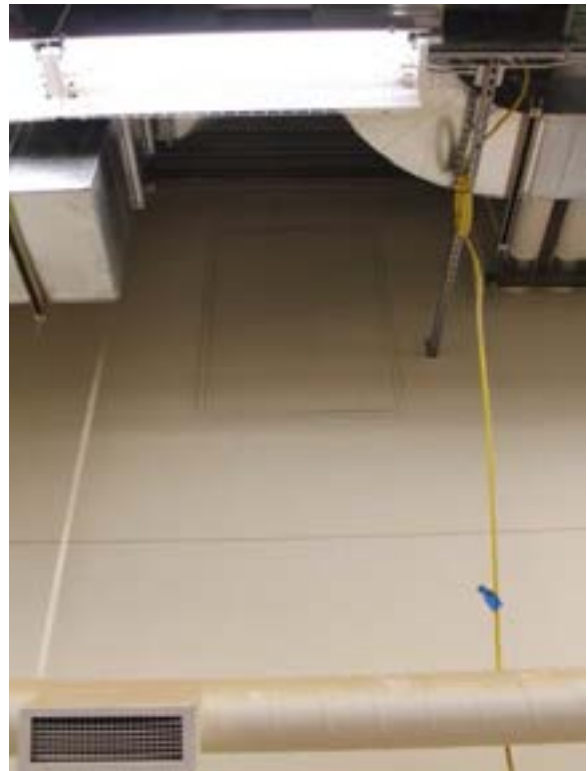
Figure C20.3 – Choir room ductwork access

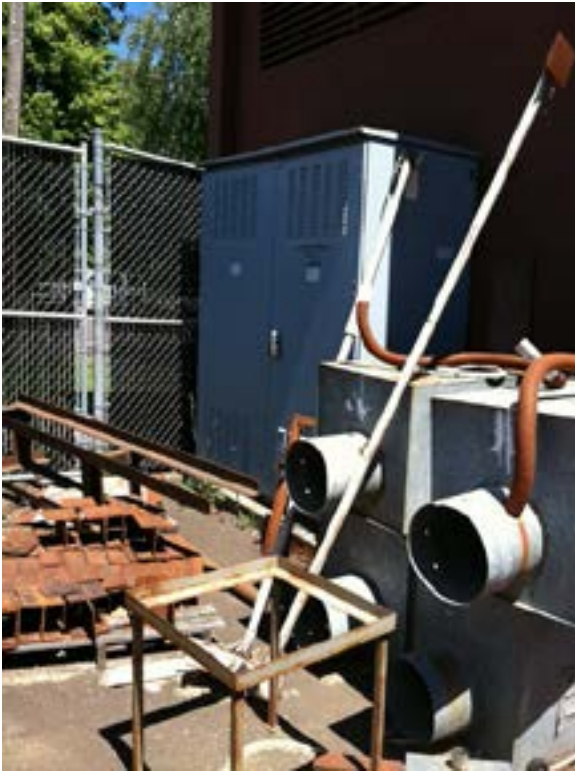
Figure D10.2.c – Inaccessible switchboard

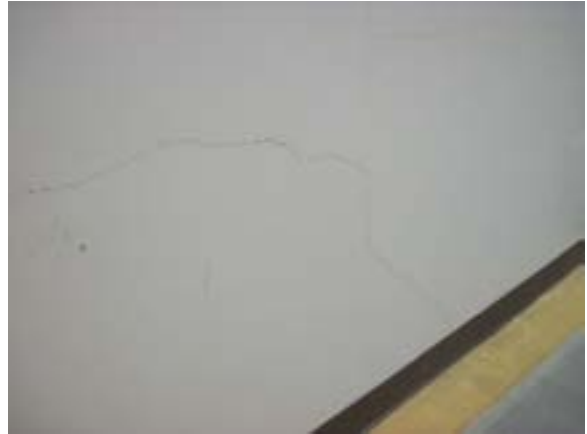
Figure A10.3.a – Cracks in panels

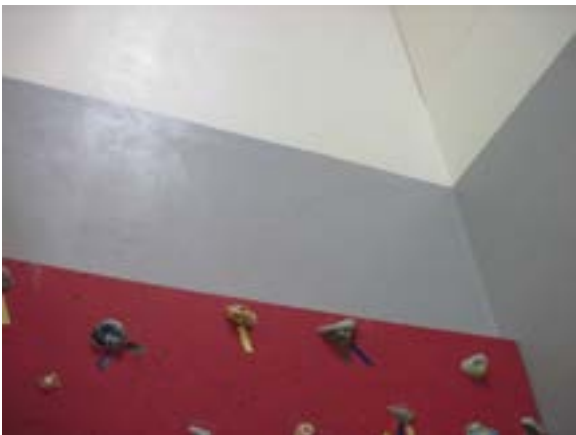
Figure A10.3.b – Cracks in panels

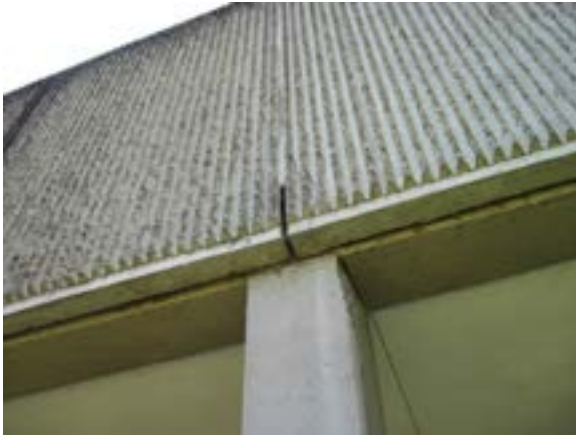
Figure A10.3.d – Cracks at exterior columns

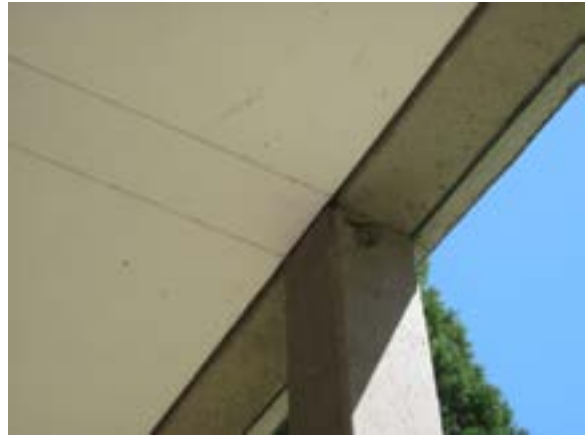
Figure A10.3.e – Cracks at exterior columns
