Facilities Assessment Report Corvallis School District

Submitted to Corvallis School District
by DOWA - IBI Group Architects, Inc.
February 2014

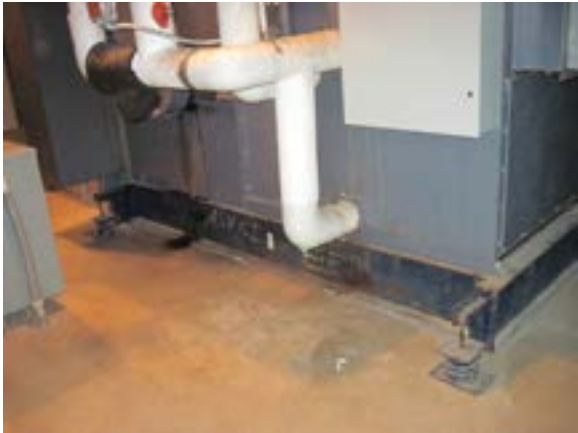
Figure A10.3.h – Equipment not anchored

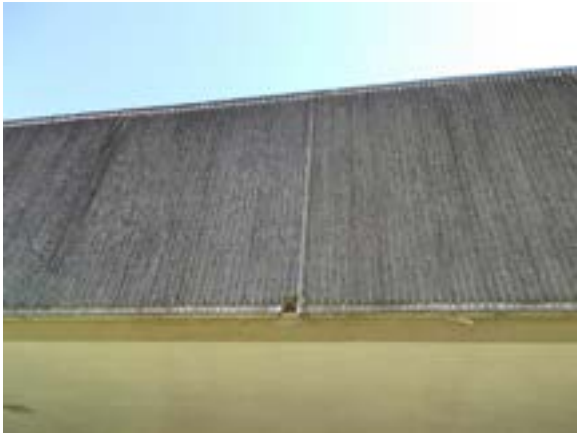
Figure A20.1 – Exterior Walls

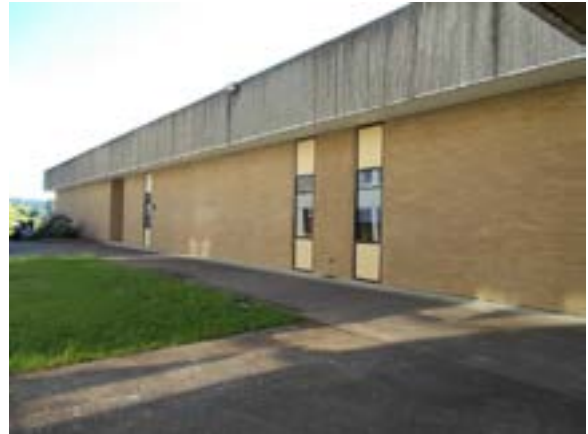
Figure A20.3.b – Exterior windows

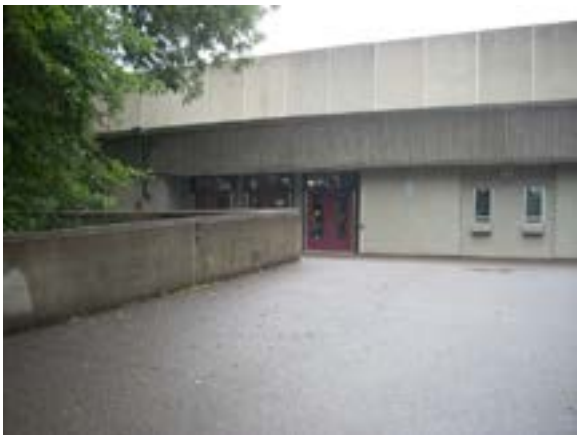
Figure B10.3 – Exterior ramp

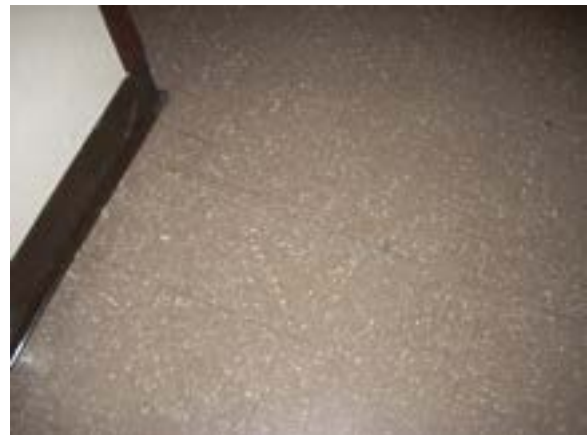
Figure B20.1.a – Flooring issues

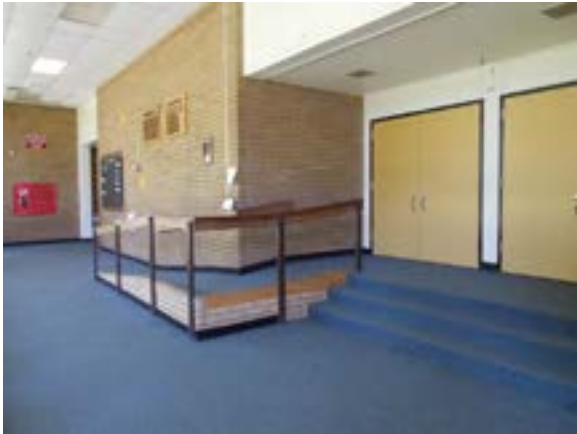
Figure B20.1.b – Flooring issues

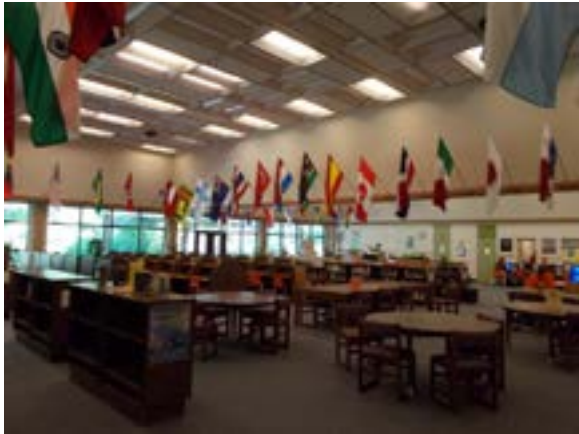
Figure B20.1.c – Flooring issues

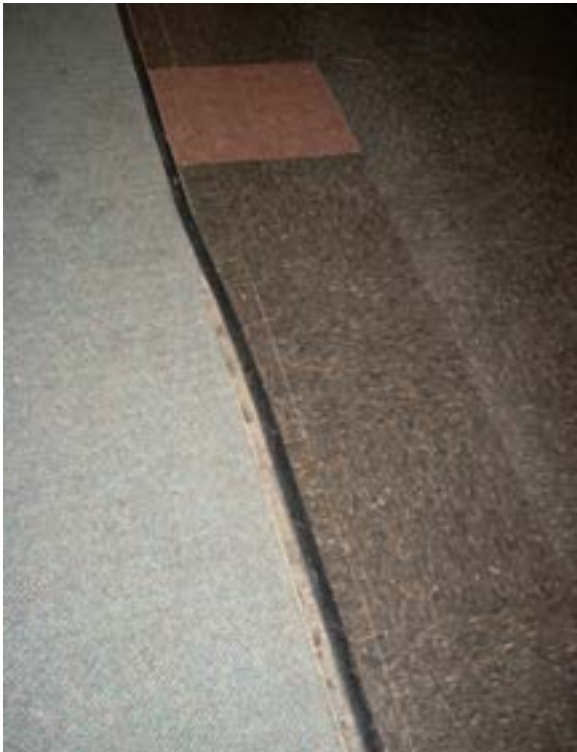
Figure B20.1.d – Flooring issues

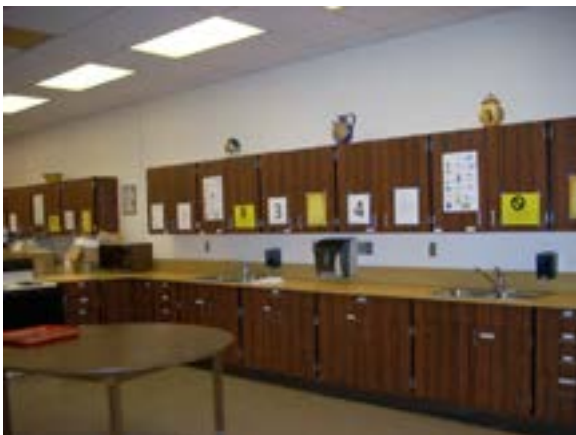
Figure B30.4.a – Classroom casework

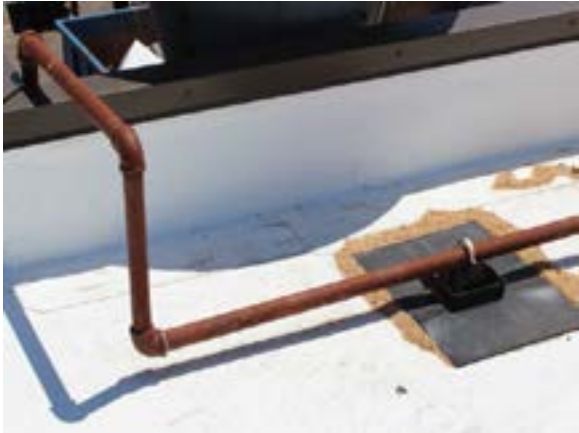
Figure C10.3 – Rusted gas piping

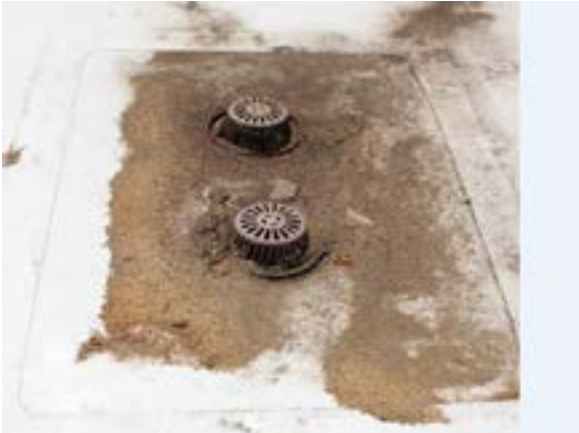
Figure C10.4 – Storm drains with sawdust

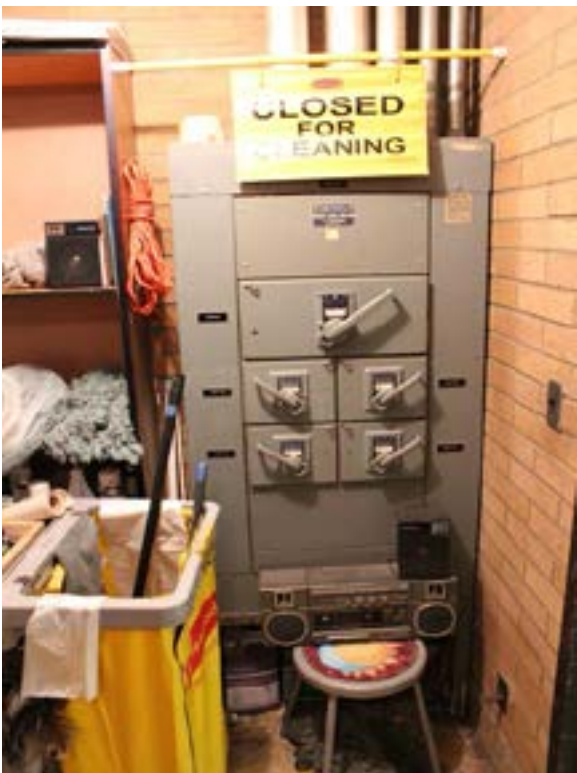
Figure D10.2.a – Blocked panel

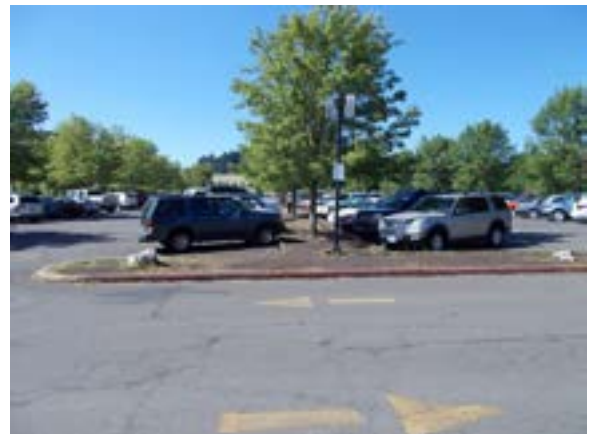
Figure E10.4.a – Sidewalks

E10.4	1 Demolish and repour sidewalks in front of the gymnasium			X			\$ 20,872		
	2 Extended sidewalks from the gymnasium and parking area to the varsity baseball field, JV baseball field and greenhouse, improve existing pedestrian bridge			X			\$ 63,381		
E10.5	1 Provide an ADA pathway to the varsity baseball field			X			\$ 7,906		
E10.6	1 Add covered bicycle parking structure near front entry of school			X			\$ 26,090		
E20 - SITE COMPONENTS									
E20.1	1 Resurface and restripe running track		X			\$ 351,828			
	2 Replace grass football field with turf field			X			\$ 1,581,250		
	3 Replace visitor bleachers with a larger bleacher system that accommodates accessible seating			X			\$ 158,125		
E20.2	1 Re-landscape parking area islands with hardier drought-resistant plants around existing trees and a semi-permeable hard surface between planting areas for pedestrian foot traffic			X			\$ 7,906

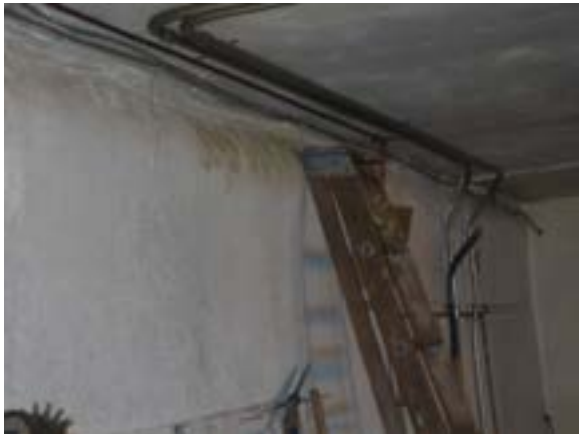
Figure A10.3 – Top of wall at lift

RECOMMENDATIONS			
A10.2	Install improved drainage to prevent future flooding. Investigate the cause of bulging finishes and remediate issues.		
A10.3	Seal cracks in exterior walls to prevent water filtration and further deterioration. Roughen, apply bonding agent and fill in rock pocket at top of wall near the existing lift with non-shrink grout and trowel finish. Prioritize and perform the recommended improvements to structural systems as outlined in the CH2MHILL report. The report provides specific recommendations. These include but are not limited to the new plywood diaphragms and shear walls, improved connections tying diaphragms to shear walls, wall out-of-plane bracing at the gym and anchoring shear walls adequately to the foundations. Perform recommended seismic improvements to non-structural components as outlined in the CH2MHILL report. These include, but are not limited to, anchoring and strapping of mechanical and electrical equipment, and bracing suspended equipment and ceiling.

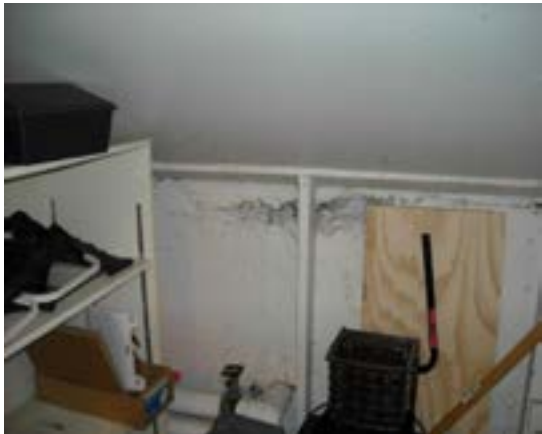
A20 - EXTERIOR COMPONENTS			
Item		Findings	Comments
A20.1	Exterior Walls	<ul style="list-style-type: none"> Concrete walls around the building have damaged and or visible cracking. See Figure A20.1. 	<ul style="list-style-type: none"> Exterior materials are a combination of exposed concrete, brick and wood siding.

Figure A20.1 – Damaged concrete

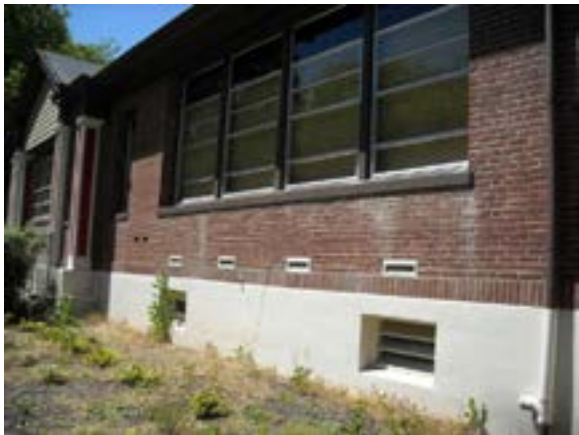
A20.2	Doors and Hardware	<ul style="list-style-type: none"> • Exterior doors contain wire glass. • Door hardware has not been upgraded; doors were observed to have a door knob (no longer allowed as accessible hardware). See Figure A20.2.a. • Exterior doors near the gymnasium are in poor condition. See Figure A20.2.b. • Doors at (6) classrooms and (3) egress doors need actuators for accessibility. 	<ul style="list-style-type: none"> • Wire glass is no longer permitted in educational facilities. • Several classroom spaces are used for instruction of individuals with disabilities.
A20.3	Windows and Skylights	<ul style="list-style-type: none"> • Windows are in fair to poor condition. 	<ul style="list-style-type: none"> • Window systems are single pane glass in wood or metal frames.
A20.4	Roof	<ul style="list-style-type: none"> • A separate roofing assessment is located in the appendix of this report. 	<ul style="list-style-type: none"> • Roofing is a combination of single ply and shingle roofing and ranges in age from 18-25 years old.

Figure A20.2.a – Outdated hardware

ITEMS	Harding (College Hill Campus)	Priority Level (Refer to Legend)				Priority Level I	Priority Level II	Priority Level III	Priority Level IV
		I	II	III	IV				
A - STRUCTURE/SHELL									
A10 - STRUCTURE/SUBSTRUCTURE									
A10.2	1	Install improved drainage to prevent future	X			\$ 7,906			
	2	Investigate the cause of bulging finishes and remediate issues	X			\$ 2,371			
A10.3	1	Seal cracks in exterior walls to prevent water filtration and further deterioration	X			\$ 1,581			
	2	Roughen, apply bonding agent and fill in rock pocket at top of wall near the existing lift with non-shrink grout and trowel finish	X			\$ 2,371			
	3	Complete seismic upgrades per previous reports	X			\$ 1,953,718			
A20 - EXTERIOR COMPONENTS									
A20.1	1	Repair damaged concrete wall		X			\$ 2,371		
A20.2	1	Replace wire glazing in exterior doors		X			\$ 6,109		
	2	Replace hardware at exterior doors	X			\$ 82,225			
	3	Replace exterior gym doors			X			\$ 17,710

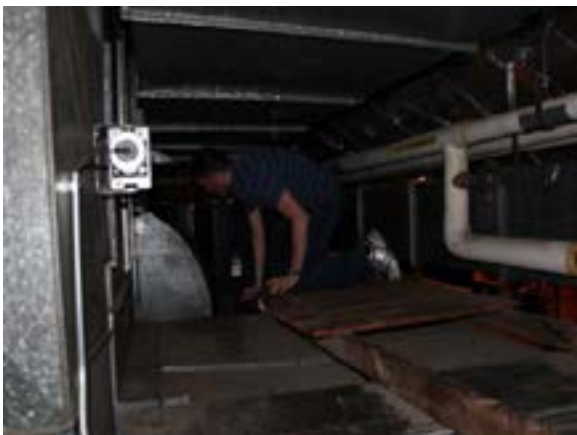
Figure C20.1.b – Dirty units from lack of accessibility

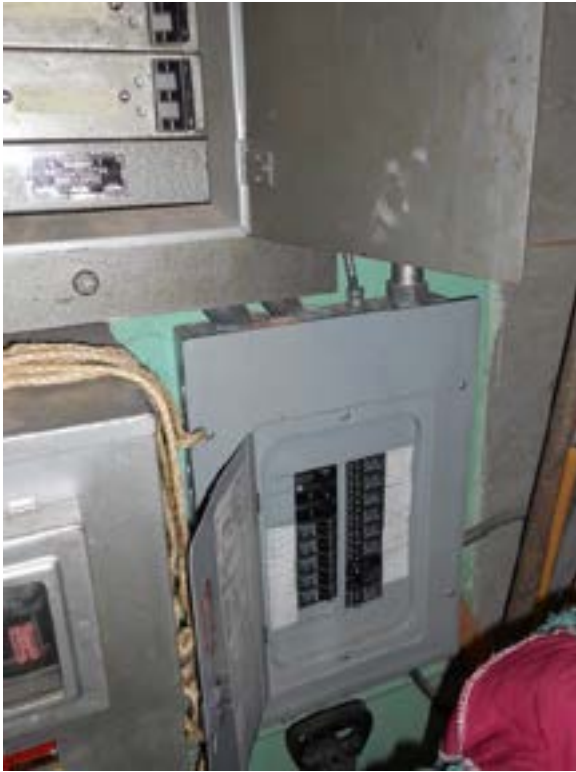
Figure D10.2.b – Electrical clearance issues

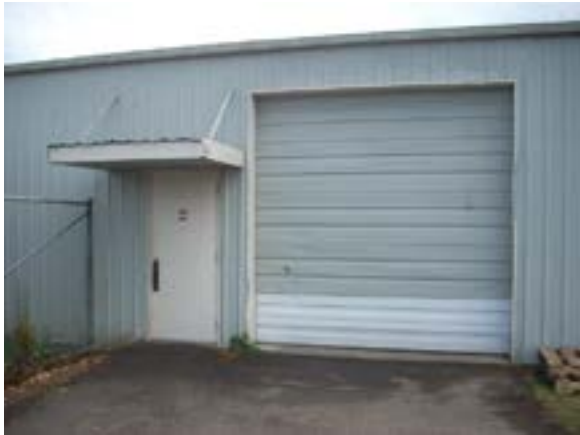
Figure A20.2.b – Overhead Doors

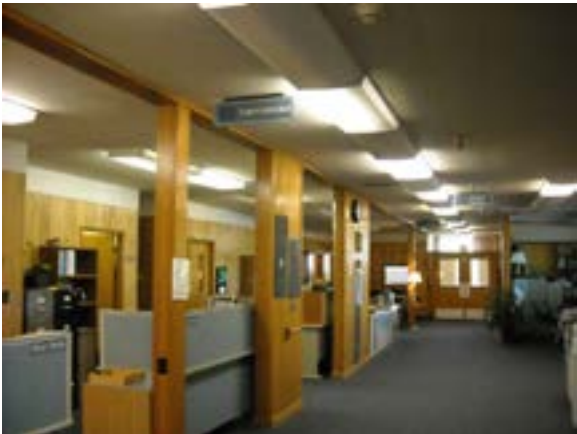
Item		Findings	Comments
B20.1	Flooring	<ul style="list-style-type: none"> • Carpeting in this facility is mismatched, and generally in fair condition. Carpeting in the maintenance office area and in room #41 is in poor condition. • The flooring in the staff room is asbestos tile flooring. • Carpeting located adjacent to the restrooms is in poor condition. See Figure B20.1.a. • Carpeting and/or entry mat in entry vestibules is in poor condition. • The board room carpeting is stained and in poor condition. See Figure B20.1.b. 	<ul style="list-style-type: none"> • Shop and maintenance floor finishes are in good condition, considering their use and wear. • Hard surface flooring in this facility is vinyl composition tile (VCT), which is in good condition.

Figure B20.1.a – Hallway carpeting

- B20.1 Replace all carpeting in the administration building. Abate asbestos tile flooring in the staff room and replace with VCT flooring and rubber base. Remove carpeting in hallway adjacent to restrooms and install VCT flooring. Remove carpeting and/or entry mat flooring at (2) entry vestibules and replace with walk off mats.
- B20.2 Replace ceilings in (4) offices with 2x4 lay-in acoustical ceiling tile. Replace ceiling in main entry and in main office area.

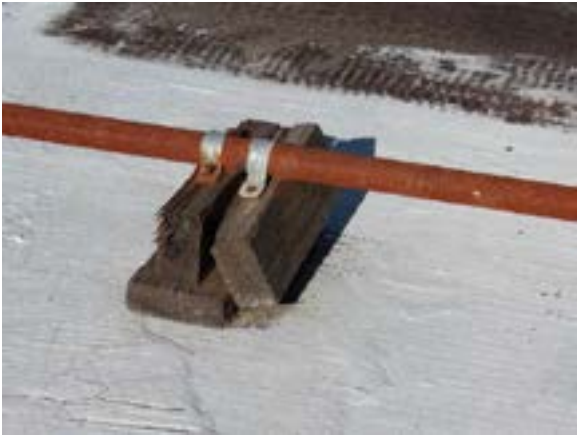
Figure C20.1.b – Current mechanical system

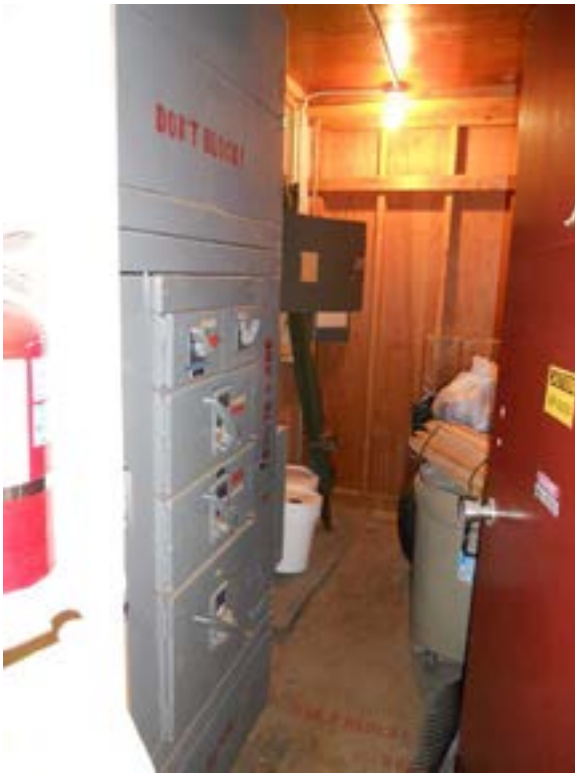
Figure D10.2.c – Existing branch panel conditions

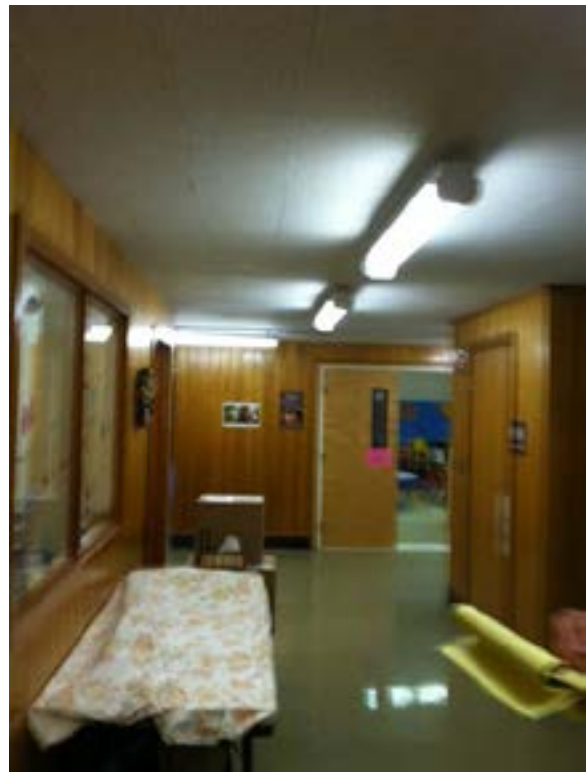
Figure D10.5 – Insufficient egress lighting

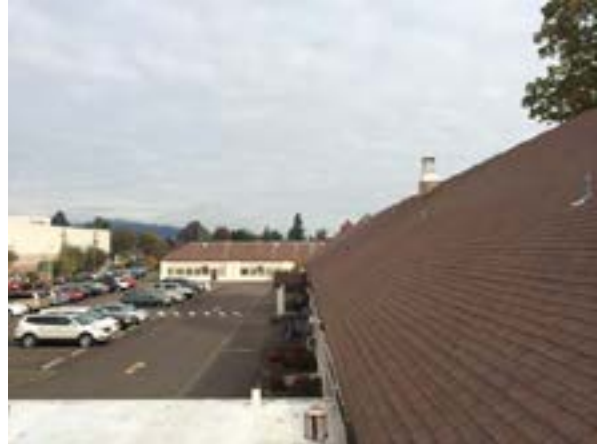
This older facility has a combination of steep shingled roof areas over a non-vented attic space and flat roof areas with TPO roofing. The TPO roofs were installed in 1989 and the shingles were installed in 1995-1997. Maintenance reports numerous leaks with this facility and our visual inspection shows the shingles are very brittle and breaking apart. Furthermore, according to maintenance the shingles were installed over skip sheathing so plywood and seismic upgrades should be completed during the next re-roof which I am recommending occurs this next summer. The TPO membrane is near the end of its life cycle and should be replaced at the same time. All gutters, downspouts and flashings will also need to be replaced. Although patching took place this summer, more maintenance will be required to get through this winter.

Shingles are brittle and breaking apart

Recommended Repairs Estimate: \$ 5,000.00
 Budget for Replacement in 2014: \$ 486,000.00

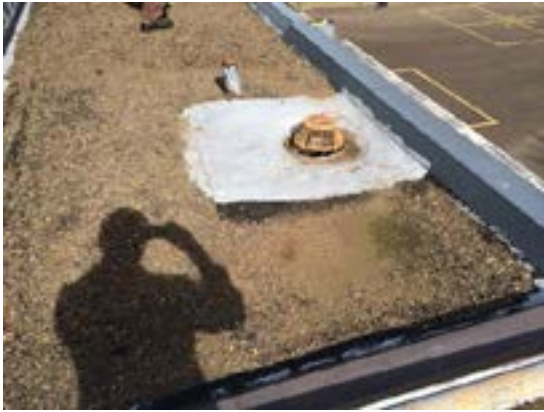
The entire school was roofed in 1988 in what appears to be a BUR or EPDM with Gravel Ballast. Maintenance reports numerous leaks and failures every year. There are screens on two roof decks which create a trap for water and should be removed during the next roofing cycle. The roof is clearly at the end of its life cycle and should be replaced this coming year. Given the history there will probably be some maintenance required this winter.

ROOF DRAINS HAVE BEEN PATCHED

Recommended Repairs Estimate: \$ 5,000.00

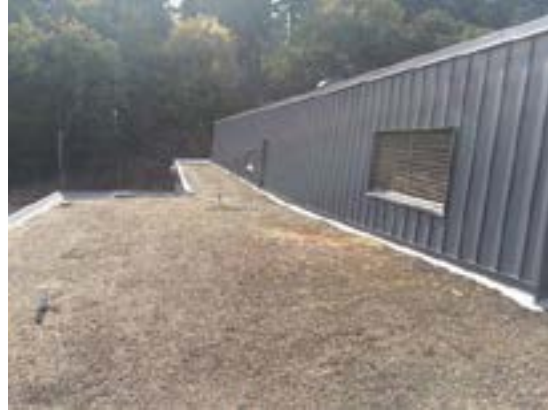
MOSS BUILDUP AT DRAINS AND MUST BE REMOVED

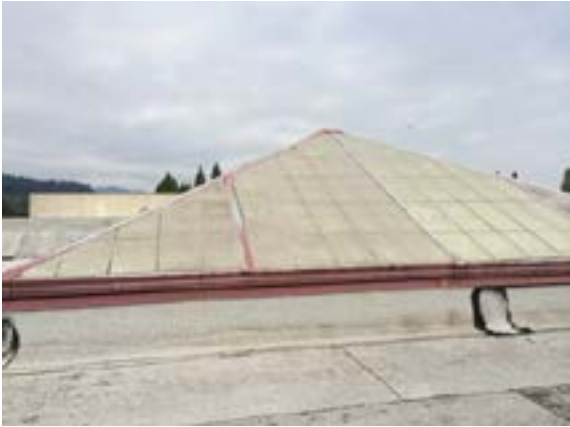
This was one building left from the original campus which was retained during the 2006 construction / replacement. The BUR was installed in 1988 and is in poor shape with numerous repairs. The BUR has reached the end of its life cycle and has many leaks. The large fiberglass skylight structure appears to have worn down to the fiber, has at least one hole and needs to be replaced. With some repairs this roof may last another year or two at the very best.

Fiberglass Skylight weathering through

Recommended Repairs Estimate: \$ 5,000.00

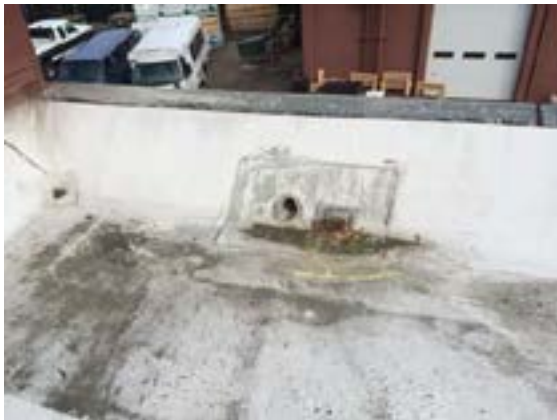
The majority of Corvallis High School received a TPO roof in 2006 which is already experiencing failures common to TPO roofs and is being dealt with under warranty. Therefore, the main portion of Corvallis High School is not part of this study. The industrial arts buildings, T-South and T-North are two buildings reviewed in this study. T-North has two decks one with a Tremco EPDM single ply roof installed in 1988 and one deck with a BUR installed the same year. Both roofs are 25-years old and nearly the end of their projected life cycles. Both are experiencing leaks, especially at roof drains.

T-North Drain and TPO wearing out

Recommended Repairs Estimate: \$ 10,000.00

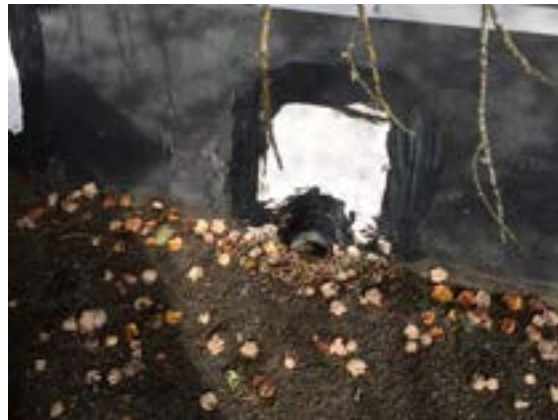
The T-South building has a Tremco EPDM roof installed in 1989 which is also at the end of its projected life cycle and is experience numerous failures. Maintenance indicates a current contract for repairs is out for bidding. If adequate repairs are accomplished, I would recommend replacing within a 2-3 year window.

T-South Drain and EPDM wearing out

Recommended Repairs Estimate: \$ 10,000.00

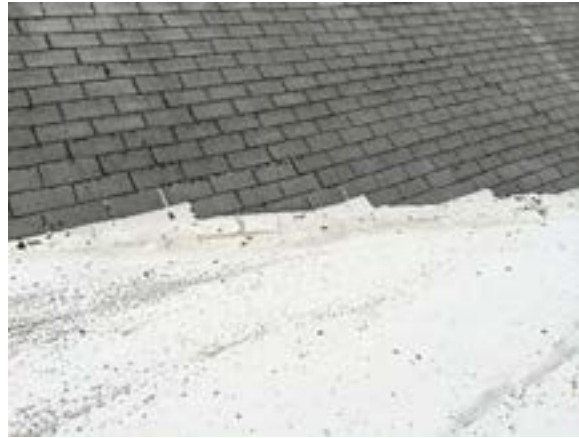
Shingles are brittle and falling apart

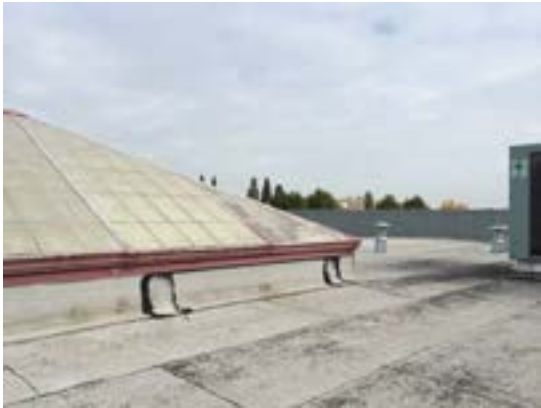
The BUR was installed in 1988 and is in poor shape with numerous repairs. The BUR has reached the end of its life cycle and has many leaks. The large fiberglass skylight structure appears to have worn down to the fiber, and needs to be replaced. With some repairs this roof may last another year or two at best.

SKYLIGHT WEARING THROUGH

Recommended Repairs Estimate: \$ 5,000.00

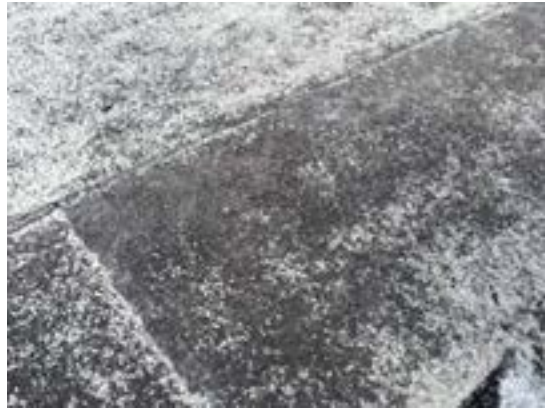
BUR WORN DOWN TO ASPHALT

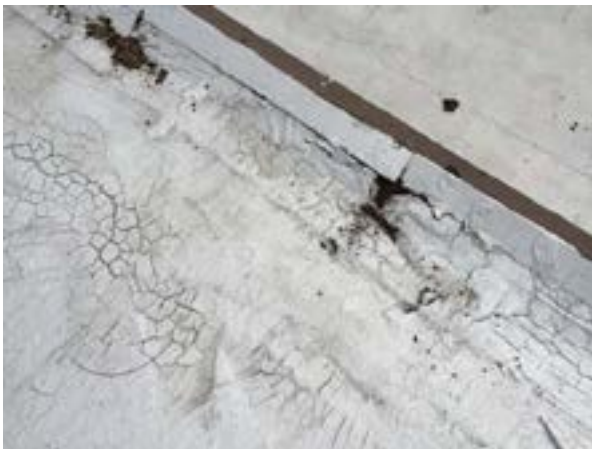
The district offices/administration building is a BUR installed in 1986 and then a Tremco Ply felt flood coat aluminum emulsion coating which was reapplied in 2006. New HVAC equipment was installed above the board room recently and was installed with too many penetrations without counter flashings. A few leaks have been reported in this area. In general, this roof has expended its useful life cycle but has been nursed along with the aluminum emulsion coatings. Given the fact that there are no apparent blisters, I would recommend touching up the aluminum emulsion coating and sealing penetrations while budgeting for replacement within the next three years.

Cracking and Failing along edges of Roof

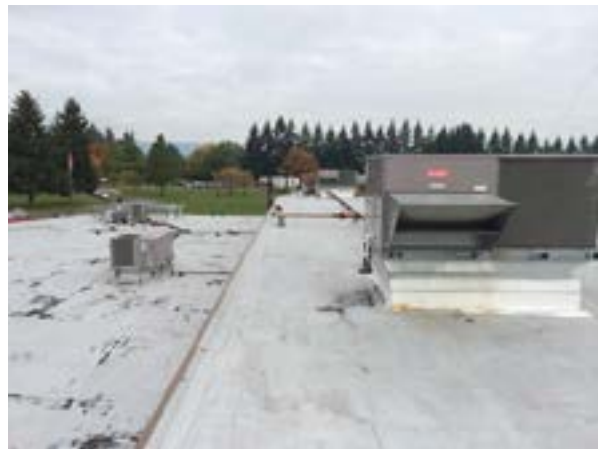
Emulsion wearing off, edges failing

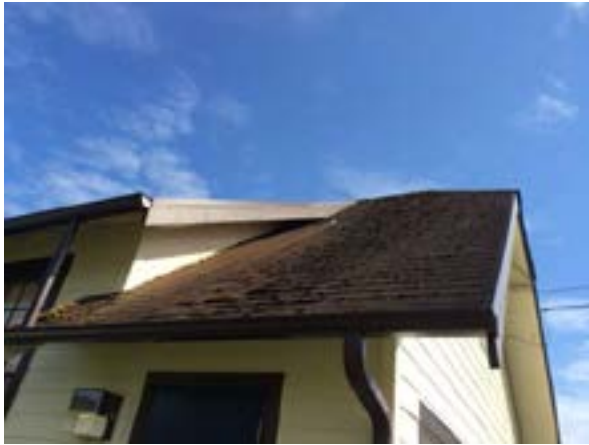
This school has three distinct roof areas. The shingle portion was re-roofed in 1993 and is approximately 20 years old. The main building is a Tremco Bur with Gravel and was roofed in 1997 and has a few leaks. The gym has a Tremco Hypolan Single Ply roof installed in 1993. I would budget to replace the shingle roof in 5-10 years, the BUR with a few repairs could be extended out 5 years and the Single ply is reaching the end of its life cycle and should be replaced in the next 2-3 years.

SHINGLES SHOULD HAVE MOSS REMOVED

Recommended Repairs Estimate: \$ 5,000.00

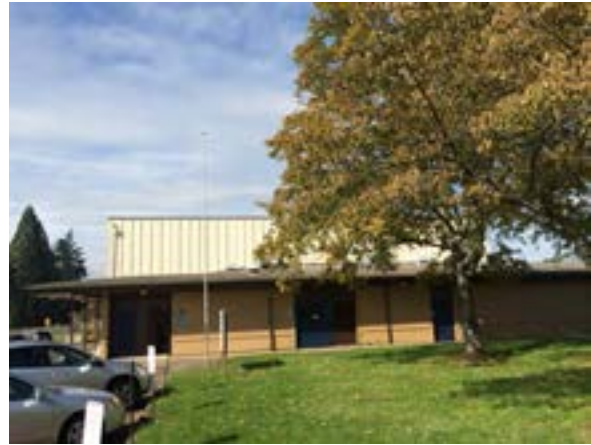
BUR NEARING END OF ITS USEFUL LIFE
