Facilities Assessment Report Corvallis School District

Submitted to Corvallis School District
by DOWA - IBI Group Architects, Inc.
February 2014

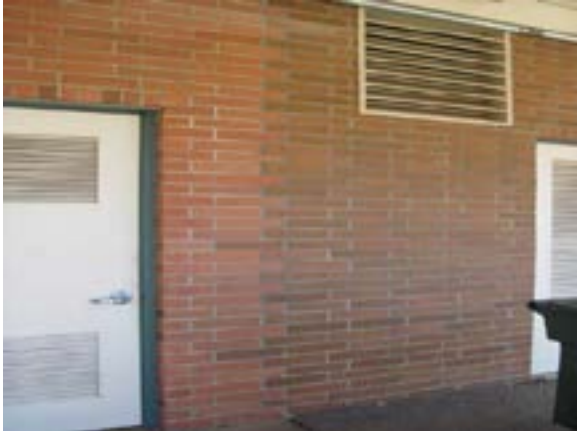
Figure A10.2.b – Brick wall

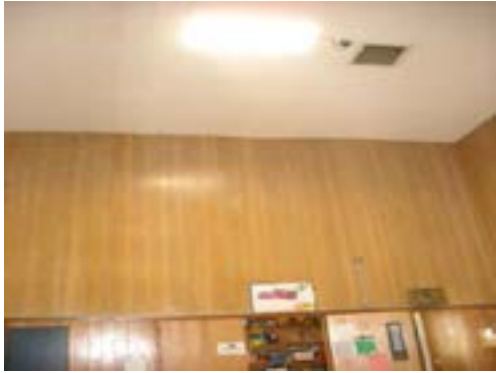
Figure B20.2 – Ceiling issues in Gym

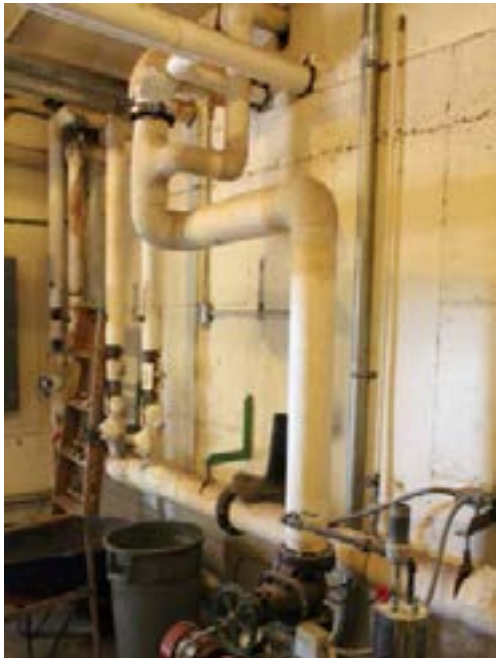
Figure C10.2 – Piping

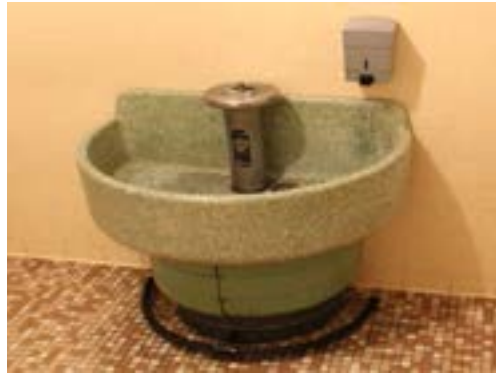
Figure C10.3 – Restroom sink

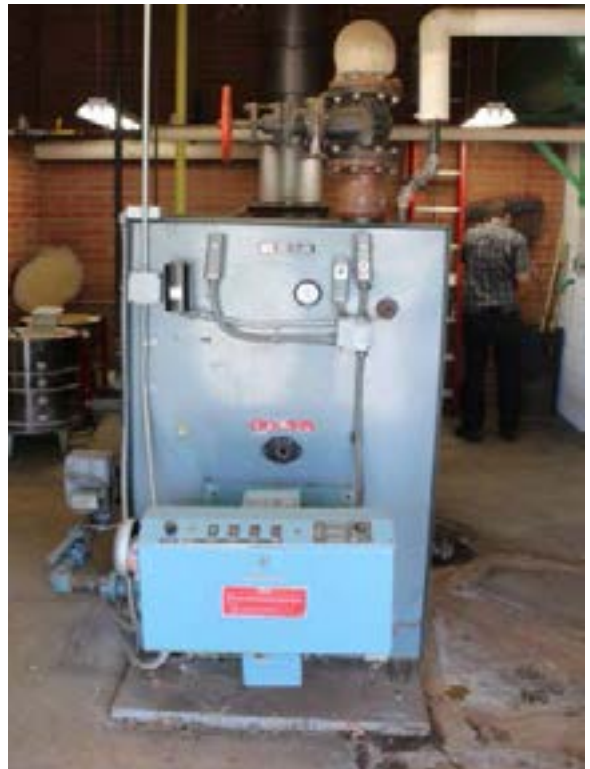
Figure C20.7 – Existing boiler

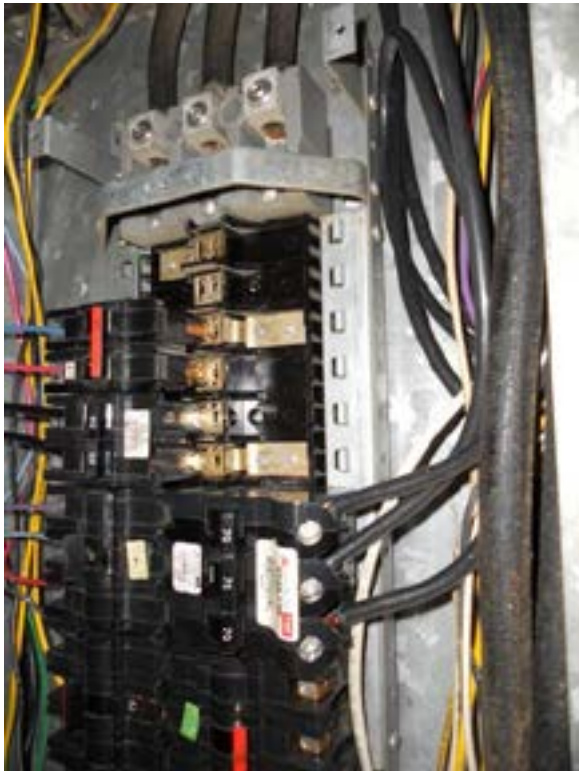
Figure D10.2.a – Typical panelboard

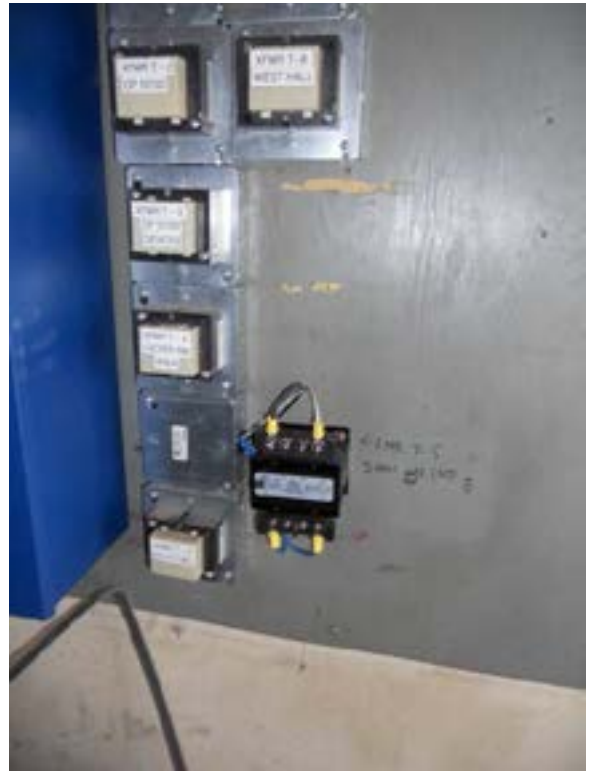
Figure D10.2.b – Control transformer

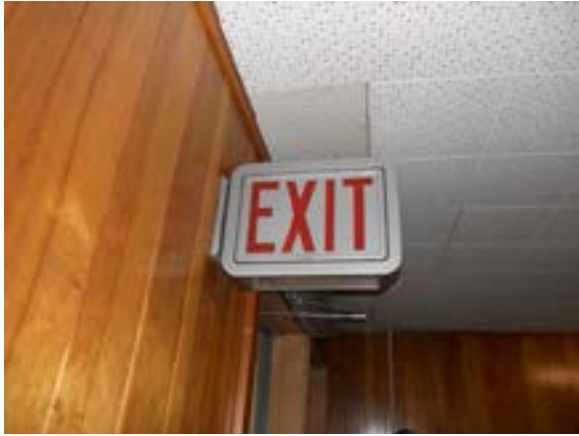
Figure D10.7.a – Exit signage

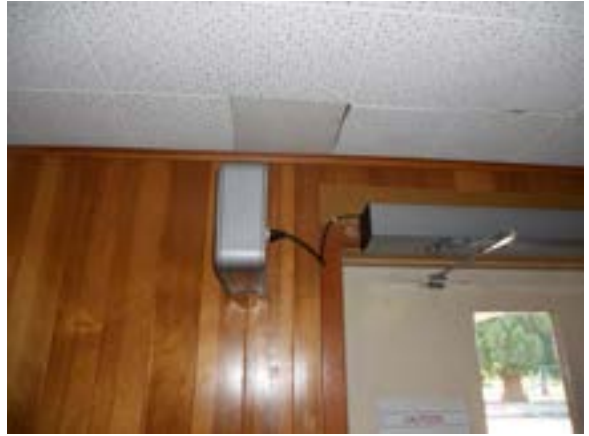
Figure D10.7.b – Circuit issues

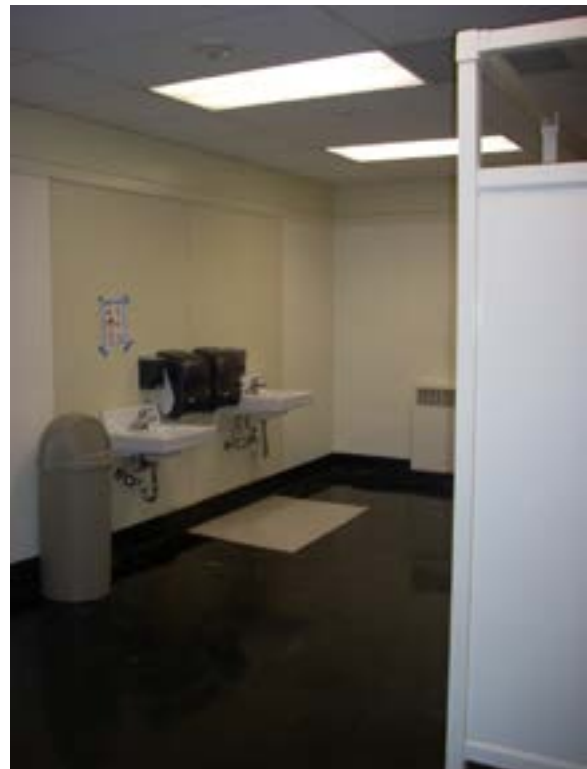
Figure B40.2 – Boys restroom flooring

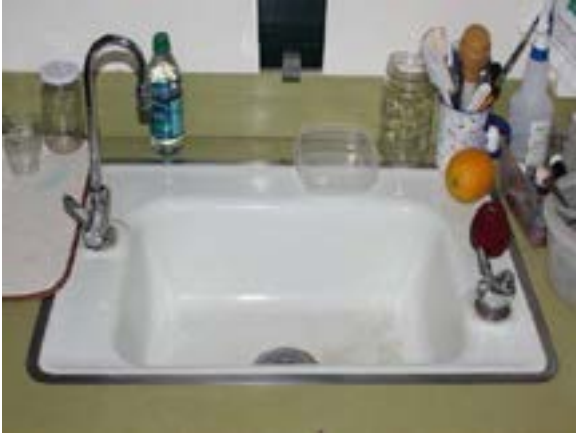
Figure C10.3 – Typical plumbing fixture

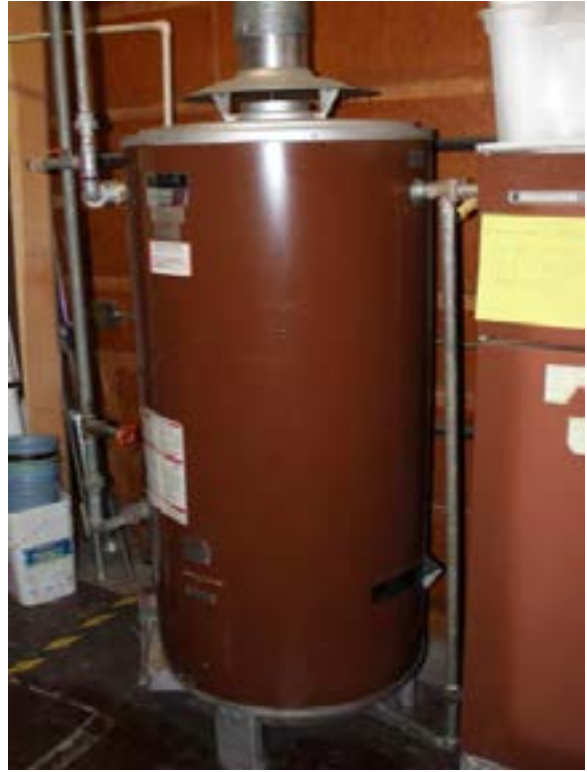
Figure C10.5 – Domestic hot water heater

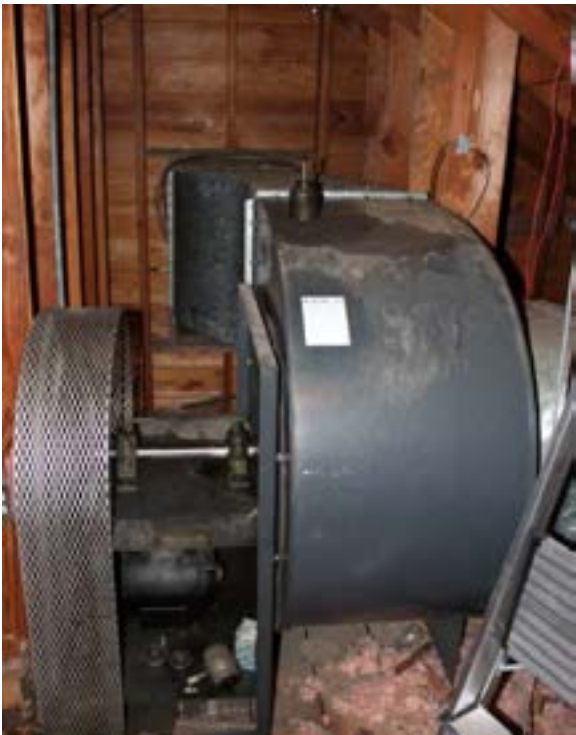
Figure C20.1 – Mechanical equipment

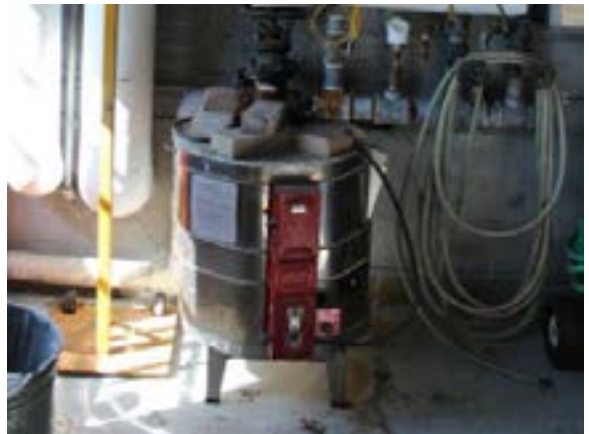
Figure C20.7 – Mechanical equipment

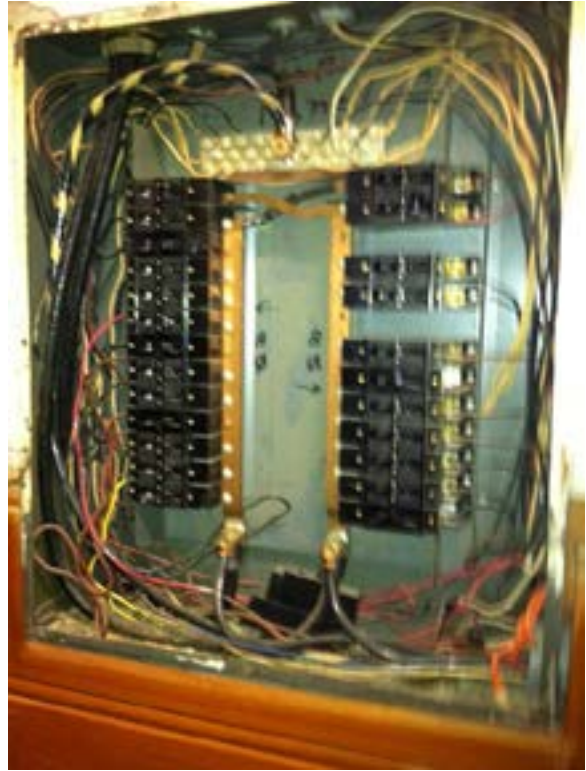
Figure D10.2.b - Typical original panel

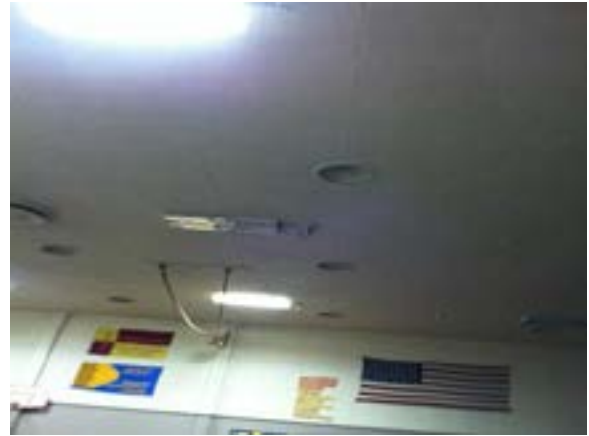
Figure D10.3.b – Cafeteria lighting

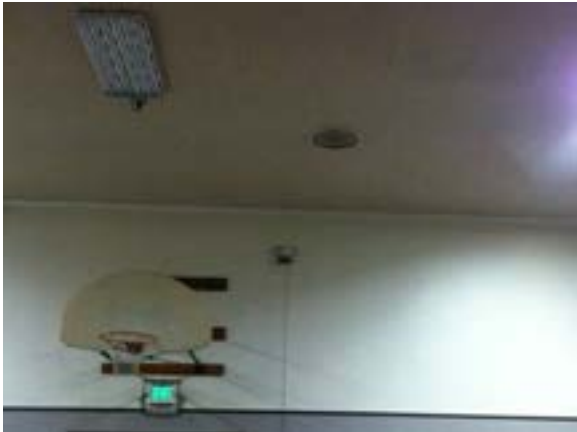
Figure D10.6 – Egress Lighting

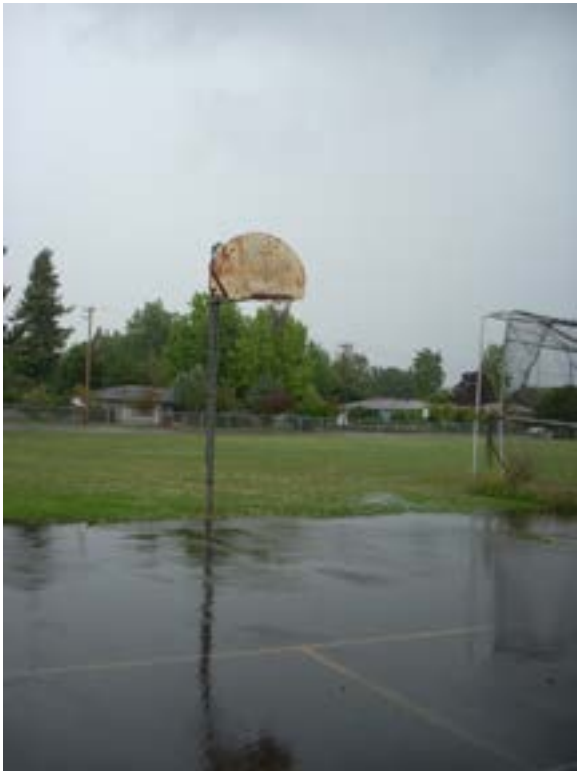
Figure E20.8 – Backboards

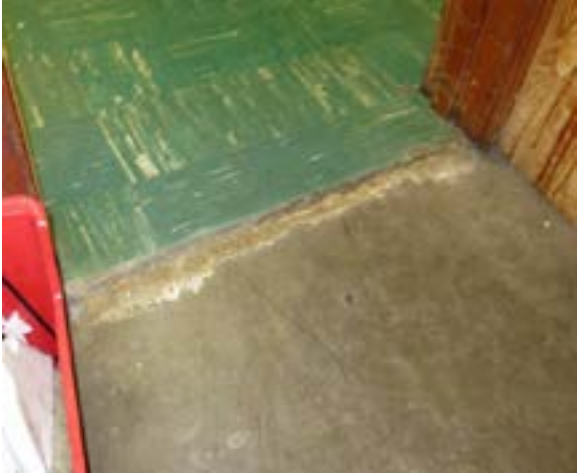
A - STRUCTURE / SHELL			
A10 – STRUCTURE / SUBSTRUCTURE			
Item		Findings	Comments
A10.1	Foundations	<ul style="list-style-type: none"> No issues observed 	
A10.2	Subgrade Enclosures	<ul style="list-style-type: none"> There is significant settlement of the slab on grade between the corridor and classrooms. See Figure A10.2. 	<ul style="list-style-type: none"> It is thought that settlement is due to poor compaction of soil below slab on grade and insufficient/absence of doweling to adjacent slabs. There does not appear to be signs of settlement of the foundations.
A10.3	Structural Systems	<ul style="list-style-type: none"> There are recommendations available for seismic improvements to the building structure, outlined in the ABKJ Seismic Analysis report, dated May 1997 and in the Degenkolb Seismic Building evaluation Phase 2 report, dated July 2000. There are recommendations available for seismic improvements to non-structural systems, outlined in the Degenkolb Seismic Building evaluation Phase 2 report, dated July 2000. 	<ul style="list-style-type: none"> In 2006 the school received a new roof with seismic upgrades including strengthening the connections of the roof diaphragm to the shear walls and adding plywood sheathing to previously deficient areas. The old brick chimney was also removed and replaced with a code-approved metal flue.

Figure A10.2 – Settlement at door threshold

RECOMMENDATIONS			
A10.2	Remove existing flooring and grind the existing concrete to provide a smooth transition. Refer to Section B20 for flooring findings and recommendations.		
A10.3	<p>Prioritize and perform the recommended improvements to structural systems as outlined in the ABKJ and the Degenkolb reports. The report provides specific recommendations. These include but are not limited to the new plywood shear walls, wall out-of-plane bracing at the gym and blocking at vertical diaphragm discontinuities.</p> <p>Perform recommended seismic improvements to non-structural components as outlined in the Degenkolb report. These include, but are not limited to, installing seismic shut off valves and flexible couplings in gas pipes where they enter the building, anchoring and strapping of mechanical and electrical equipment, and bracing suspended equipment and ceiling.</p>		
A20 - EXTERIOR COMPONENTS

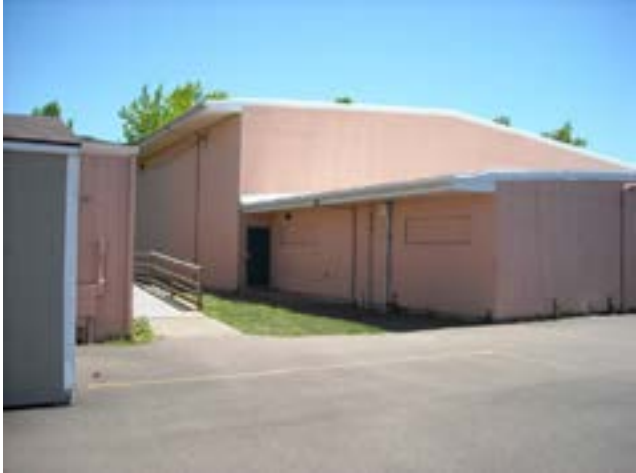
Item		Findings	Comments
A20.1	Exterior Walls	<ul style="list-style-type: none"> The wood siding on (2) sides of the gymnasium are in poor condition. See Figure A20.1. Mechanical grilles are damaged along the north classroom wing. Skirting around the modulars needs to be replaced. 	<ul style="list-style-type: none"> Brick veneer is in good condition.

Figure A20.1 – Gymnasium siding

RECOMMENDATIONS	
A20.1	Remove damaged siding on two sides of building and replace with prefinished fiber cement siding. Replace (6) mechanical grilles. Replace modular skirting at all modulares.
A20.2	If remodel work were to occur at this facility, the replacement of wire glass with tempered glazing may be required. Wire glass may also be replaced at the District's discretion to prevent any issues if glazing is damaged or broken. Replace (8) doors at modulares. Re-paint (12) exterior doors and frames on main building. Replace (3) pairs of exterior doors at the gymnasium. Replace (7) classroom wood doors with hollow metal doors.
A20.3	Replace all single pane glazing with aluminum storefront, tempered glazing and operable vents. Repaint all wood trim around windows. Replace (1) door knob with lever-type hardware.
A20.4	Provide internal roof access (hatches and ladders). Replace roofing per roofing assessment recommendations.

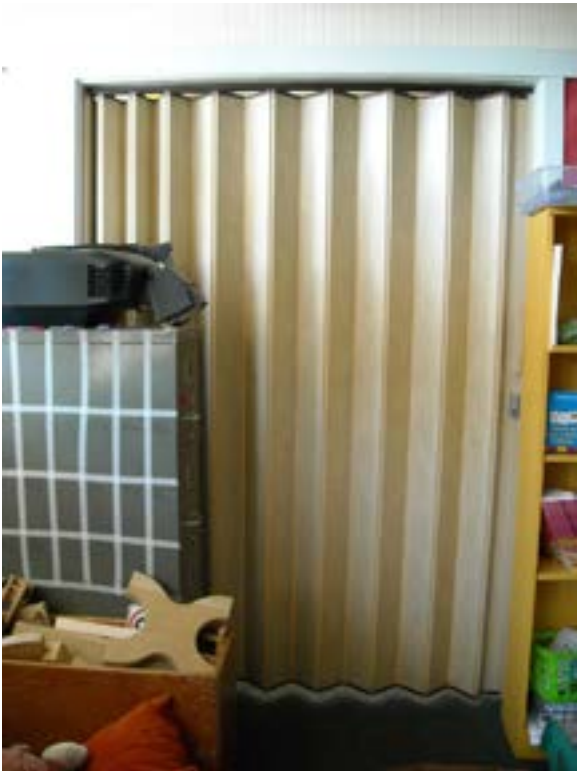
Figure B30.3 – Operable Partitions

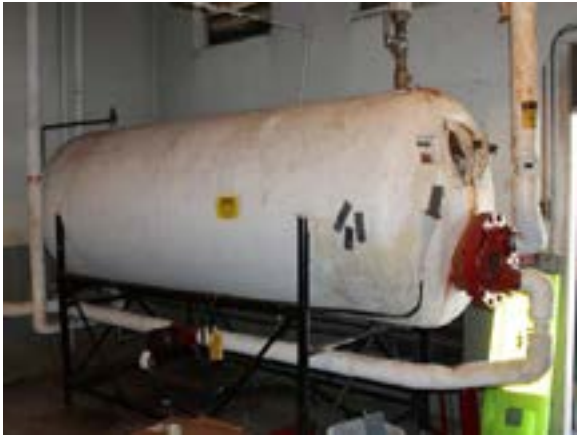
Figure C10.5 – Domestic hot water storage tank

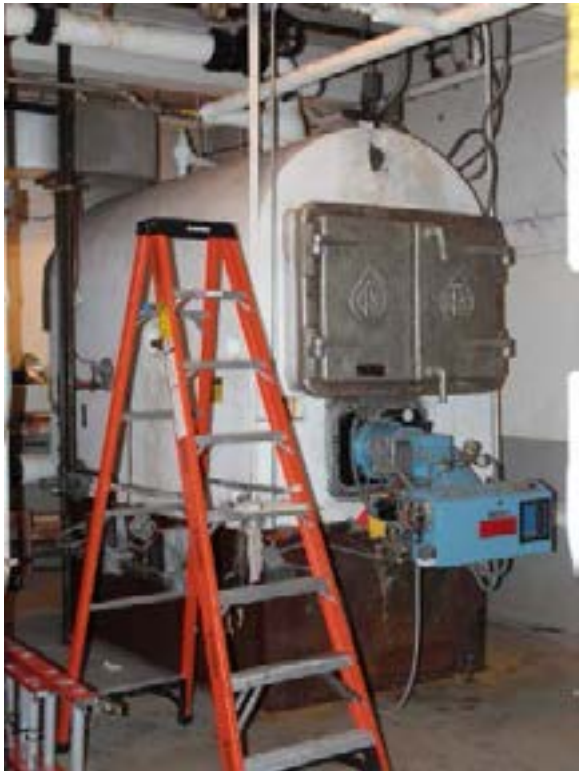
Figure C20.7.b – Existing boiler

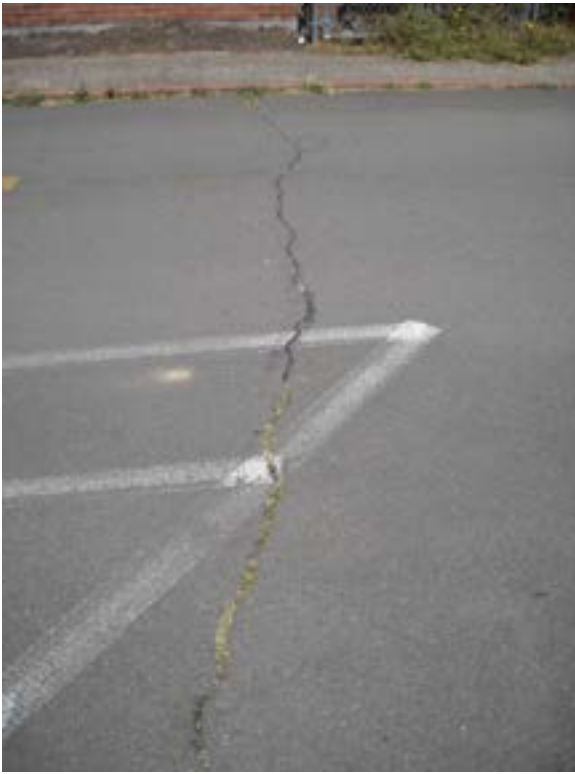
Figure E10.1 – Parking lot

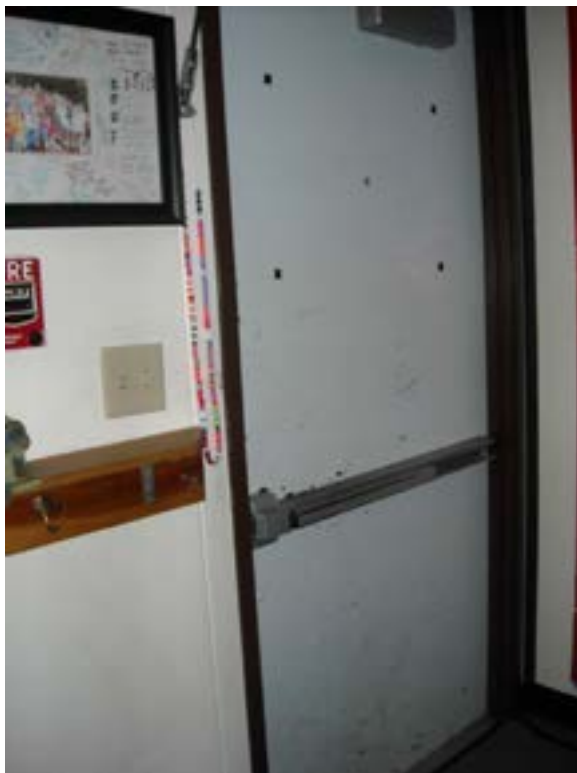
Figure A20.2 – Portable door

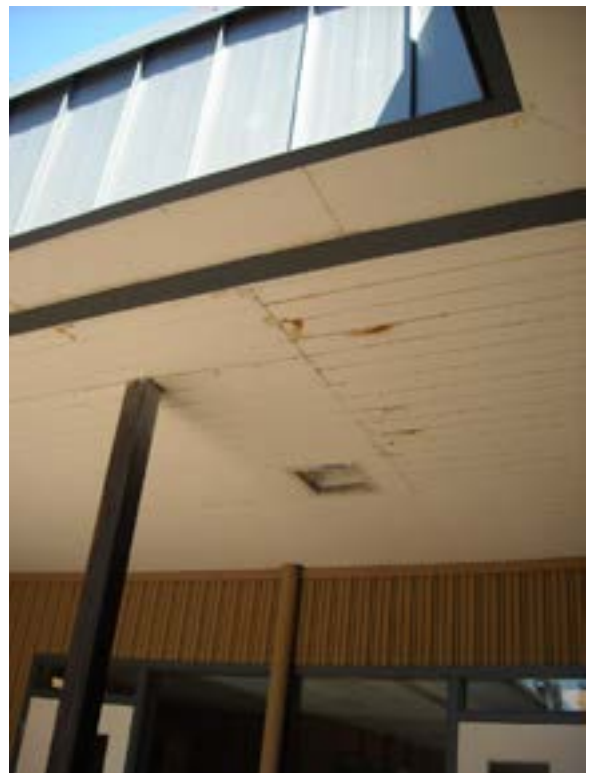
Figure A20.7- Soffit

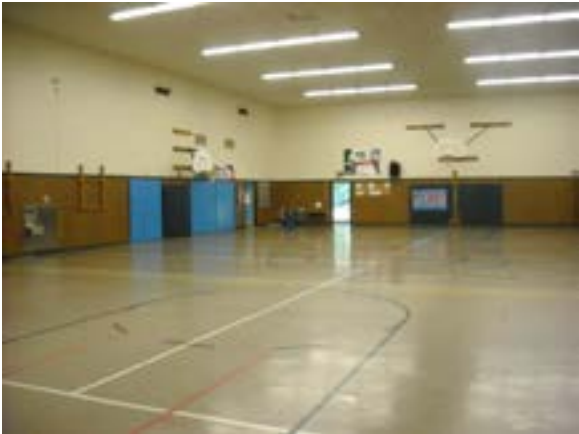
Figure B20.1.b – Gymnasium flooring

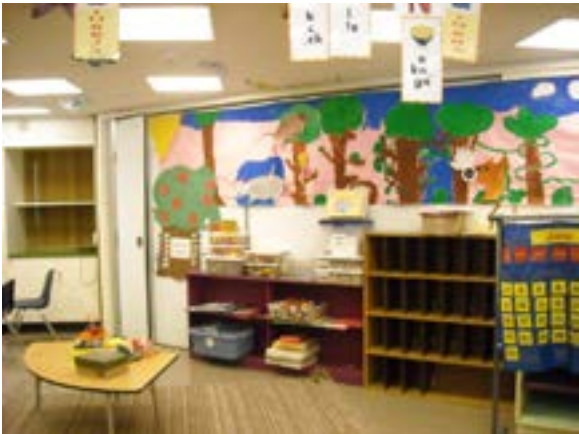
Figure B30.3 – Typical classroom partition

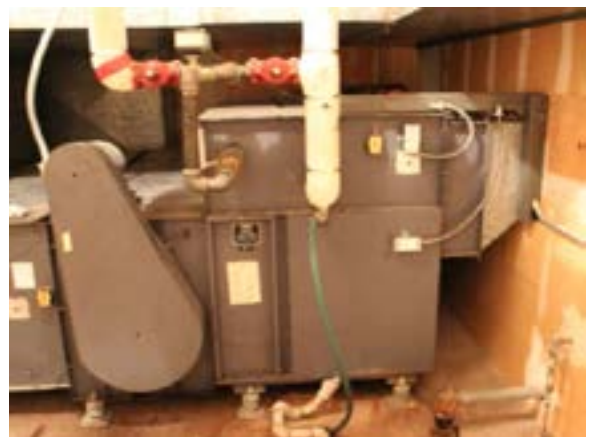
Figure C20.7.a – Boiler

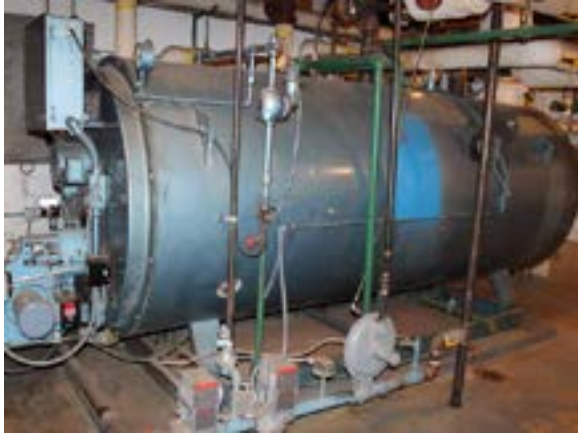
Figure C20.7.b – Hot water piping/pumps

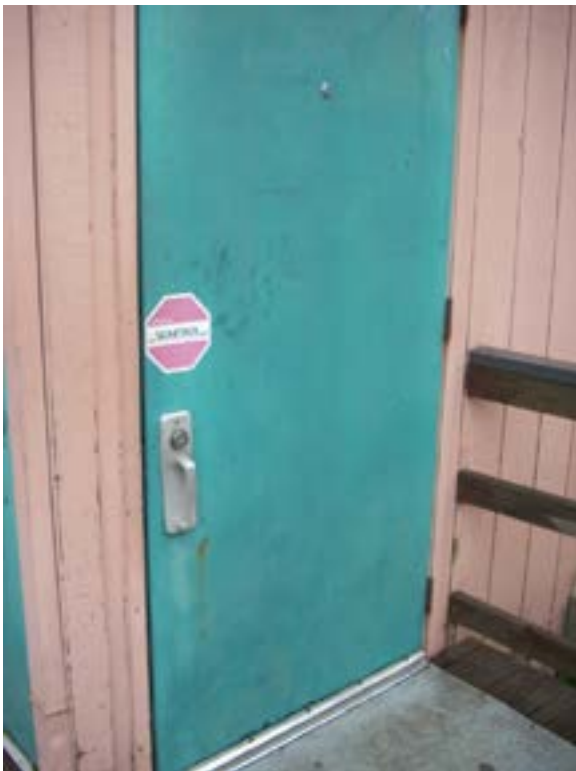
Figure A20.8 – Ramps at portable

- A20.1 Install skirting/panels at all modulares.
- A20.2 If remodel work were to occur at this facility, the replacement of wire glass with tempered glazing may be required. Wire glass may also be replaced at the District's discretion to prevent any issues if glazing is damaged or broken.
Repaint (18) single doors and frames. Replace (2) single exterior doors and frames at gymnasium.
Provide new doors, frames, hardware, kick plates and card readers to improve security. Replace doors, frames and associated hardware at modulares.
- A20.4 Replace roofing per roofing assessment recommendations.
- A20.8 Replace (2) ramps and (2) sets of stairs at modulares.

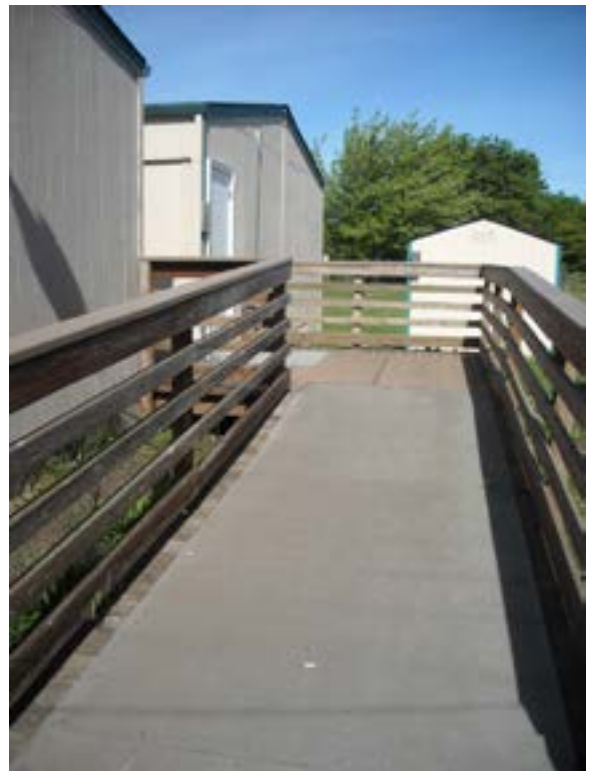
Figure B20.1 – Hallway carpeting

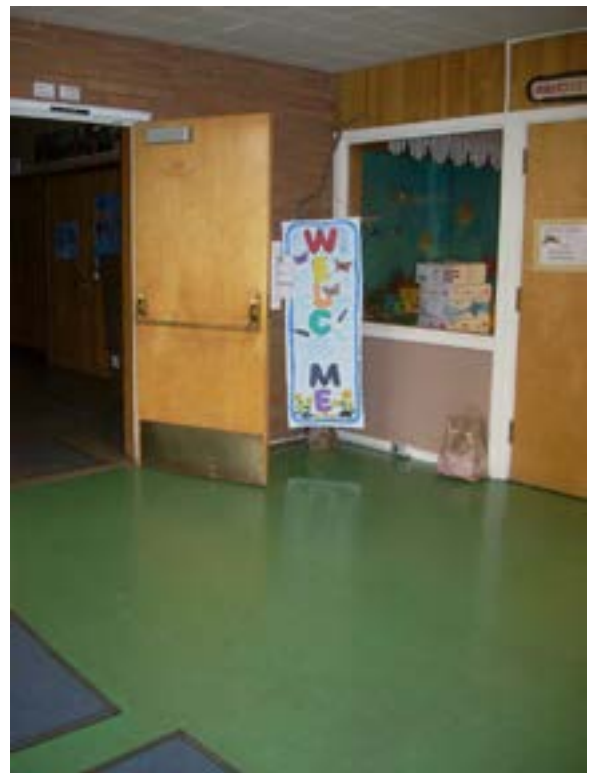
Figure C10.2 – Hot water piping

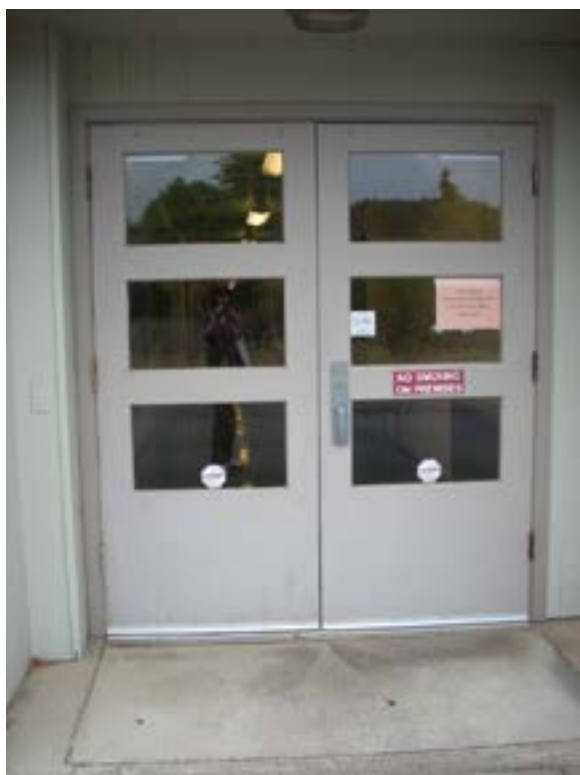
Figure A20.2 – Exterior doors

- A20.2 If remodel work were to occur at this facility, the replacement of wire glass with tempered glazing may be required. Wire glass may also be replaced at the District's discretion to prevent any issues if glazing is damaged or broken.
Replace (1) pair exterior doors and frames. Replace (6) single metal doors and frames at modulars and provide weather-stripping above doors for protection. Replace (1) single door and frame at gymnasium; provide new door, frame, hardware and kickplate.
- A20.4 Replace roofing per roofing assessment recommendations.
- A20.8 Replace (3) ramps and handrails at modular buildings.

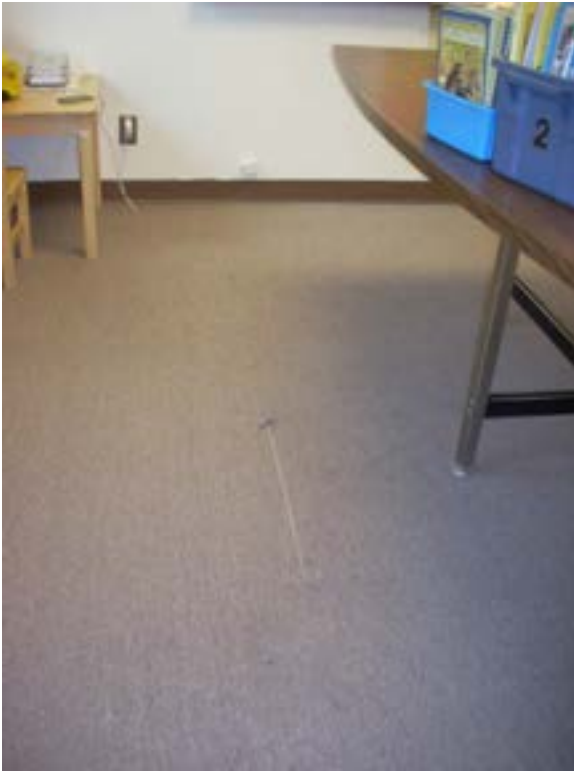
Figure B20.1 – Carpeting in office

RECOMMENDATIONS	
B20.1	Remove all asbestos flooring tile in hallways, main office, gymnasium and (7) classrooms and replace with VCT. Remove all wood and rubber base in this facility and replace with new rubber base. Replace carpeting in office area and principal's office, and in Classroom 8. Abate kitchen flooring and replace with slip resistant sheet vinyl flooring and coved base. Replace carpeting in the library and adjacent work room. Provide fixed walk off mats at (6) exterior door locations. Replace flooring in (1) portable with VCT.
B20.2	Replace 12x12 ceiling tile in kitchen and replace with epoxy painted gypsum board ceiling.
B20.3	Replace ceilings in all hallways, at stage and (1) classroom with 2x4 lay-in acoustical ceiling system.
B20.4	Replace (6) backstops.
B20.6	Remove FRP panels in cafeteria and replace with new FRP panels. Remove all wood paneling from hallways and replace with full height plastic laminate wainscoting.

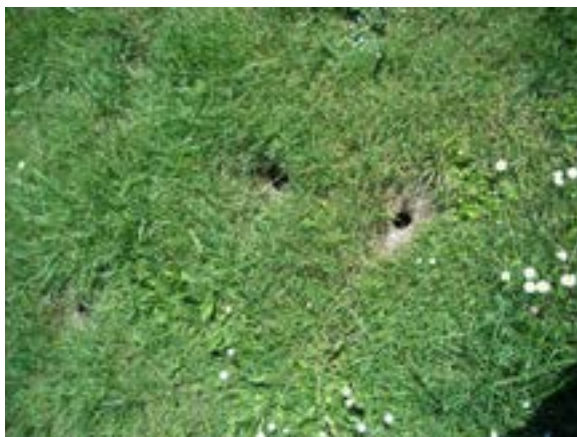
Figure E20.1 – Field issues

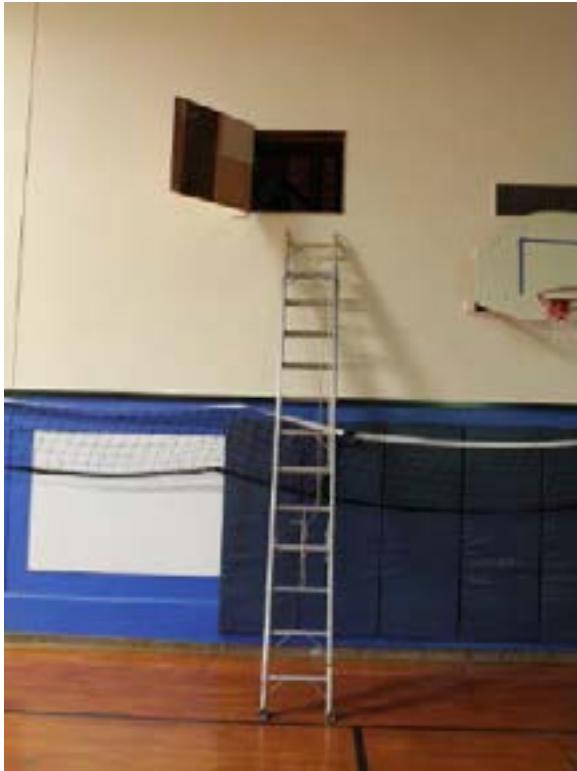
Figure C20.1.b – Equipment access

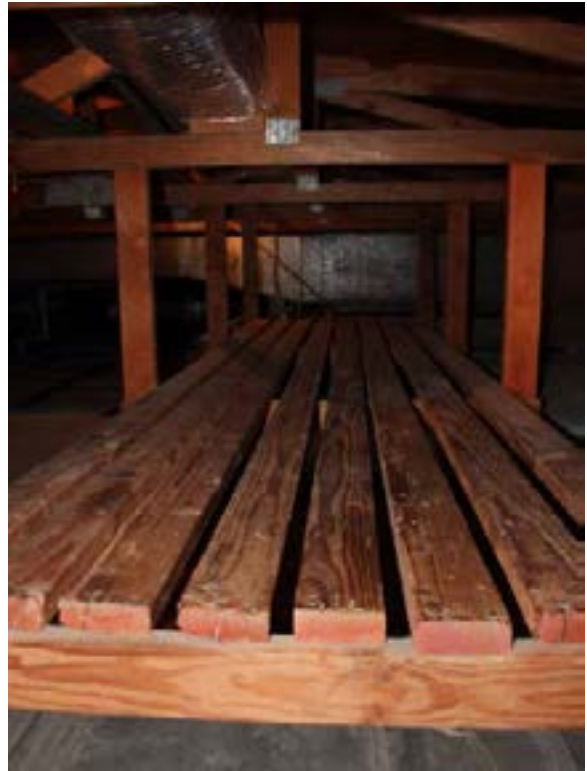
Figure C20.1.c – Equipment access

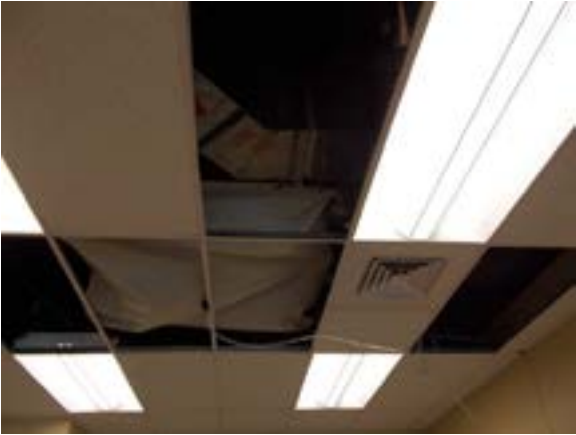
Figure B20.3 – Classroom ceiling

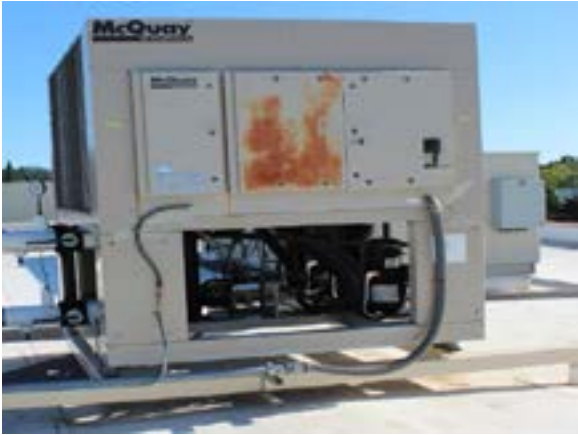
Figure C20.1 – Failing paint on unit

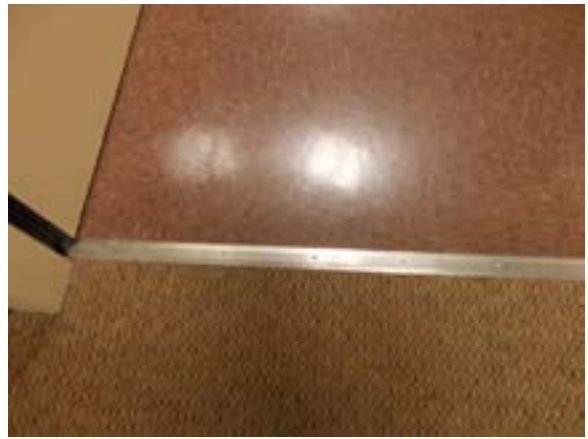
Figure B20.1 - Carpeting

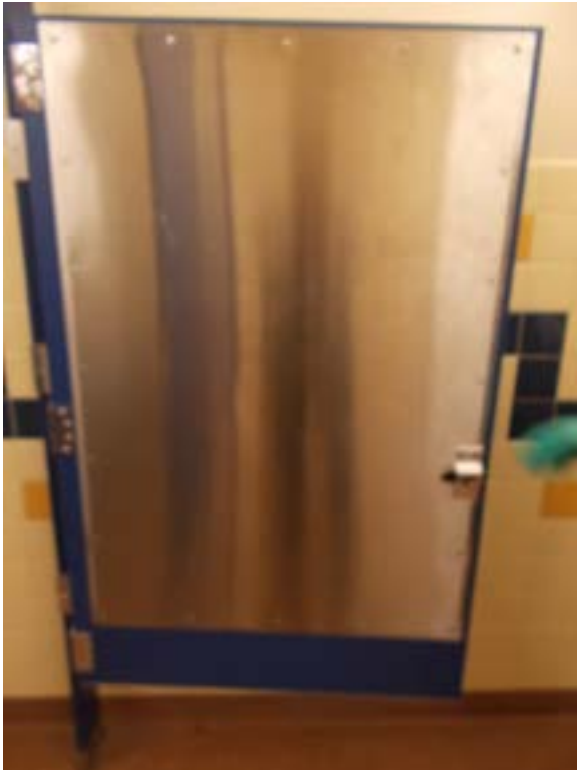
Figure B40.4 – Toilet partitions

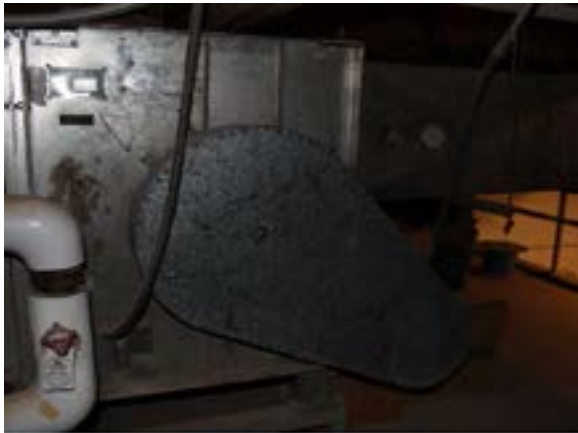
Figure C20.1.b – Mechanical equipment

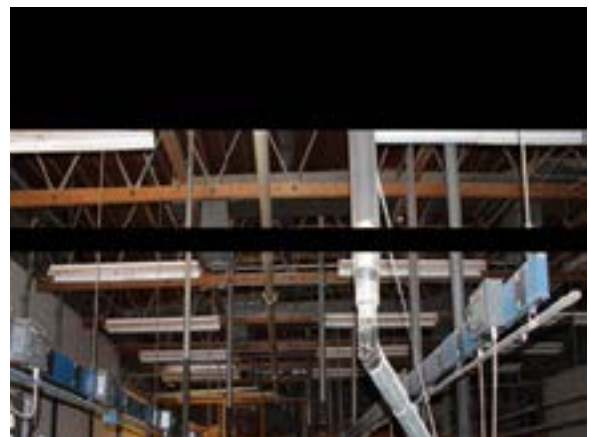
Figure D10.2.b – Aging busway system

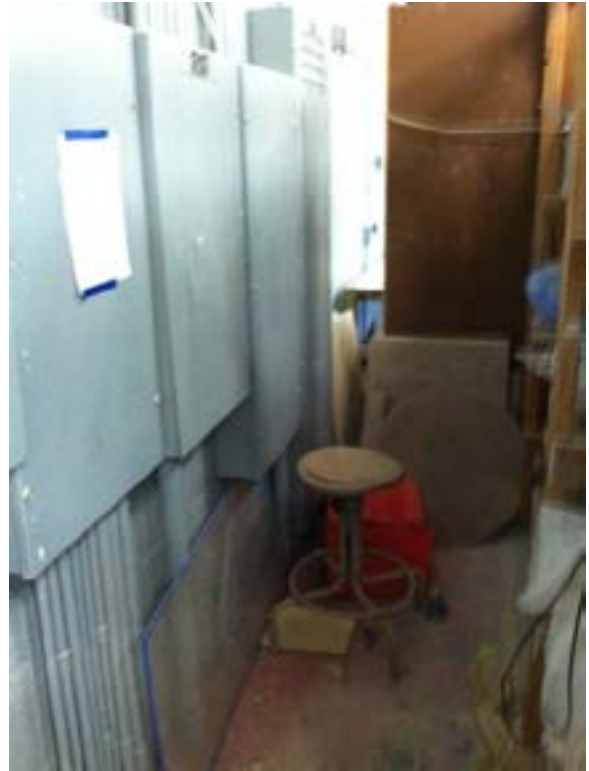
Figure D10.2.d – Electrical clearance

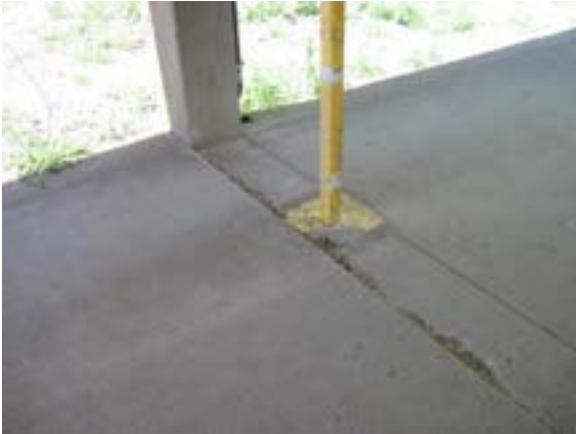
Figure A10.2 – Covered walkway

RECOMMENDATIONS	
A10.2	Fill and patch cracked concrete in covered walkway floor slabs to avoid trip hazards. In areas where a slab panel has settled relative to adjacent panel, grind the edge of the adjacent panel flush with lower slab.
A10.3	<p>Investigate the extent of the cracks and assess the probable cause at Building A. Install a crack monitor to help determine if cracks are due to original shrinkage or if there is ongoing movement. Epoxy inject or seal cracks if cracks are deemed to be original shrinkage cracks and no further study is necessary.</p> <p>At the crack in the masonry wall at Building B continue to check existing crack monitor. If movement persists, it may be necessary to remove carpeting in hallway and determine if the floor slab or foundation is experiencing some settlement or is significantly cracked, which may require further study and possible strengthening.</p> <p>At Buildings B, C/D/E and F, patch and fill cracking and spalling at top of exterior columns supporting covered walkways to prevent further wear and possible reinforcement corrosion or exposure.</p> <p>Patch and fill cracking and spalling of precast concrete fascia panels to prevent further wear and possible reinforcement corrosion or exposure at all buildings. Replace existing sealant between joints and between panels and concrete structure to prevent further wear and possible water infiltration.</p> <p>At Building C/D/E, anchor mechanical units in mechanical mezzanines. Refer to CH2MHILL report for a complete list of seismic improvements to non-structural components.</p> <p>Prioritize and perform the remaining recommended improvements to structural systems as outlined in the CH2MHILL report. The report provides specific recommendations for each of the building areas. These include but are not limited to the construction of new wood shear walls, wall out-of-plane bracing, strengthening of the roof diaphragms, and strengthening the concrete panel connections at the gym.</p> <p>Perform recommended seismic improvements to non-structural components as outlined in the CH2MHILL report. These include, but are not limited to, anchoring and strapping of mechanical and electrical equipment, and bracing suspended equipment.</p>

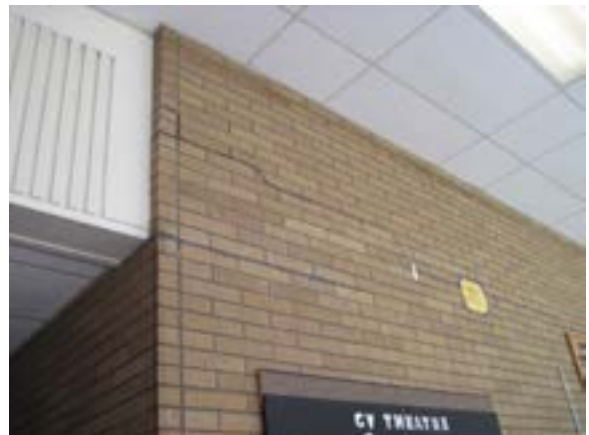
Figure A10.3.c – Cracks at Auditorium wall

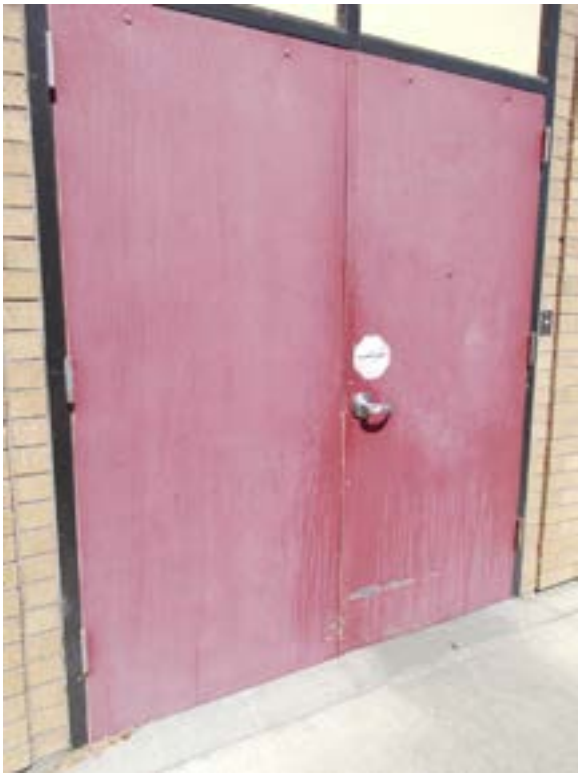
Figure A20.2.a – Exterior doors

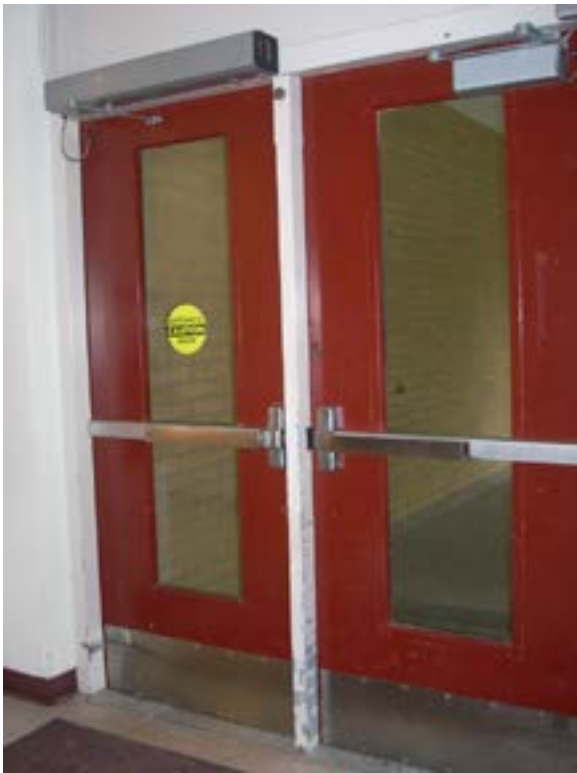
Figure A20.2.b – Exterior doors

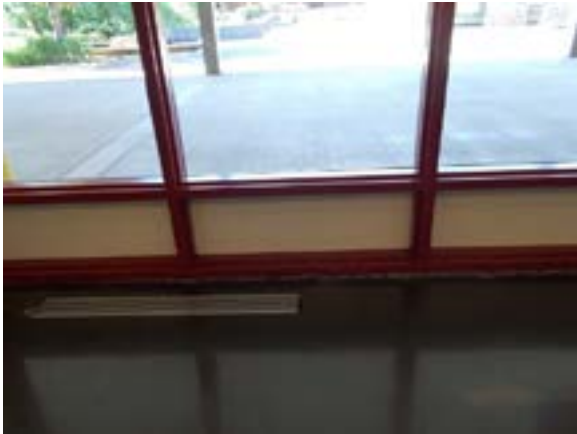
Figure A20.3.a – Windows in cafeteria

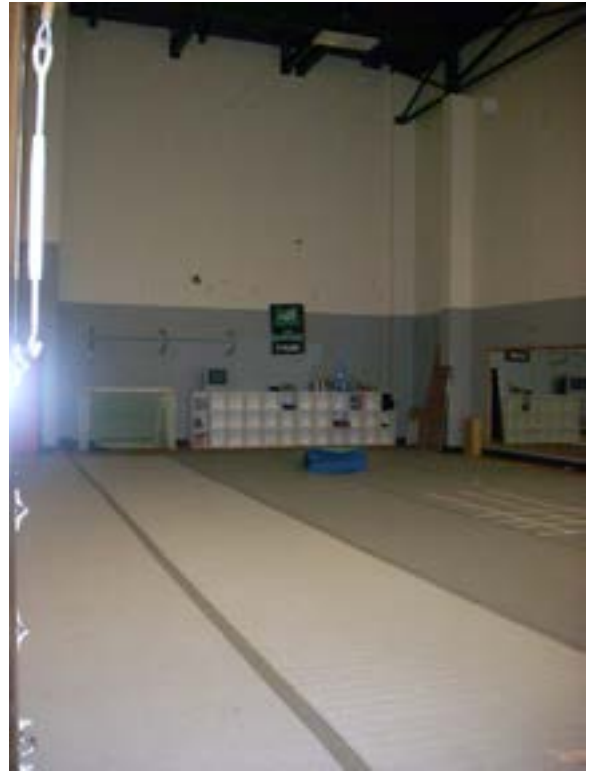
Figure B30.3 – Lack of acoustic treatment

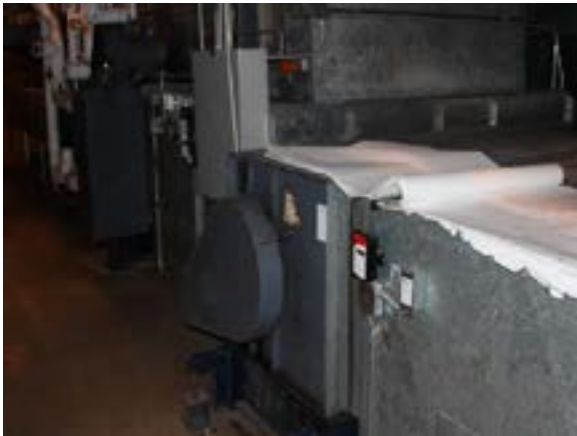
Figure C20.1 – Dated equipment

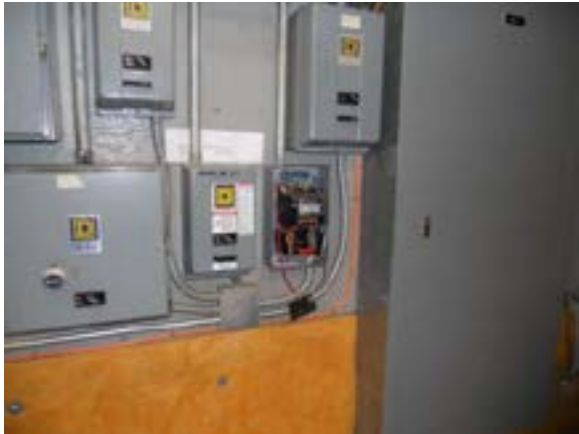
Figure D10.3.a – Typical mechanical room lighting

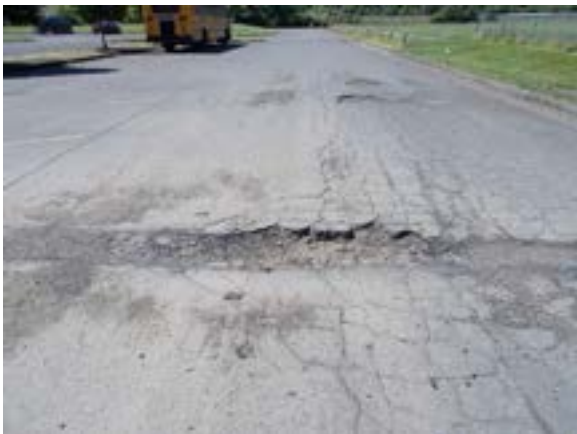
Figure E10.1.b- Parking lot

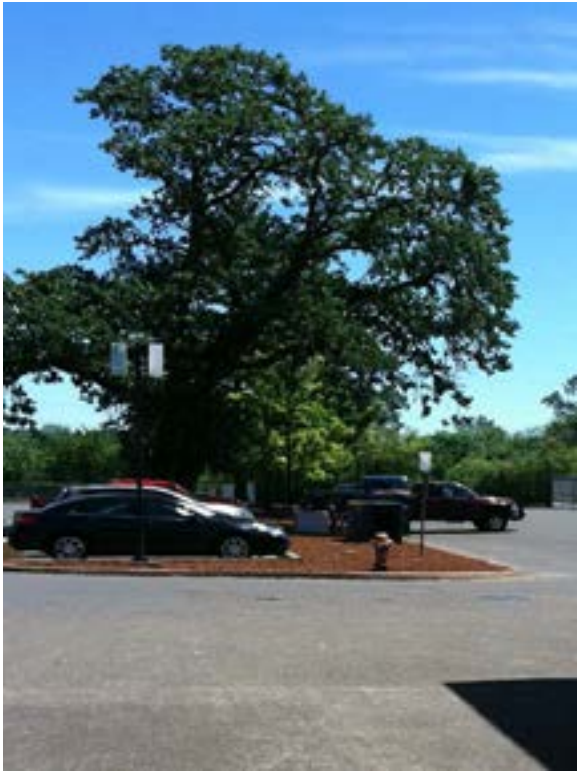
Figure E20.9.b - Unshielded lamps

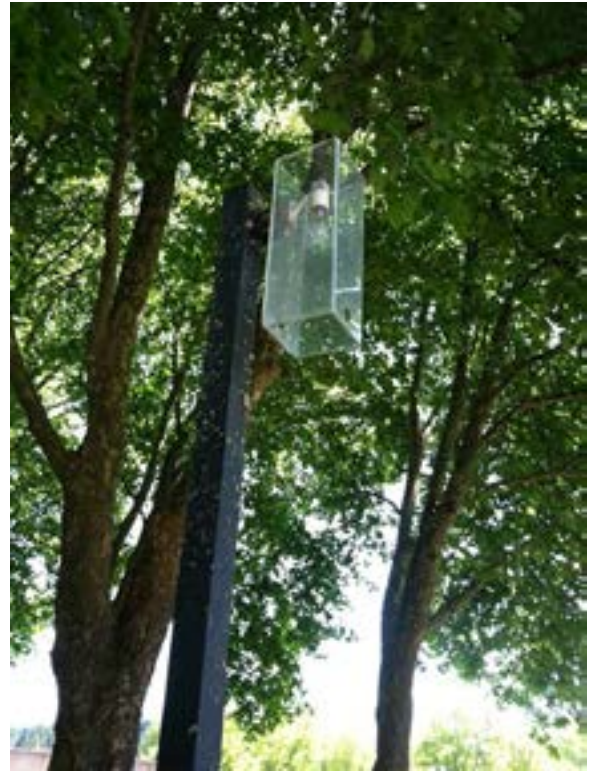
Figure E20.9.c – Walkway lighting

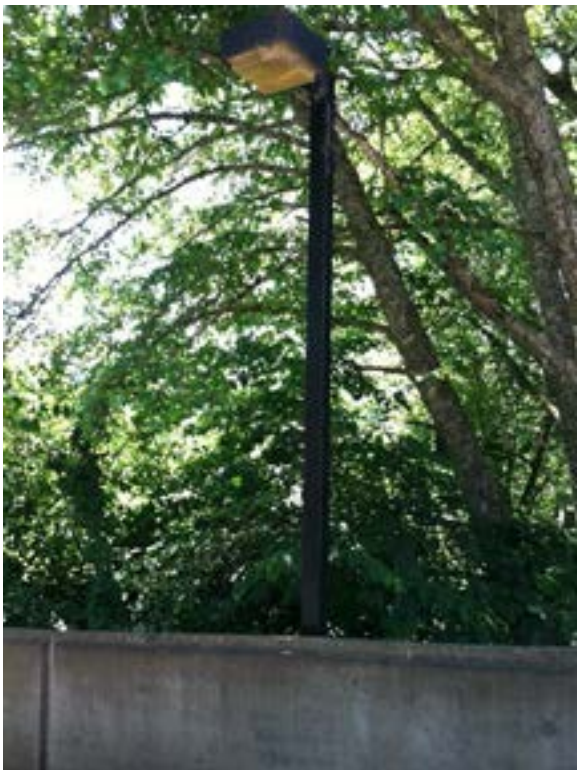
Figure E20.9.d – Site lighting

E20.3	1 Replace irrigation system at football field with a new system that has manifolds boxes out of the playing area			X			\$ 118,593		
	2 Provide a well on the site dedicated to the irrigation system		X			\$ 79,062			
E20.8	1 Replace tennis court surfacing and provide new nets and posts		X			\$ 592,968			
E20.9	1 Replace and extend parking and walkway lighting		X				\$ 210,000		
	2 Replace building luminaires			X				\$ 200,000	
	3 Replace broken light fixture behind Building B	X				\$ 50,000
