Facilities Assessment Report Corvallis School District

Submitted to Corvallis School District
by DOWA - IBI Group Architects, Inc.
February 2014

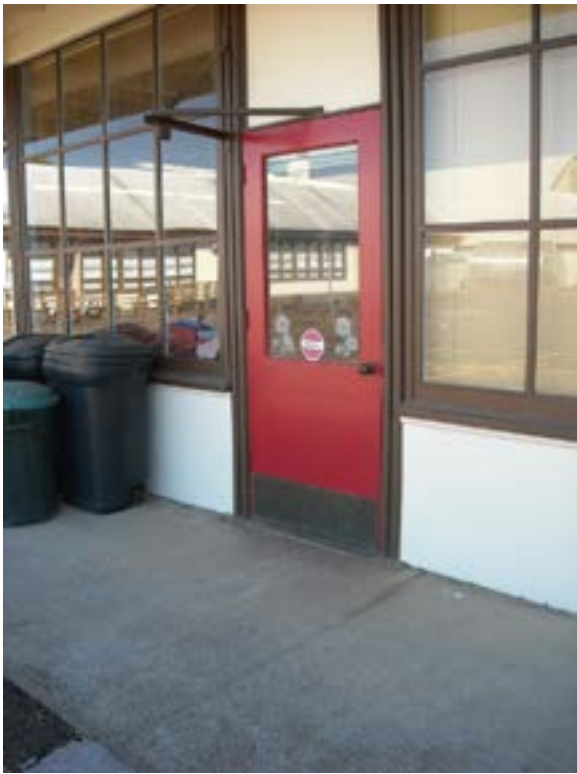
Figure A20.2.b – Gymnasium Doors

ITEMS	Harding (College Hill Campus)	Priority Level (Refer to Legend)				Priority Level I	Priority Level II	Priority Level III	Priority Level IV
		I	II	III	IV				
A - STRUCTURE/SHELL									
A10 - STRUCTURE/SUBSTRUCTURE									
A10.2	1	Install improved drainage to prevent future	X			\$ 7,906			
	2	Investigate the cause of bulging finishes and remediate issues	X			\$ 2,371			
A10.3	1	Seal cracks in exterior walls to prevent water filtration and further deterioration	X			\$ 1,581			
	2	Roughen, apply bonding agent and fill in rock pocket at top of wall near the existing lift with non-shrink grout and trowel finish	X			\$ 2,371			
	3	Complete seismic upgrades per previous reports	X			\$ 1,953,718			
A20 - EXTERIOR COMPONENTS									
A20.1	1	Repair damaged concrete wall		X			\$ 2,371		
A20.2	1	Replace wire glazing in exterior doors		X			\$ 6,109		
	2	Replace hardware at exterior doors	X			\$ 82,225			
	3	Replace exterior gym doors			X			\$ 17,710

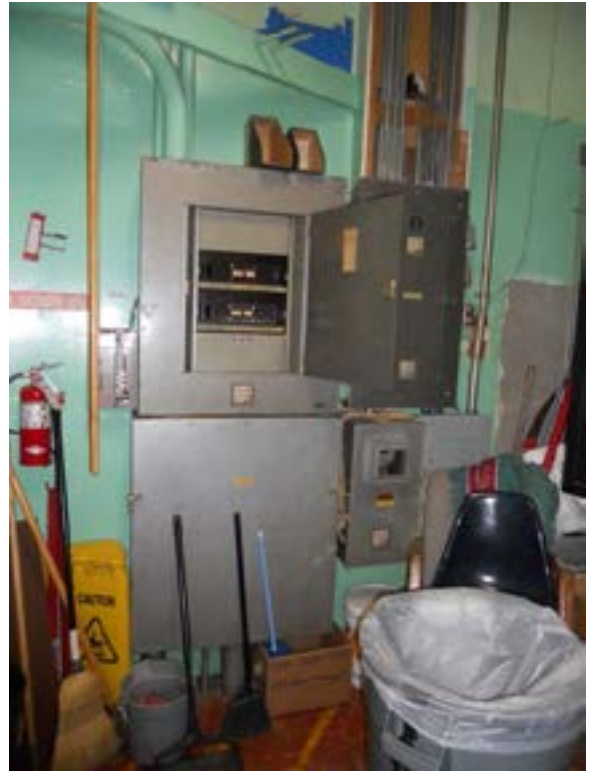
Figure D10.2.c – South electrical room

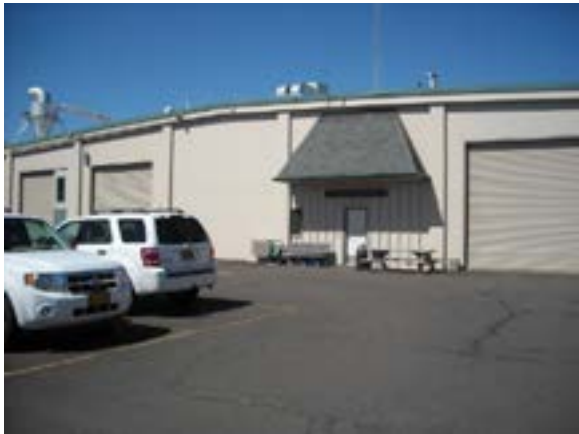
Figure B10.5 - Signage

B10.5	<p>Install compliant room signage at all buildings. Install directory signage at main entry to improve way finding. Replace ceiling hung department signage with directional signage.</p>		
B20 – INTERIOR FINISHES

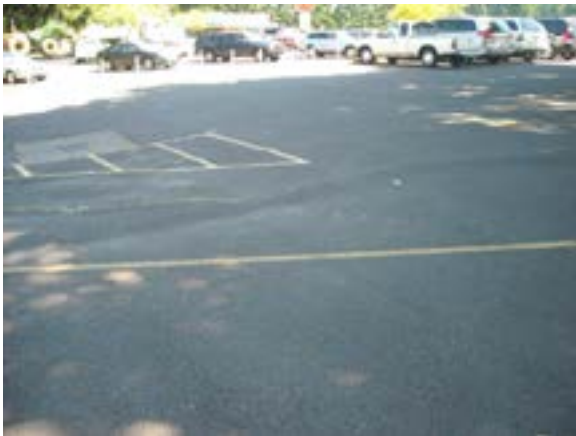
The main observation was the condition of the site's parking areas. Paving is in poor condition, and tree roots are causing damage to parking lanes. The parking lots share its ingress and egress points with the adjacent Adams Elementary School. Vehicular circulation for the school occurs in the rear of the district's campus, which feeds into the single exit point for the site.

Figure E10.1.c – Tree root damage

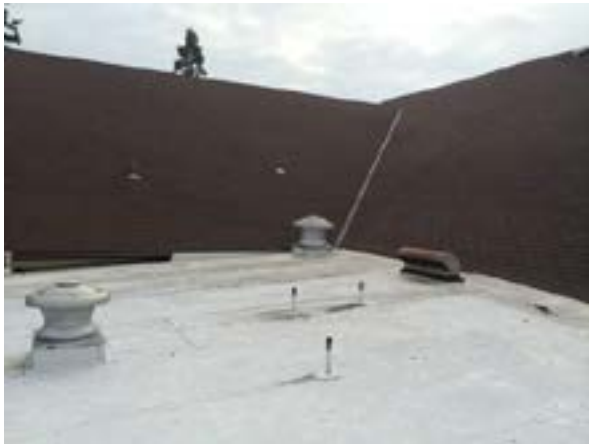
This older facility has a combination of steep shingled roof areas over a non-vented attic space and flat roof areas with TPO roofing. The TPO roofs were installed in 1989 and the shingles were installed in 1995-1997. Maintenance reports numerous leaks with this facility and our visual inspection shows the shingles are very brittle and breaking apart. Furthermore, according to maintenance the shingles were installed over skip sheathing so plywood and seismic upgrades should be completed during the next re-roof which I am recommending occurs this next summer. The TPO membrane is near the end of its life cycle and should be replaced at the same time. All gutters, downspouts and flashings will also need to be replaced. Although patching took place this summer, more maintenance will be required to get through this winter.

TPO Membrane is wearing out

Recommended Repairs Estimate: \$ 5,000.00
 Budget for Replacement in 2014: \$ 486,000.00

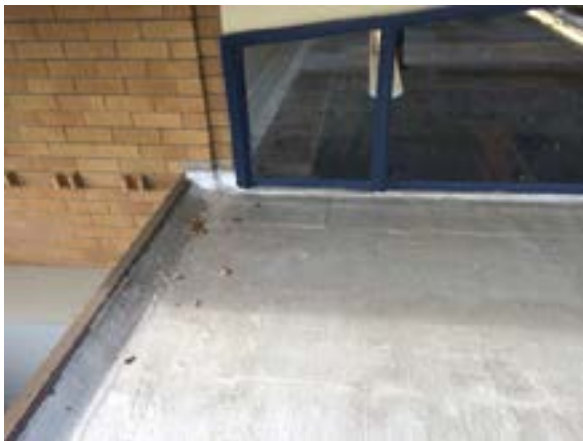
The remaining portion of the school has a BUR with Gravel which was installed in 1986-88 and has reached the end of its life cycle and experiencing leaks every year. The walkway covers are all BUR with aluminum emulsion coating which was reapplied this past summer but is losing its ability to serve as a patch. I would recommend minimal repairs this winter to get by and replace in 1-2 years maximum.

POOR DETAILING SHOULD BE REPLACED

Recommended Repairs Estimate: \$ 5,000.00

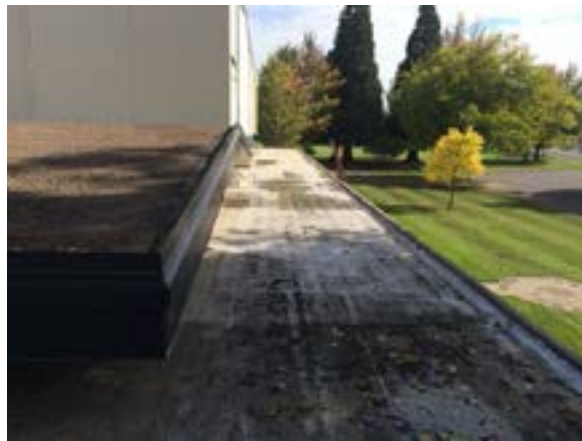
WALK COVERS ARE AT END OF USEFUL LIFE

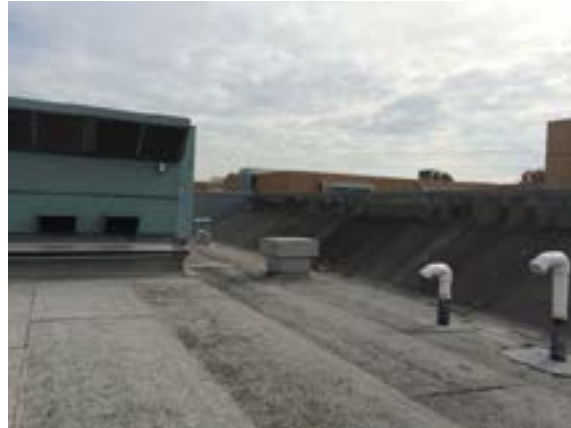
BUR wearing out

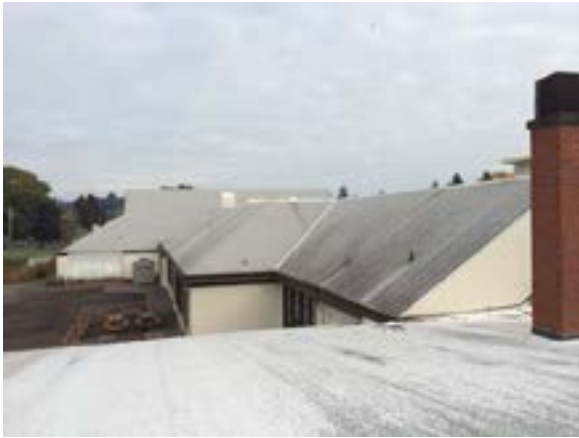
This older facility has a combination of steep shingled roof areas over a non-vented attic space and flat roof areas with TPO roofing. The TPO roofs were installed in 1988 and the shingles were installed in 1995-1997. Maintenance reports numerous leaks with this facility and our visual inspection shows the shingles are very brittle and breaking apart. Furthermore, according to maintenance the shingles were installed over shiplap sheathing so plywood and seismic upgrades should be completed during the next re-roof which I am recommending occurs this next summer. The TPO membrane is near the end of its life cycle and should be replaced at the same time. All gutters, downspouts and flashings will also need to be replaced. Some maintenance will be required to get through this winter.

TPO is reaching end of life expectancy

Recommended Repairs Estimate: \$ 5,000.00
